Memorandum

Date: September 17, 2020

Project #: 42625.00

Re: Plainfield Culvert Assessments

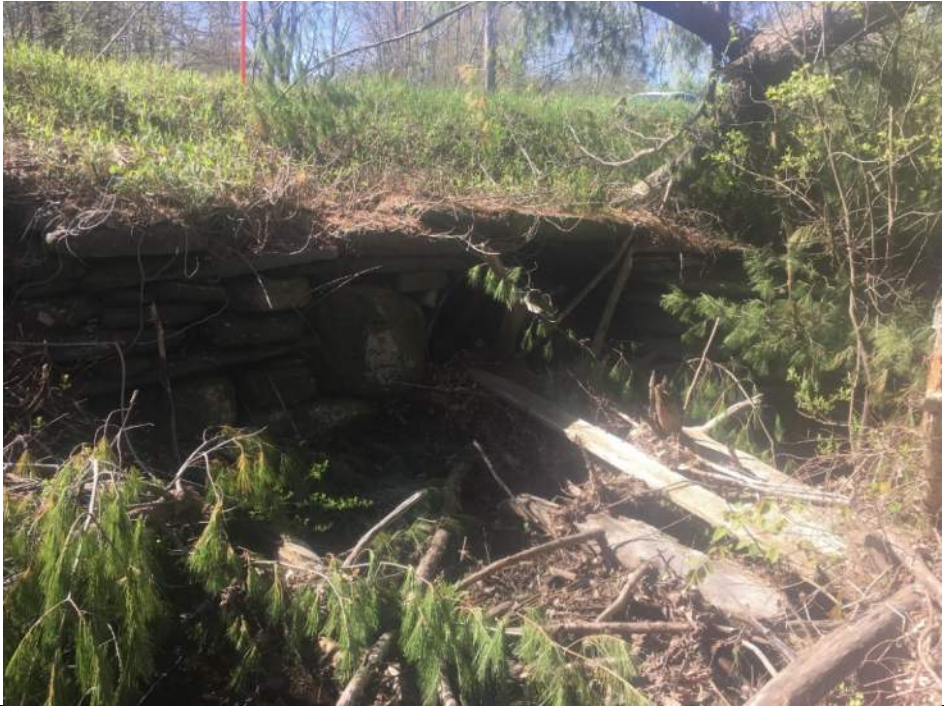
Description:				
<p>Opening filled with debris. Fall tree trunk, sticks, and leaves.</p> <p>Signs of erosion under opening in pipe</p> <p>Depression in pipe under roadway is observed</p>

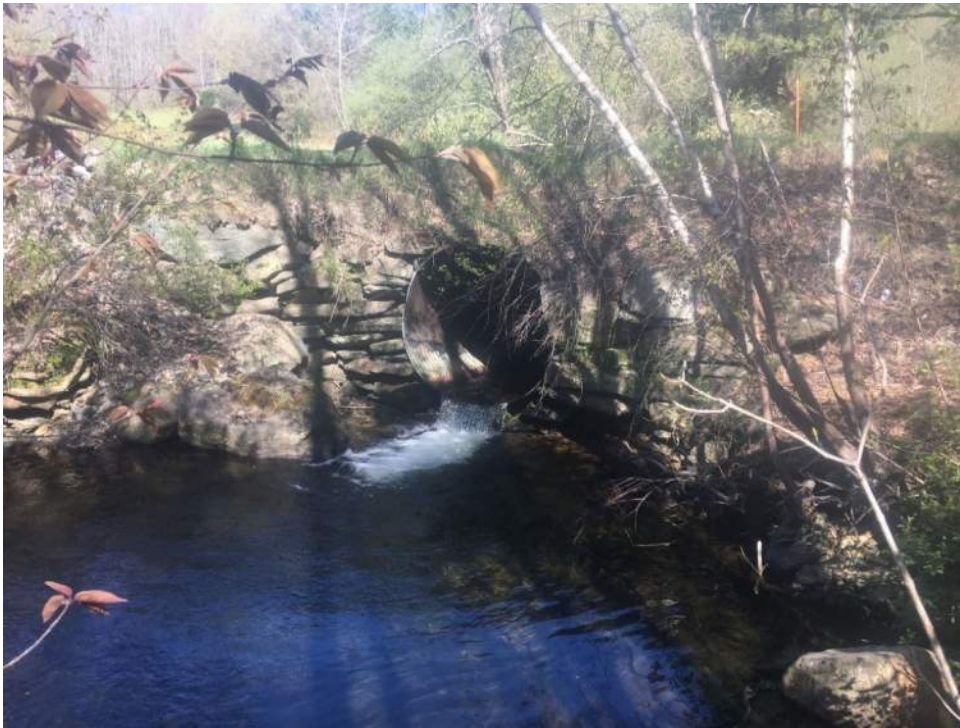
Description:				
<p>8" water dropped out of pipe</p> <p>Undercutting of stone underneath pipe edge</p>

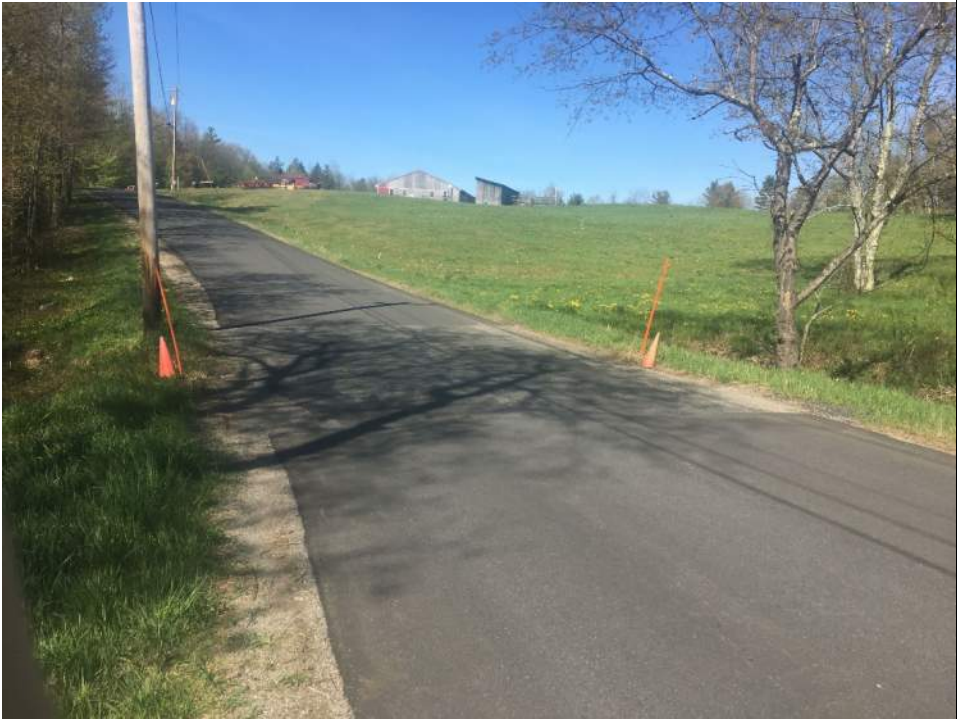
General Notes: Pipe shows signs of significant rot on metal Stone headwall falling away from road showing signs of possible collapse Section of pavement above culvert is in poor condition and in need of repair

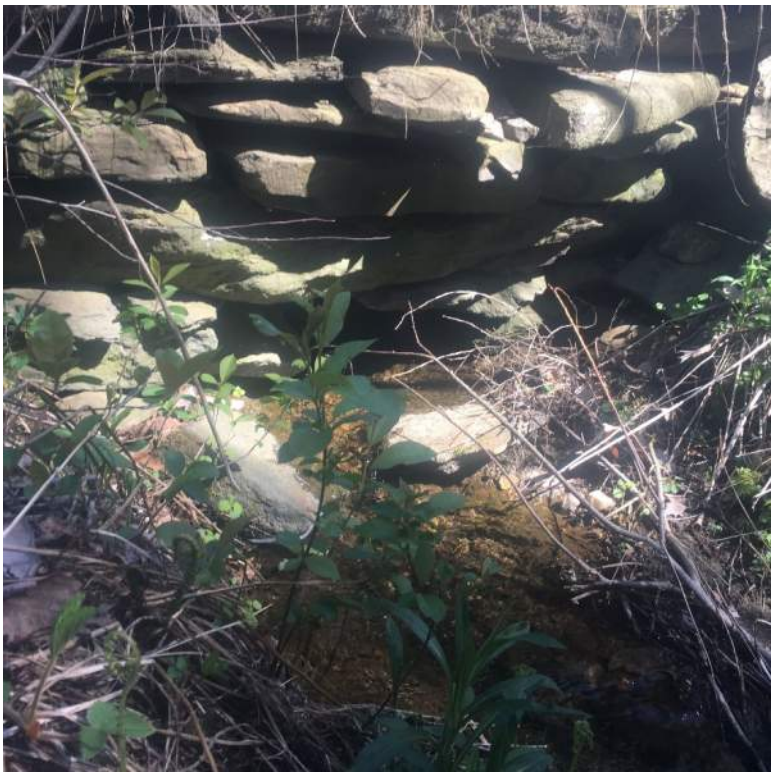
Description: Significant rot first foot of pipe Appears to be partially crushed under stone headwall Bottom of pipe filled with sediment

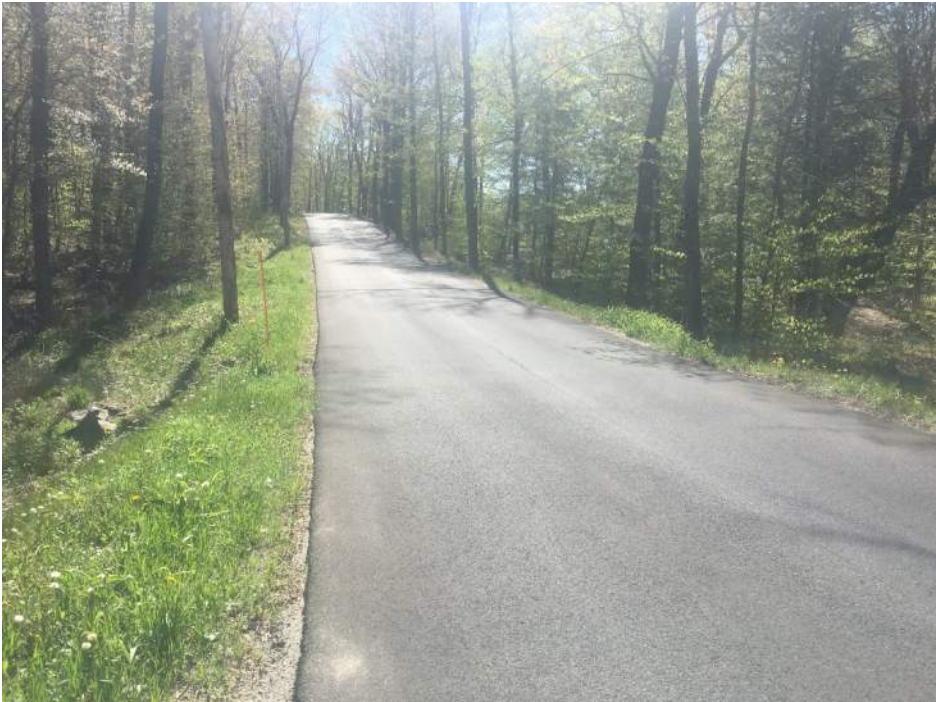
General Notes: Slight downward bend in pipe starting approximately in the center to achieve a different slope No signs of wear on pipe or build up of sediment Water flowing through pipe 2" in depth

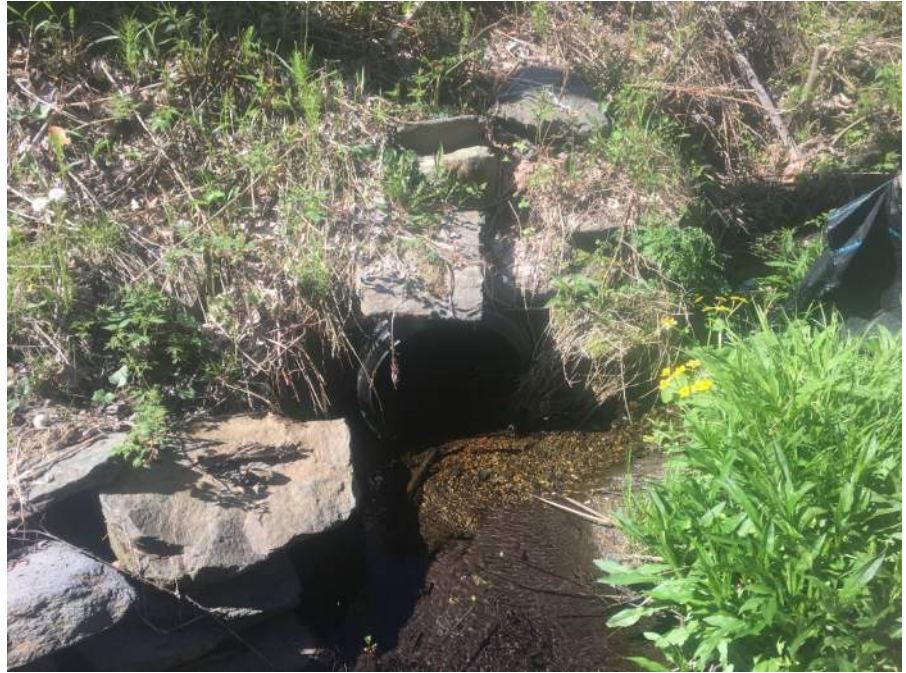
No signs of wear in pipe

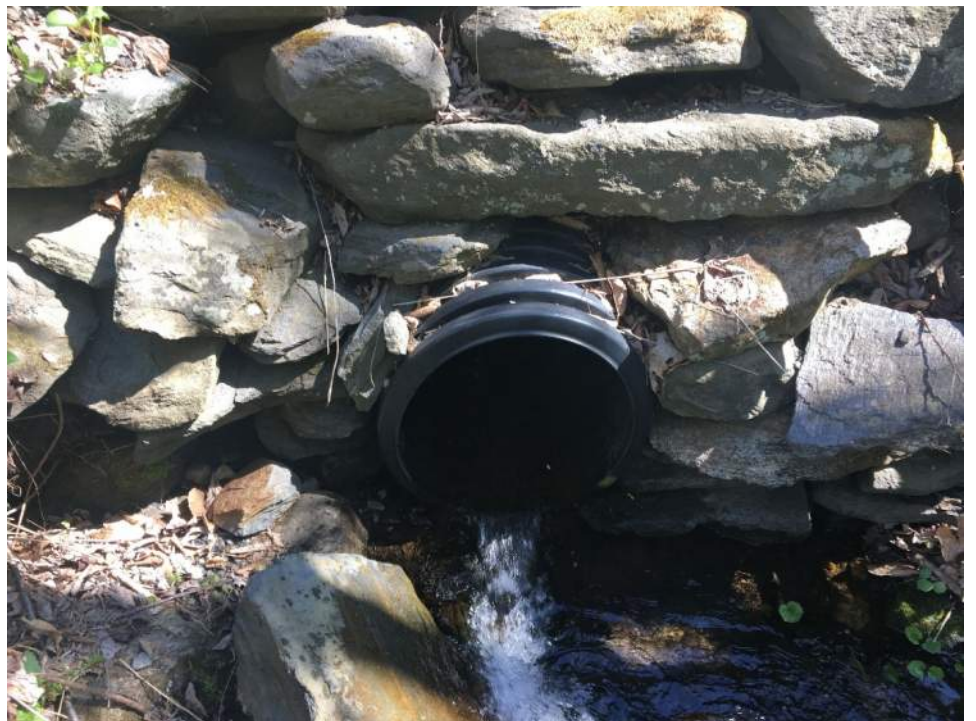
1" crack on top left side of pipe 2" from edge

Small signs of erosion undercutting pipe

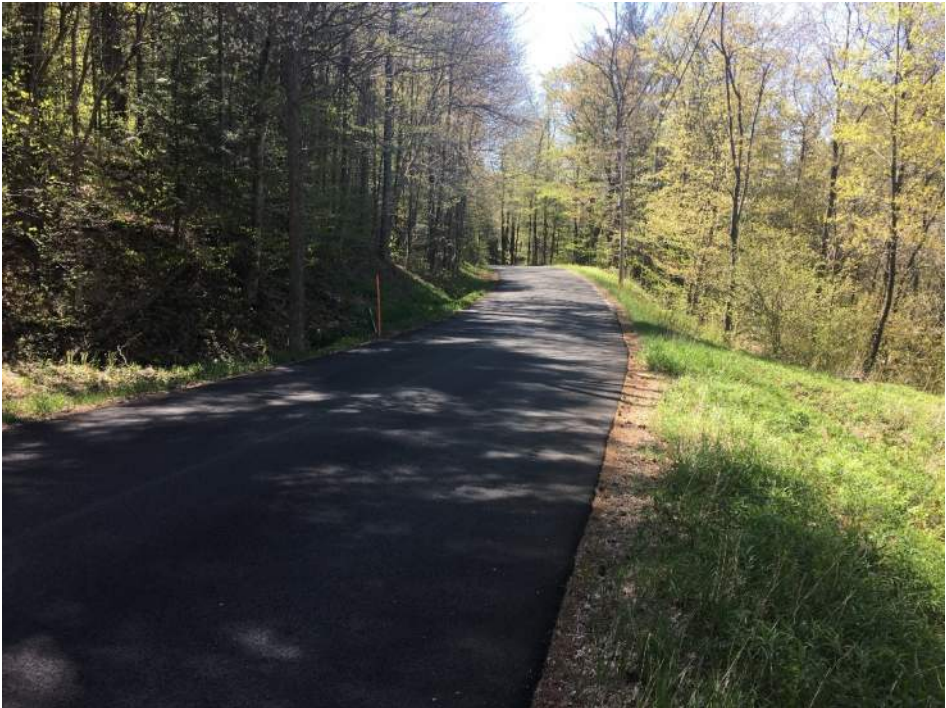
General Notes: Significant water flow coming from Route 116 Stone headwall on entrance to culvert is leaning away from road Debris build up from front lip of pipe bent upward

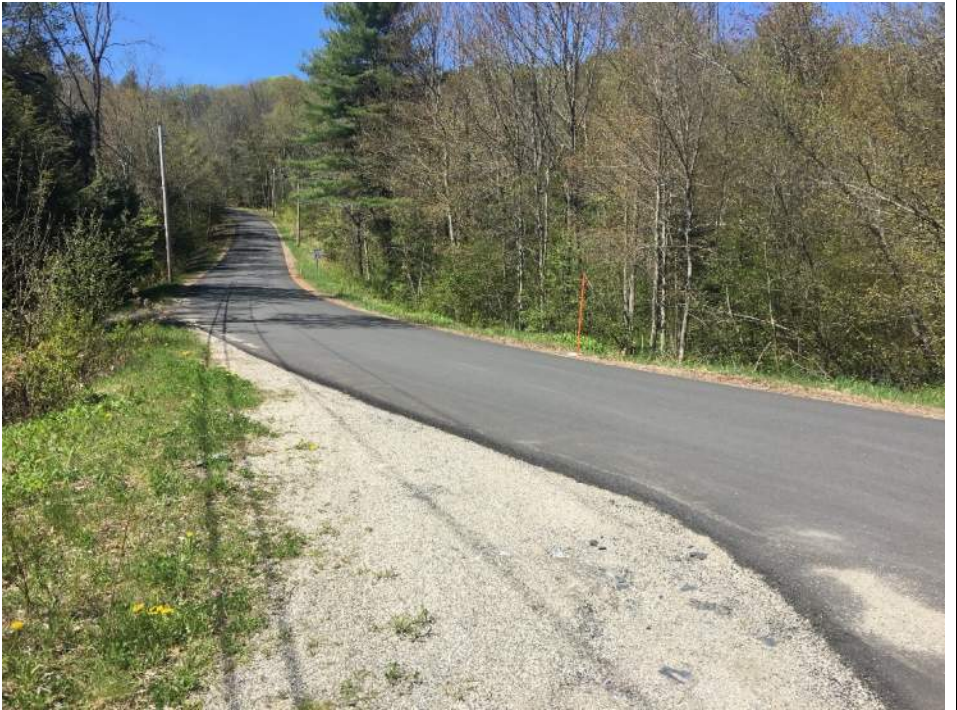
General Notes: Stagnate water Rust line 1/3 height of pipe No signs of deformation in either pipe

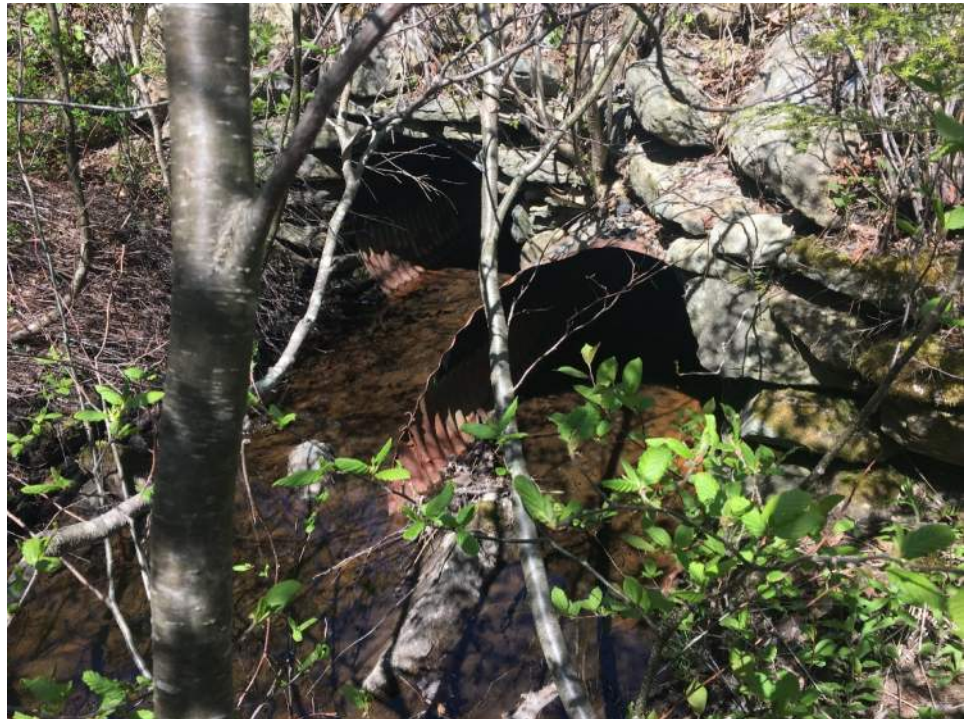
Left pipe has bottom filled with sediment
Rust line 1/3 of height of the pipe

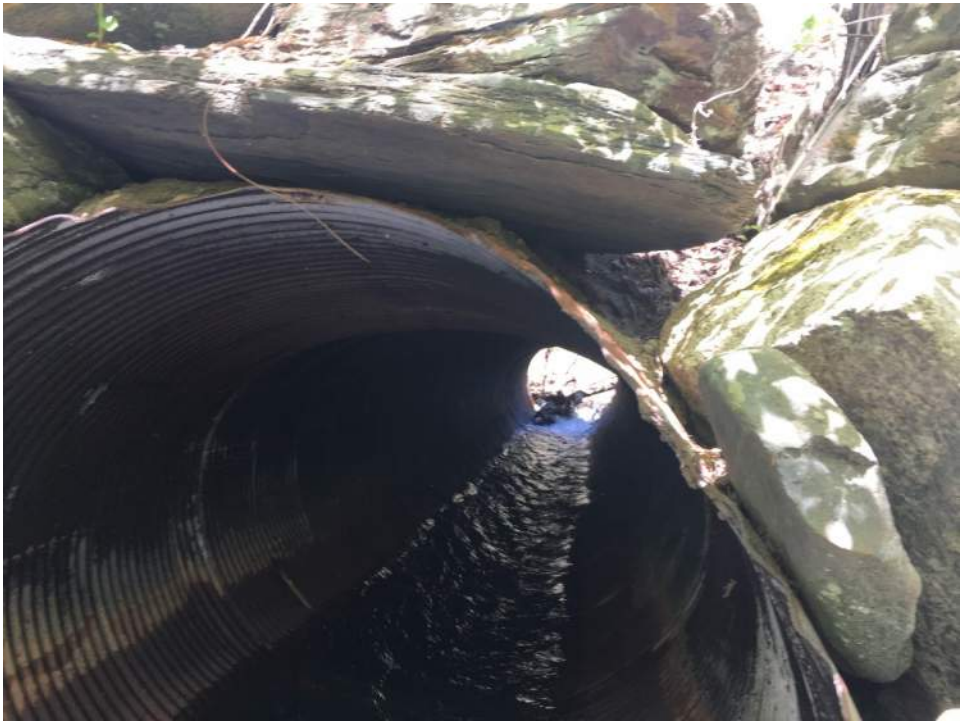
Description:			
<p>Deep under cutting</p> <p>Clear signs of deformation in top side of pipe appearing to be under the road</p>

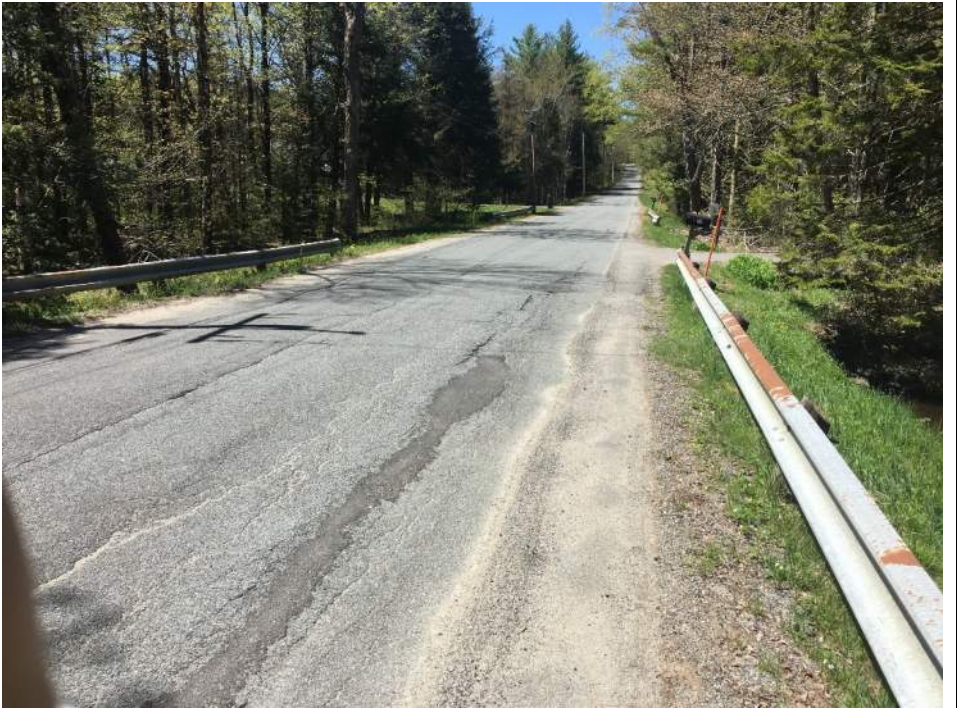
General Notes: Culvert is showing signs of erosion around the stone head wall The asphalt above the culvert is in poor condition and in need of repair

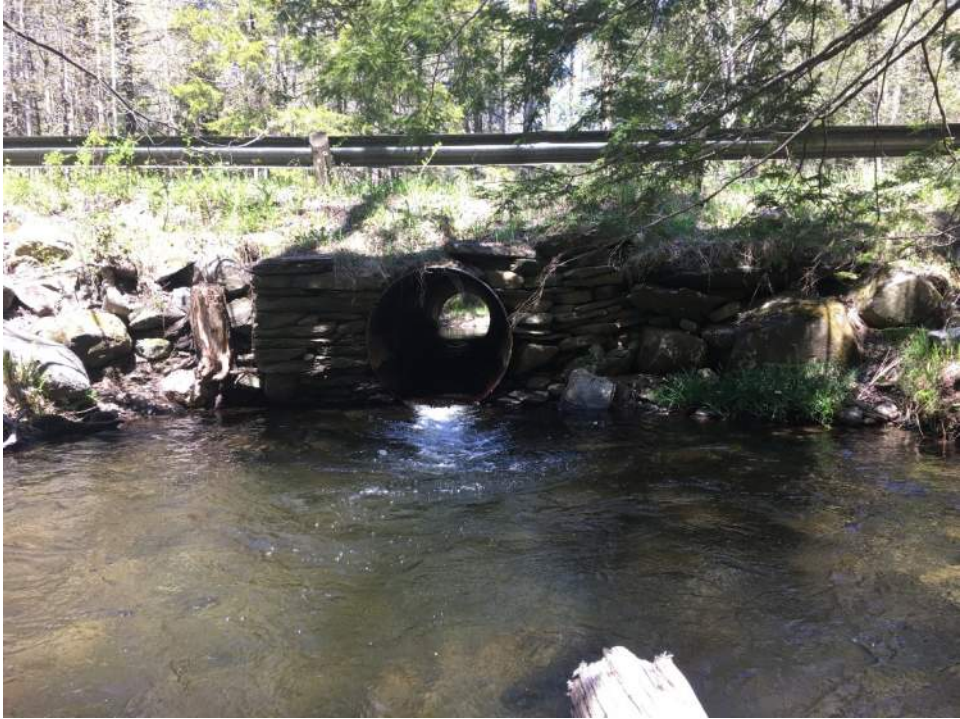
Description: Small signs of erosion under cutting the outlet pipe No rot appeared. Rust 2/5 the height of the pipe

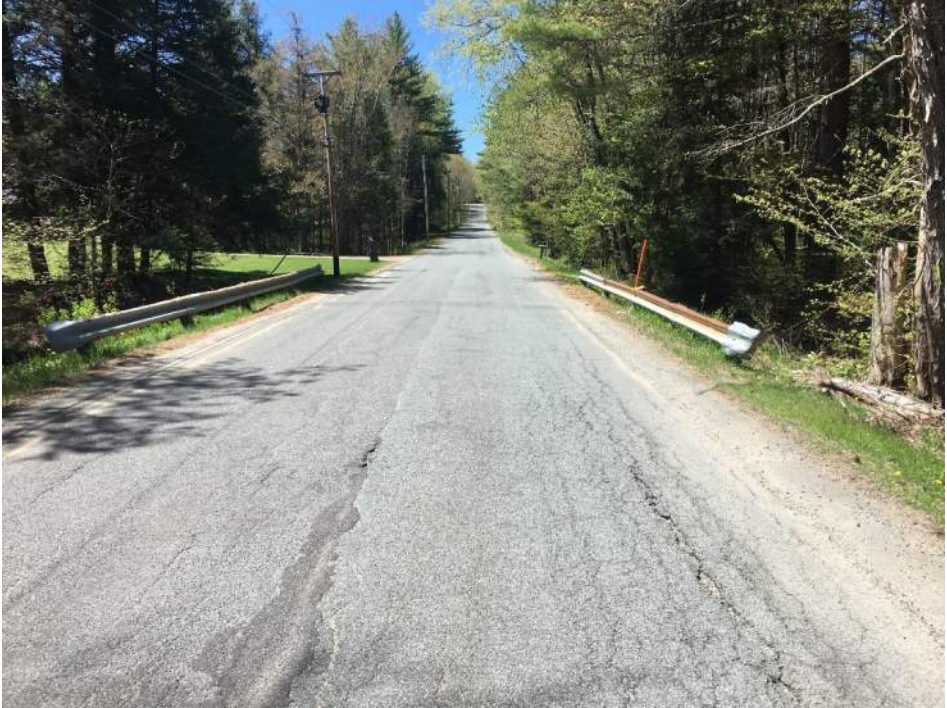
General Notes: Major debris build up causing a blockage and reducing water flow Condition of downstream culvert is deteriorating with signs of rot and stone headwall leaning away from road

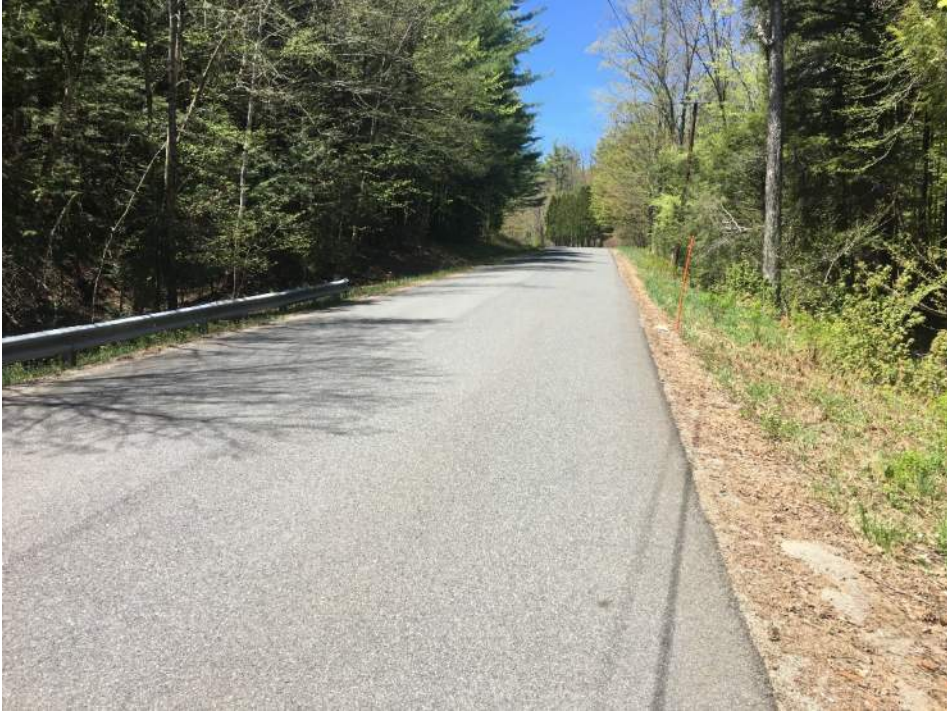
General Notes: Debris needs to be cleaner out of exit to restore full function of culvert Pipe is in adequate condition, no visible signs of damage

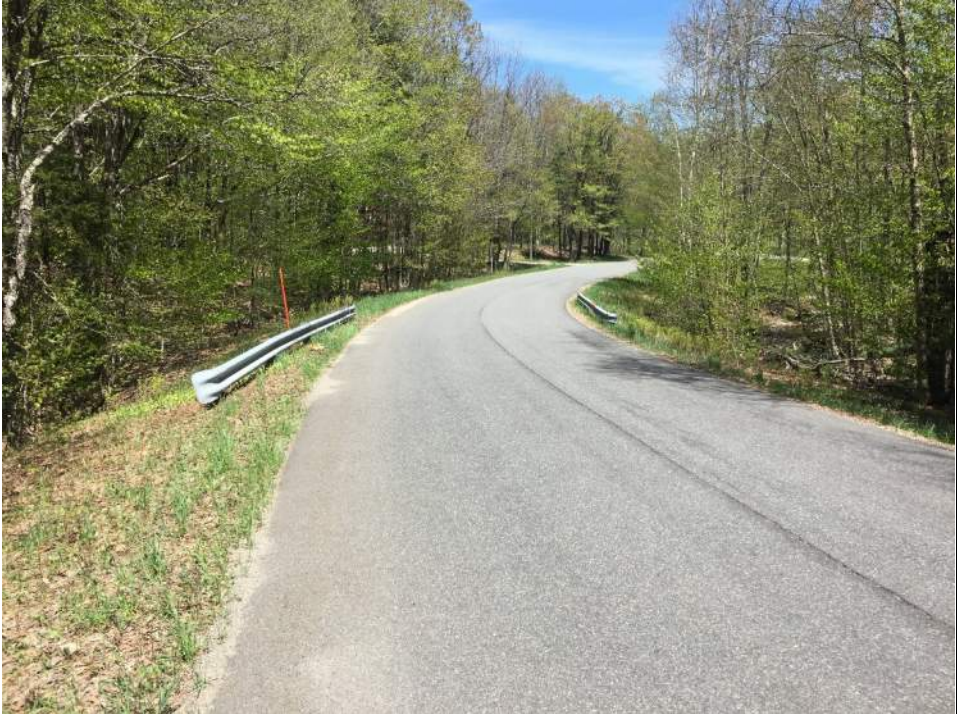
General Notes: No signs of culvert failure Pipe is in adequate condition with exception to the rot beginning at the exit of the culvert High water drop has caused erosion of the soil underneath pipe

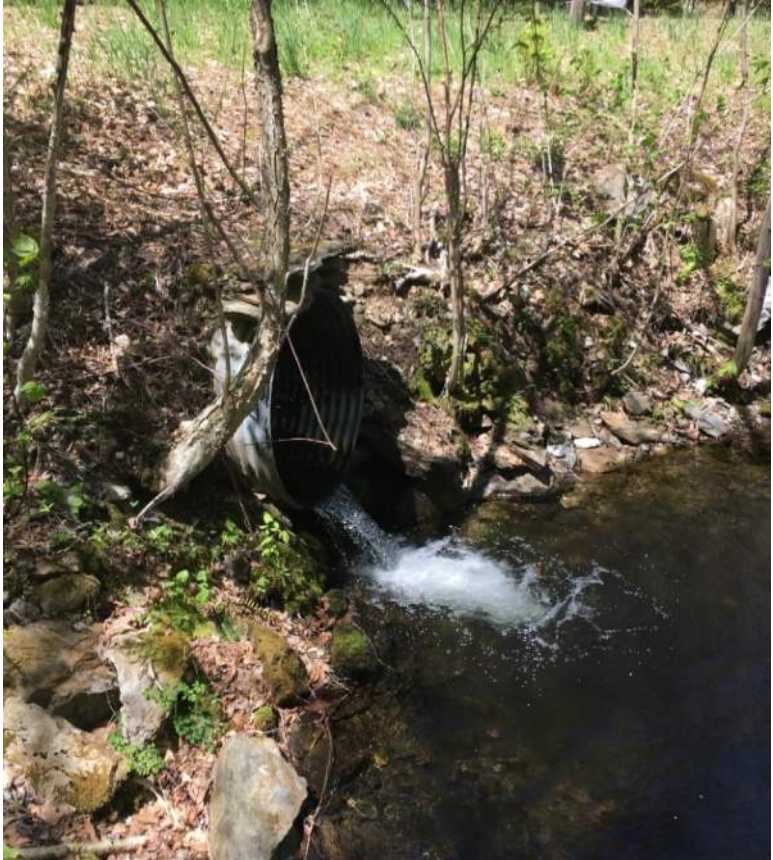
Description: 12" water drop causing undercutting underneath pipe Pipe fills a pond 3' deep End of pipe has small signs of rotted metal

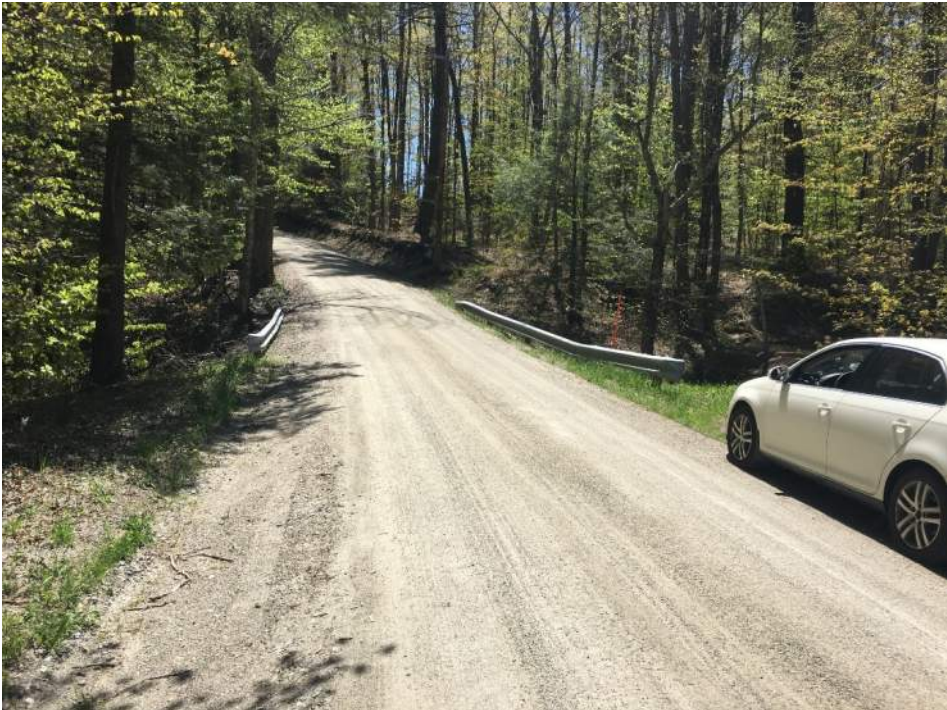
General Notes: Depression in center of pipe may indicate structural failures Metal pipe starting to show signs of rot

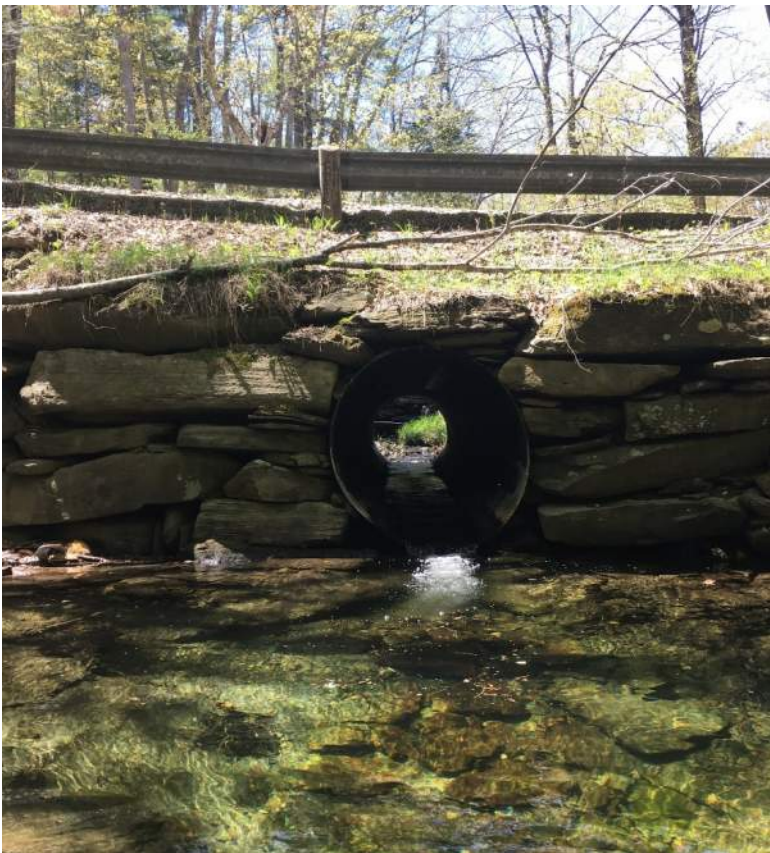
Description:			
3" water drop Significant undercutting through stone wall Large pool of water under output Signs of rotting metal

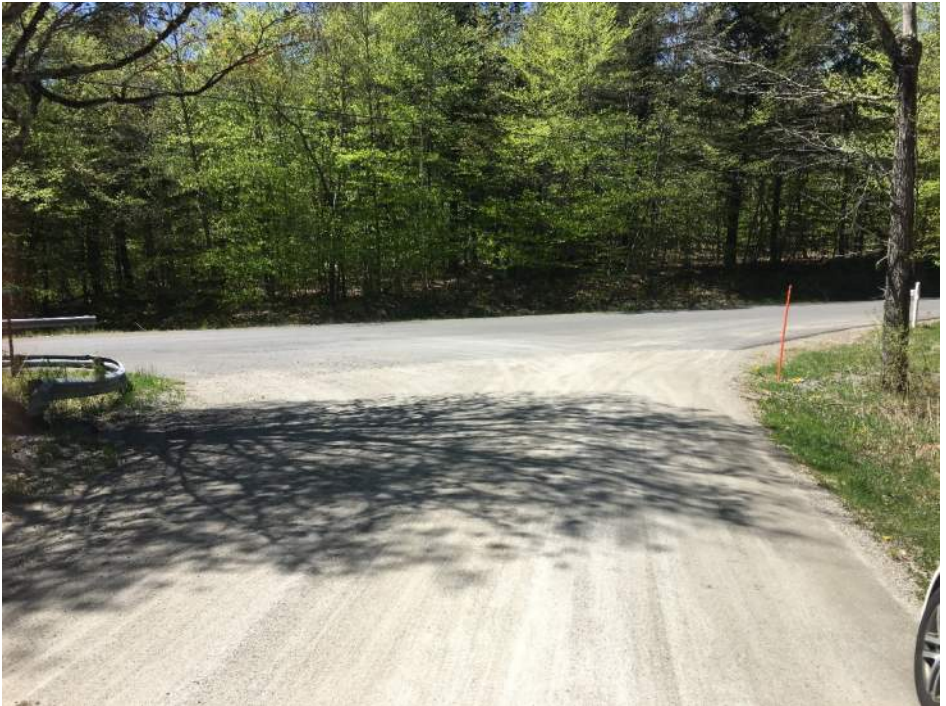
General Notes: Culvert in good condition No signs of erosion

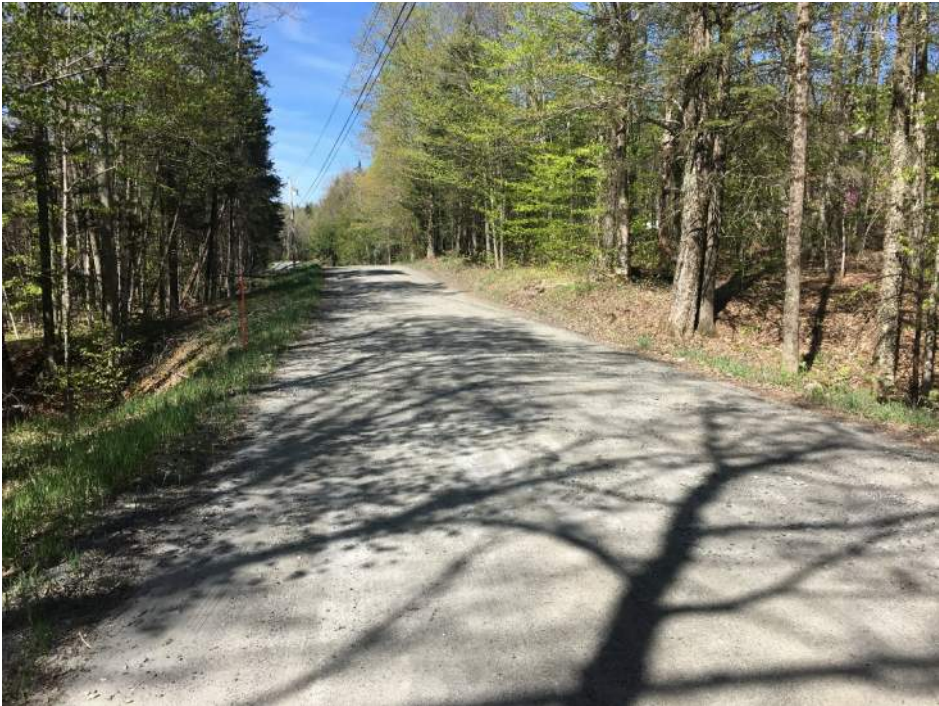
General Notes: Rock blockage at entrance of pipe End of pipe shows signs of deformation at end of pipe but is not observed underneath roadway

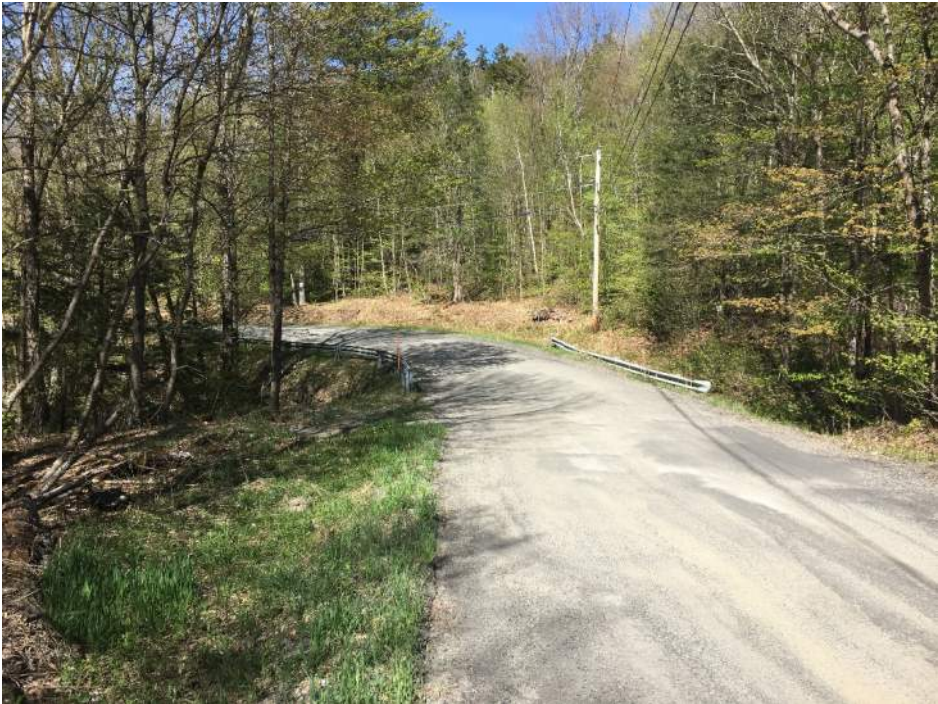
General Notes: No signs of rotting metal but entire pipe is rusted Pipe deformation observed at entrance of pipe Flowing water has worn into metal

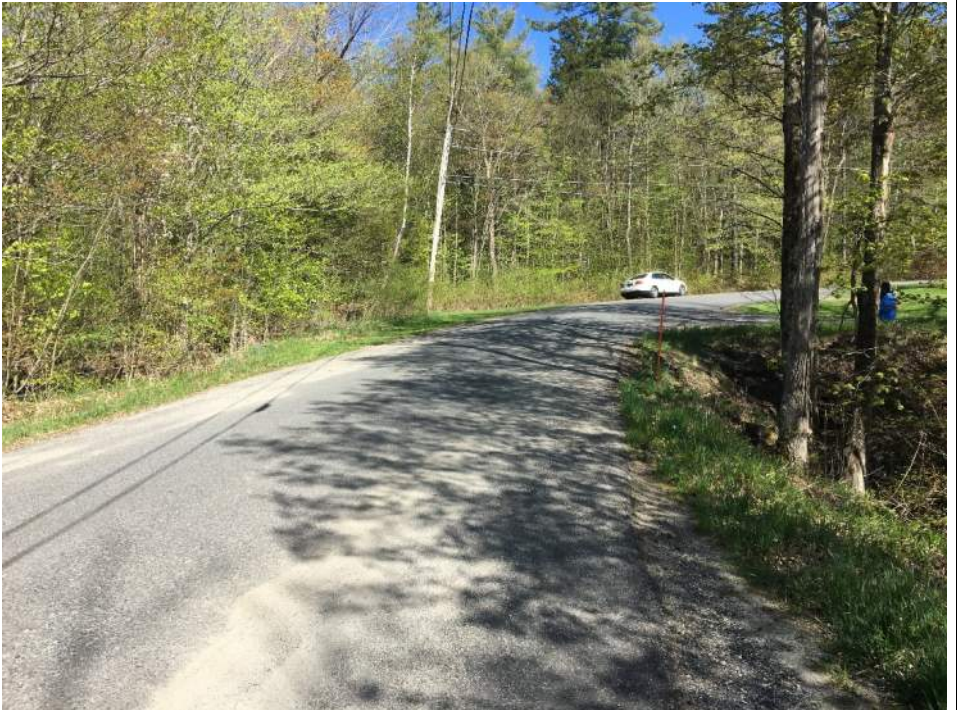
General Notes: 48" steel pipe transitions into a 36" HDPE pipe about 8' from end of culvert Steel pipe is rotted at entrance and condition is not able to be seen at end of pipe

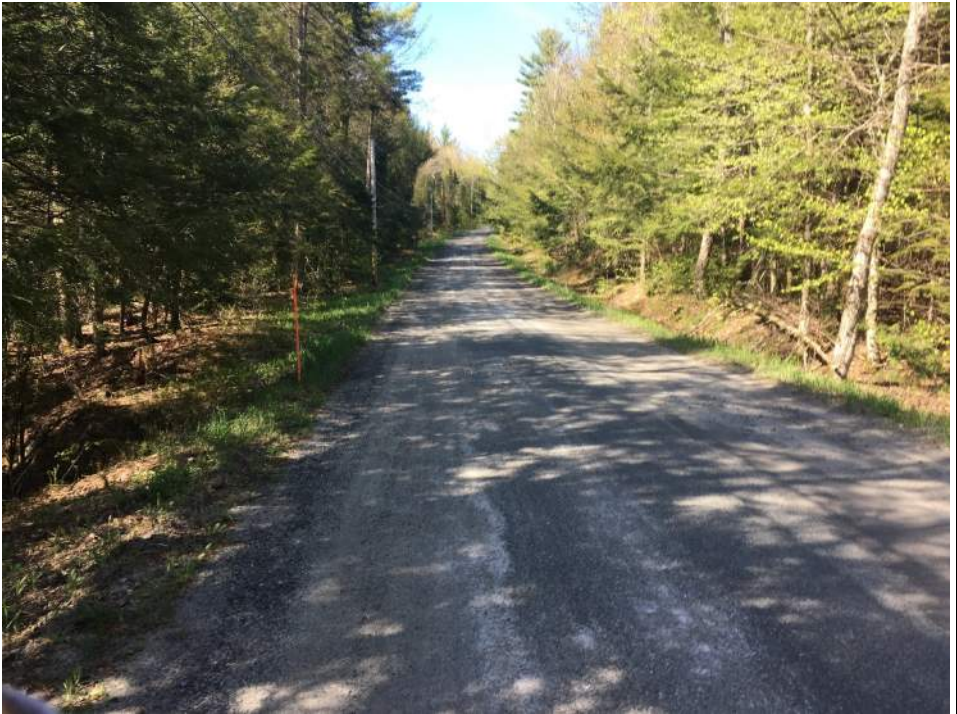
General Notes: Culvert is made of three different types of steel piping ranging in condition. Entrance pipe appears to be the news and is in adequate condition however exit pipe does appear to be structurally failing Sediment is allso observed in the bottom of pipe at entrance

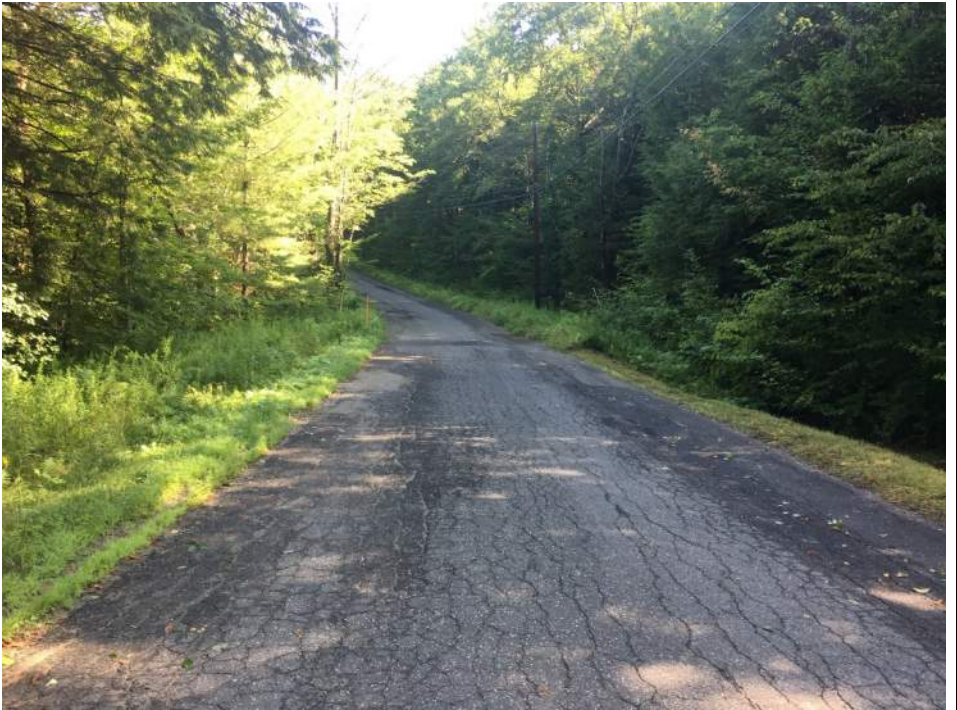
General Notes: Deformation on the topside of the corrugated steel located under the roadway indicates possible structural failure Significant sediment build up dominantly on the outflow of culvert Pavement over culvert has asphalt patches in better condition than surrounding road possibly indicating previous repairs Road on inflow side of culvert has sediment build up possible indication of road flooding Little to no water flow

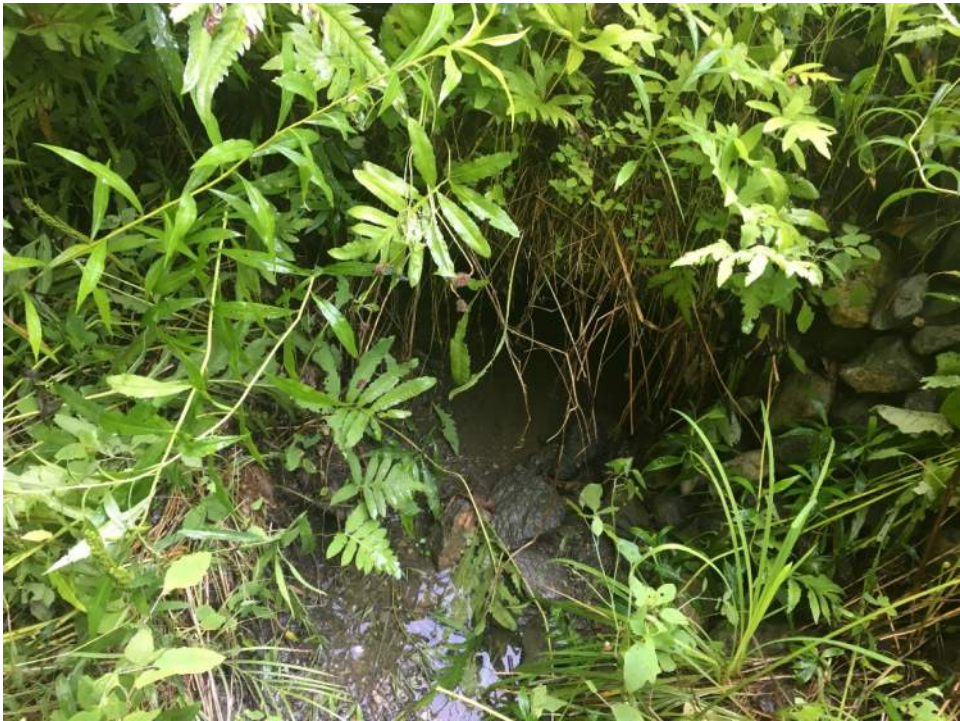
Description:			
Significant sediment build up Only 14" of pipe space from top of pipe to top of sediment

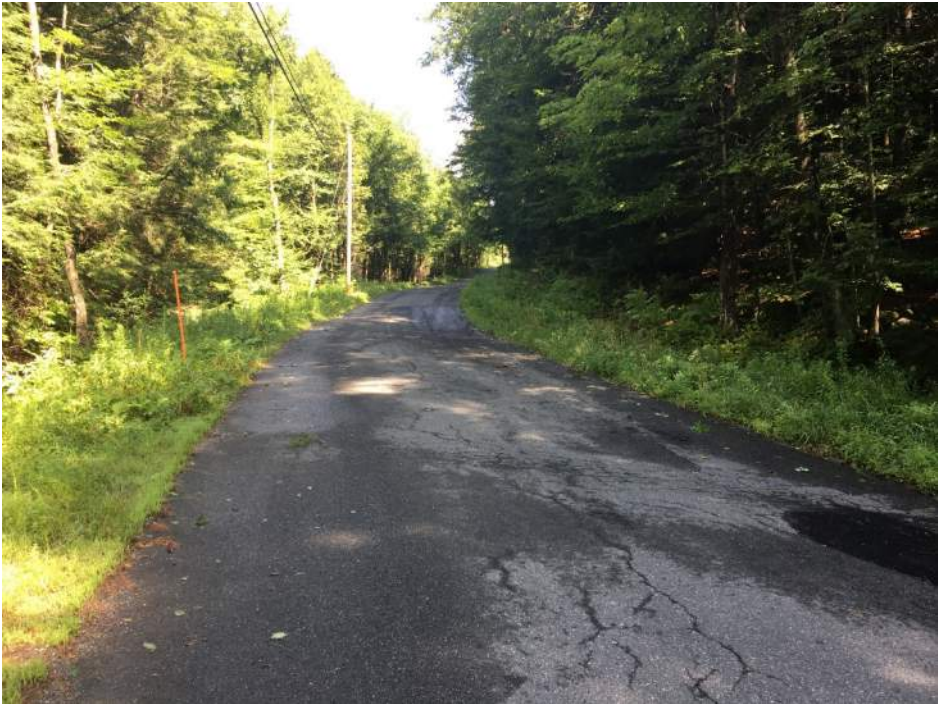
General Notes: Pavement cracks parallel to culvert run directly on top of underground pipe High build up of sediment at entrance of culvert

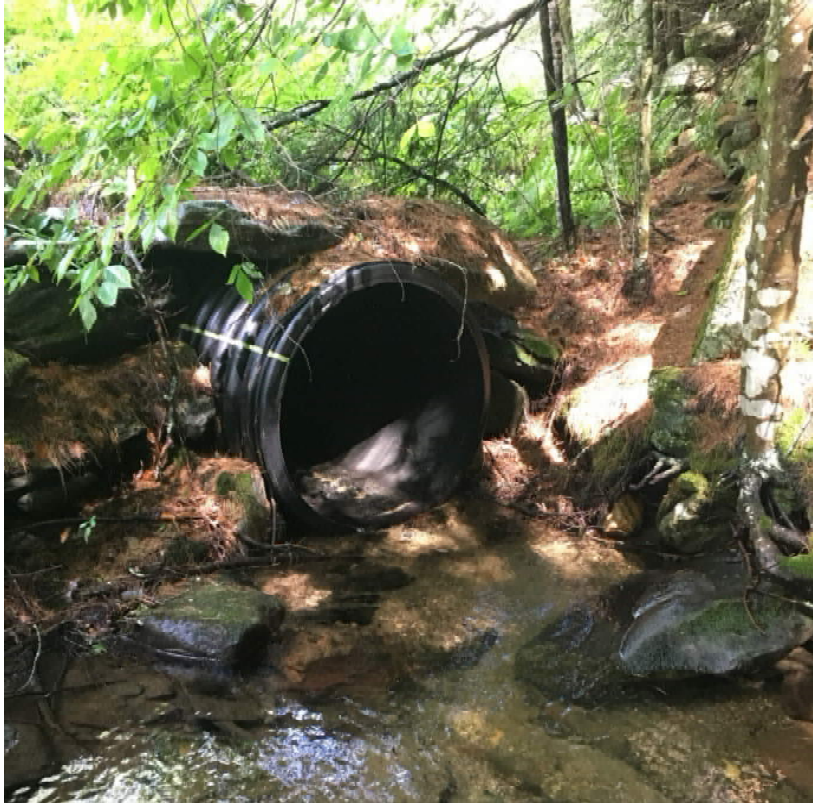
Description: Erosion under cutting on both sides of pipe outflow No water drop No sediment build up

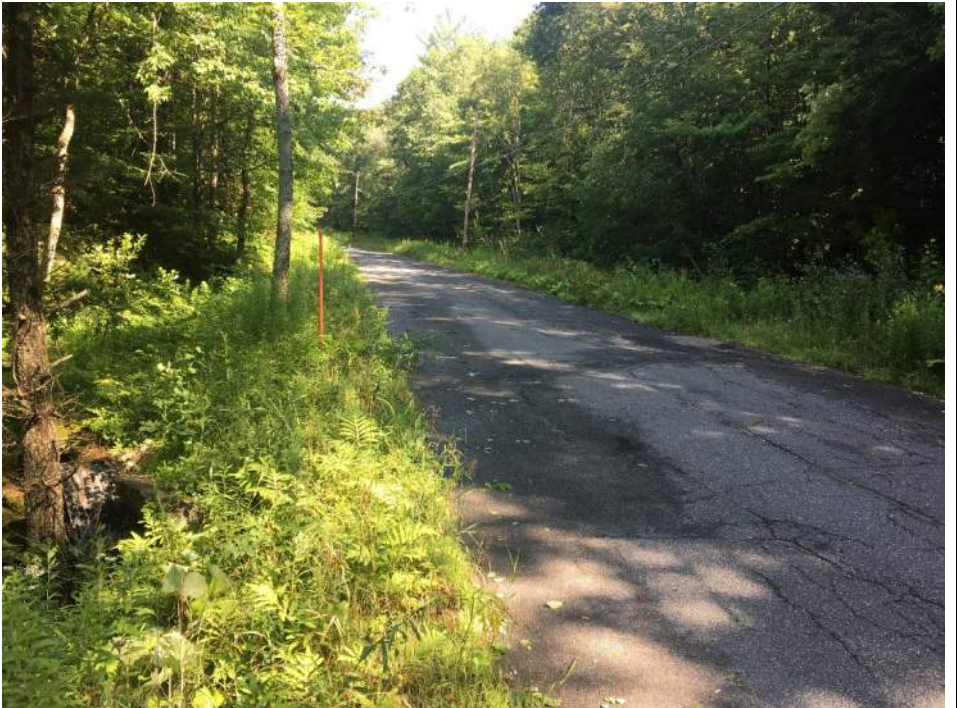
General Notes: Road way depression and cracking parallel and directly on top of culvert Significant water flow but old wasp nest and spider webs on top side of pipe indicate full capacity of pipe volume has not been met recently if at all

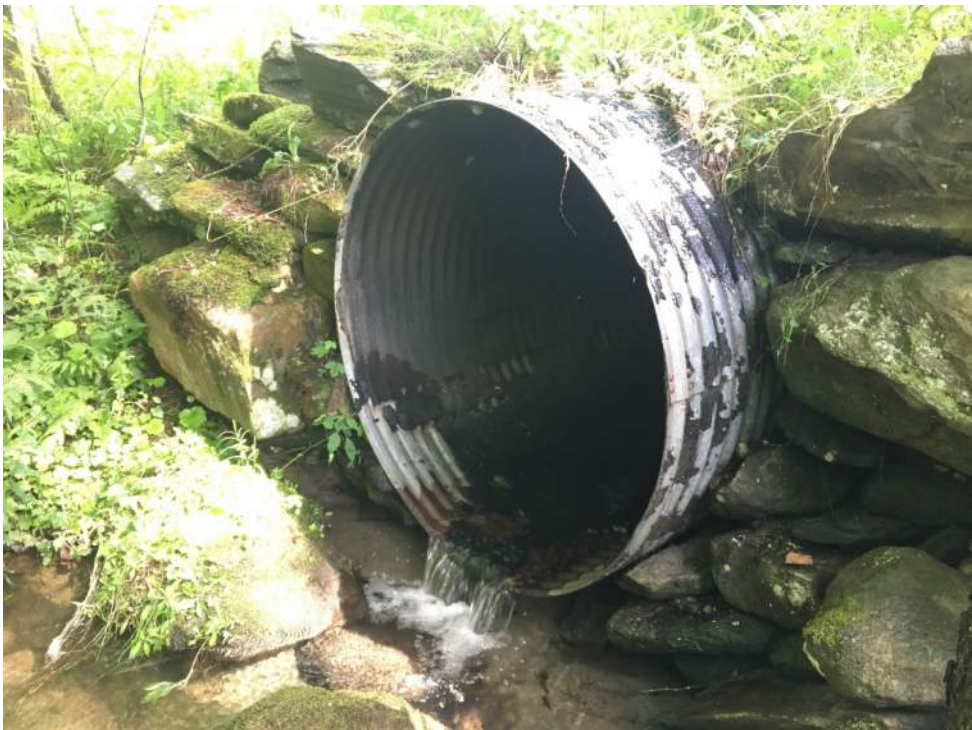
Description:			
6" water drop with erosion undercutting pipe Last couple feet of pipe has significant rusting but no visible indications of rotting or holes

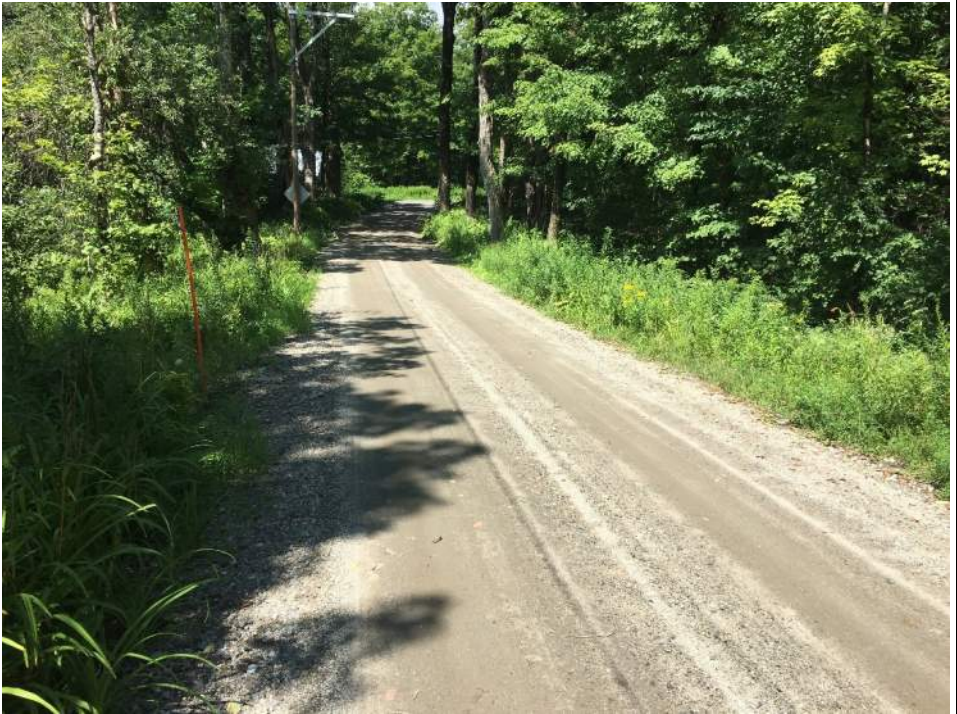
General Notes: Low water flow Entrance of pipe beginning to build up sediment Beginning of pipe lip deformed by rocks on top of pipe

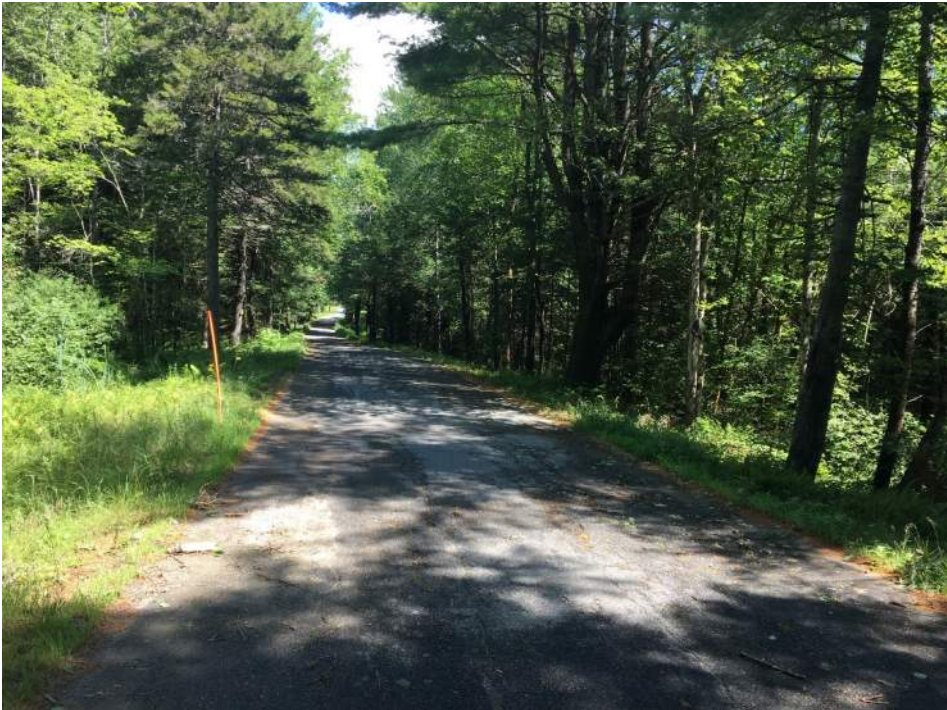
General Notes: Roadway has patches centered above and around culvert Pipe in good condition
