Memorandum

Date: September 17, 2020

Project #: 42625.00

Re: Plainfield Culvert Assessments

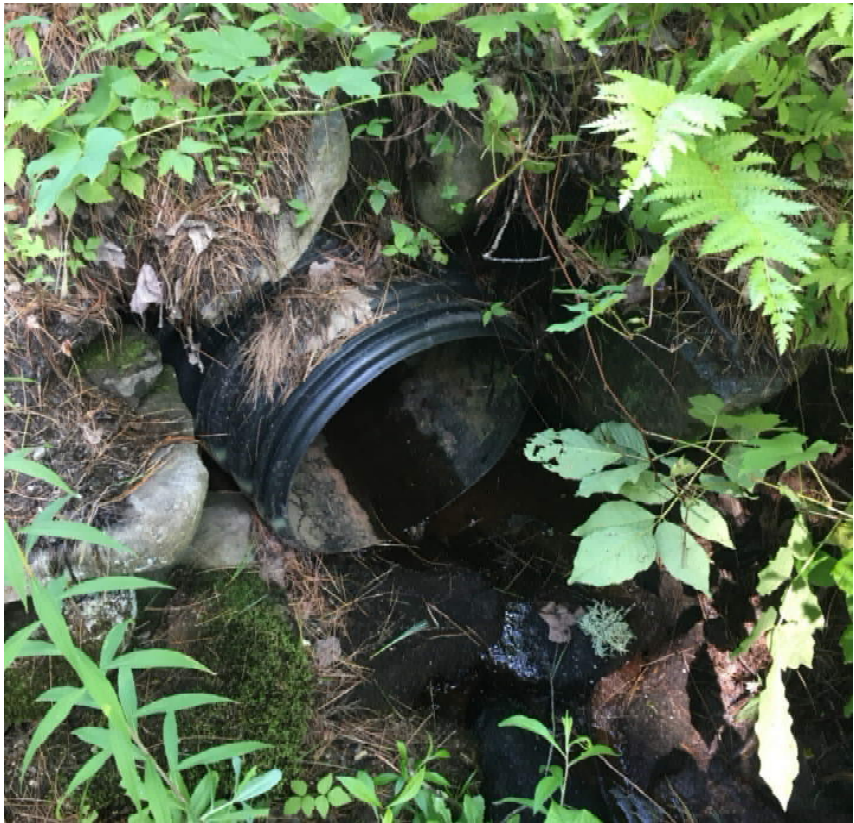
Description:			
<p>Pipe visibly appears to be in good condition</p> <p>Water drop 0.5"</p> <p>No pipe deformities</p> <p>Deep undercuts to the right side of the pipe but no water flows behind the pipe</p>

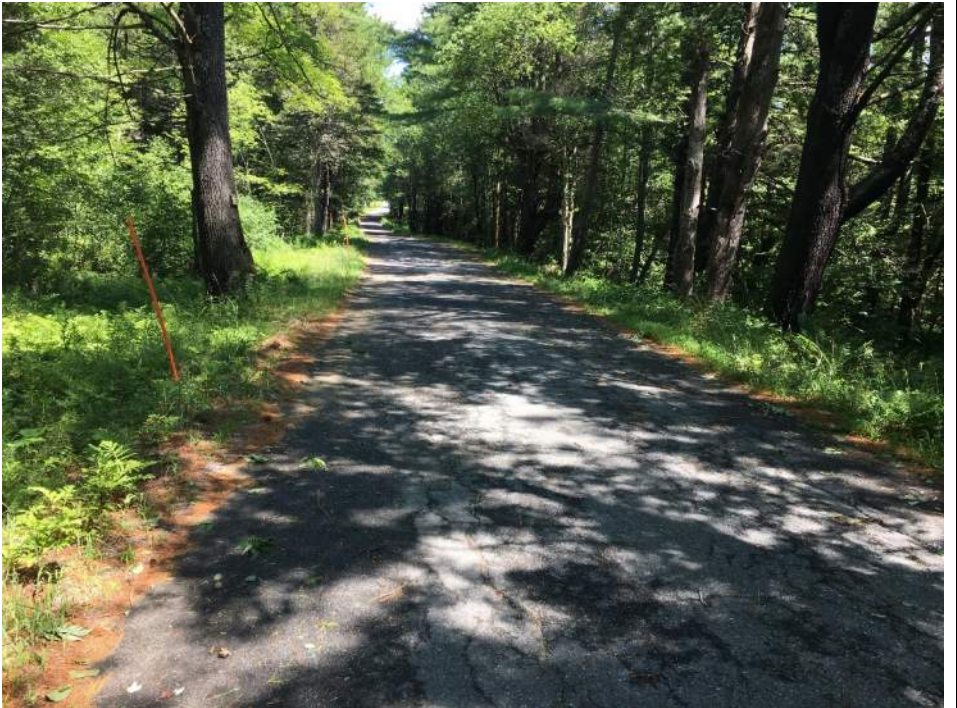
General Notes: Pipe in good condition Outlet drops water from 10" up and is causing erosion on the underside of pipe

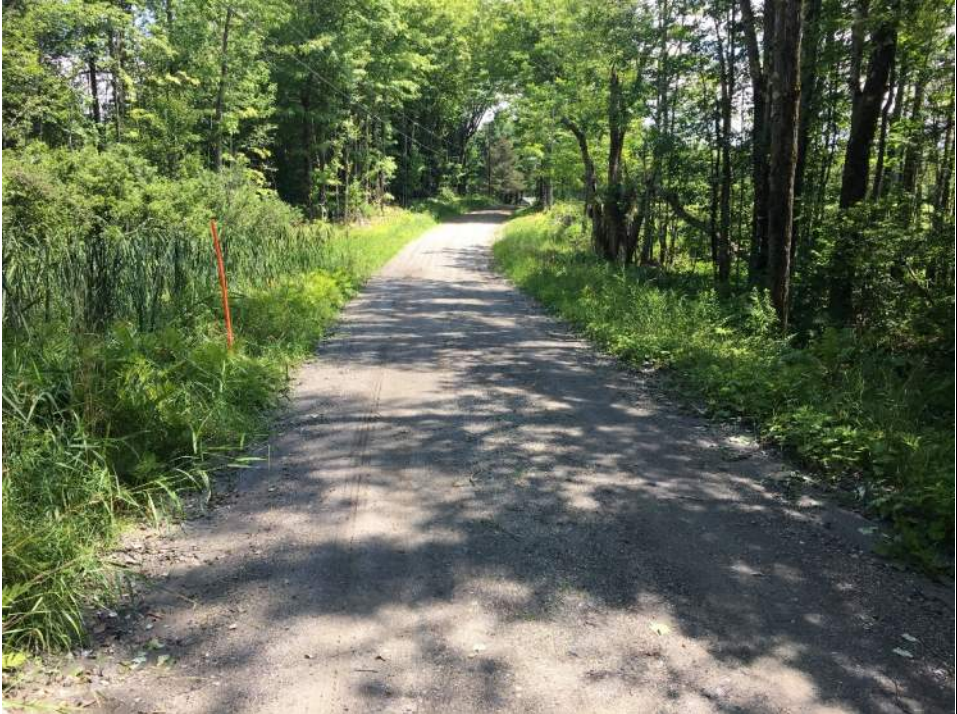
General Notes: The culvert has stagnant water on both sides due to a high inlet elevation and the outlet water gets trapped in a bowl

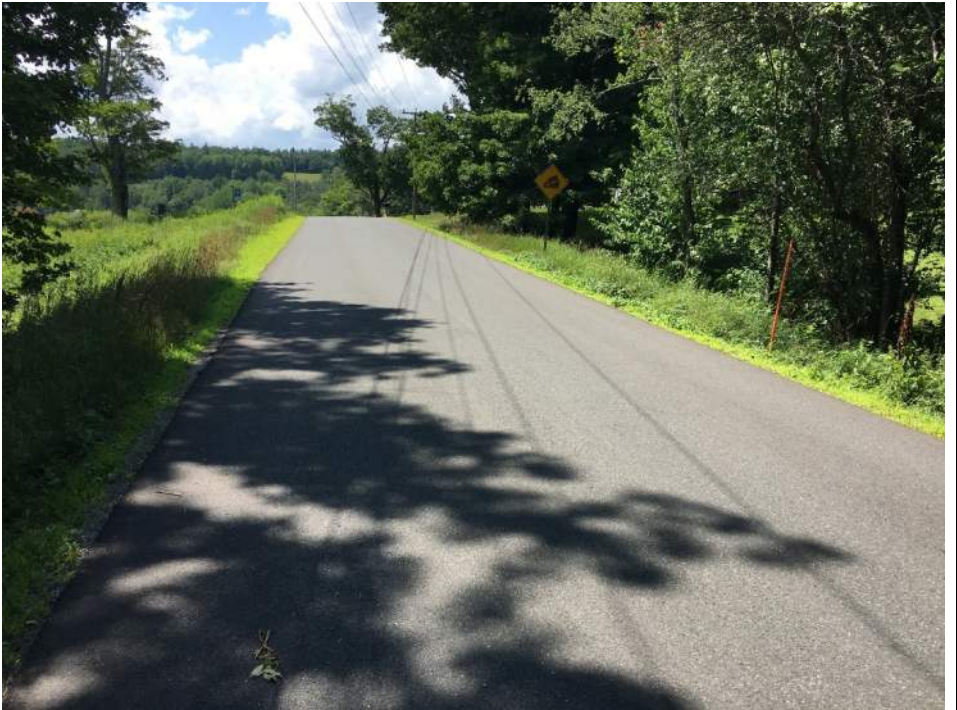
General Notes: Debris at entrance of pipe is creating a blockage Pipe visibly appears to be in adequate condition

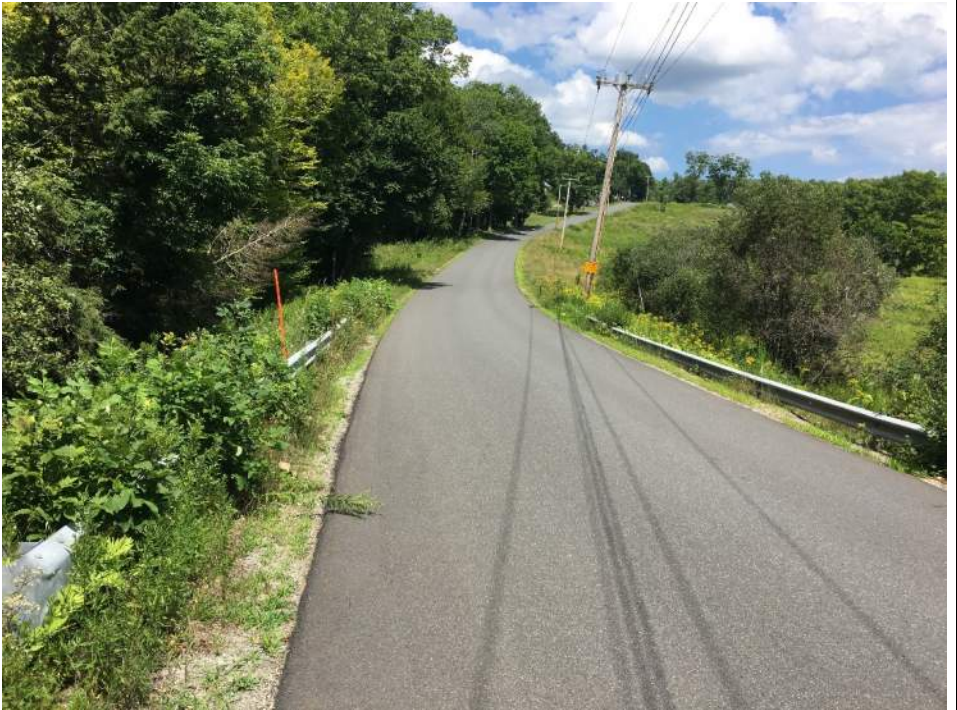
General Notes: Significant water drops have cause significant erosion under the pipe and its base Metal pipe upon inspection appears to be in adequate condition (no rot or deformation)

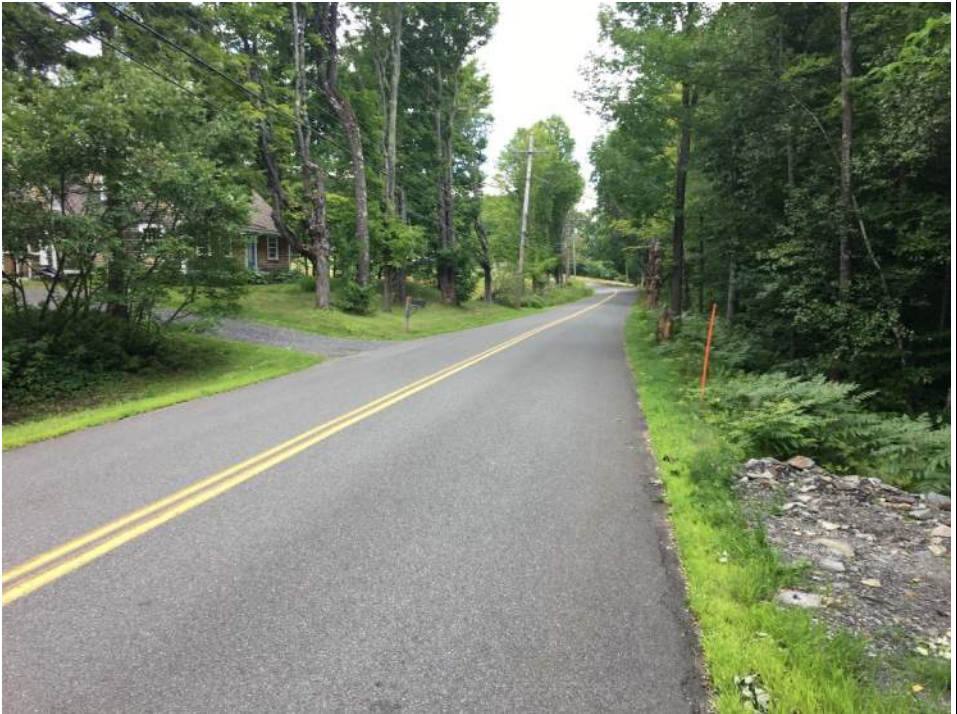
General Notes: Culvert pipe is rotted on both ends

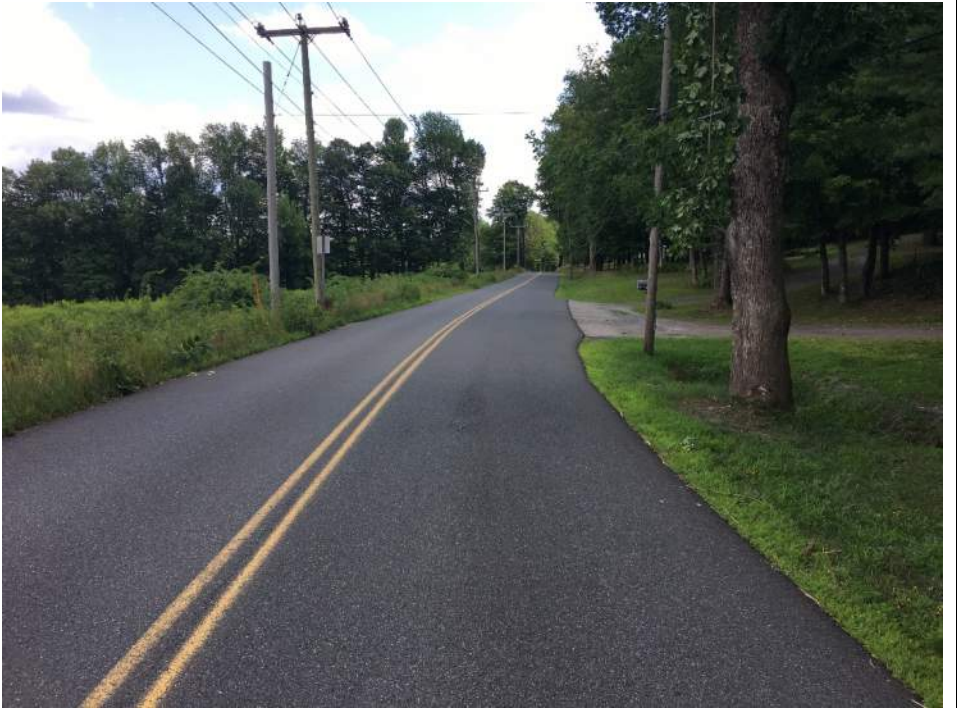
General Notes: Corrugated steel pipe does not appear to be in use. It is a smaller pipe than the PVC and is at a higher elevation. There is also no indication that the water reaches that elevation. PVC pipe is filled with heavy sedimentation and shows signs of major deformation at outlet

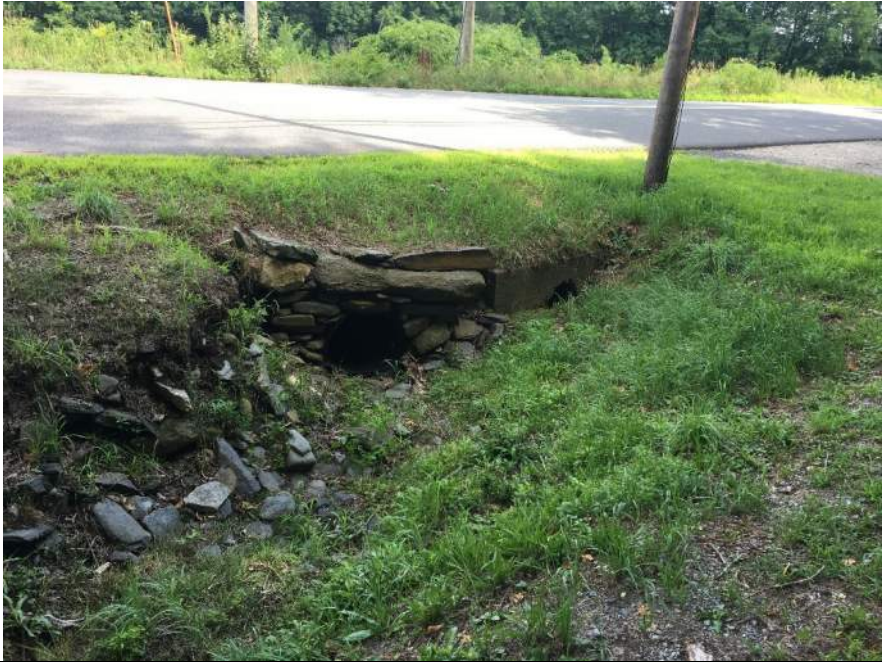
Description:			
<p>Steel: There is 7" build up of sediment and debris holding up soil that has been stabilized with grass.</p> <p>PVC: Front lip deformed upward would cause blockage of water and erosion under pipe.</p>

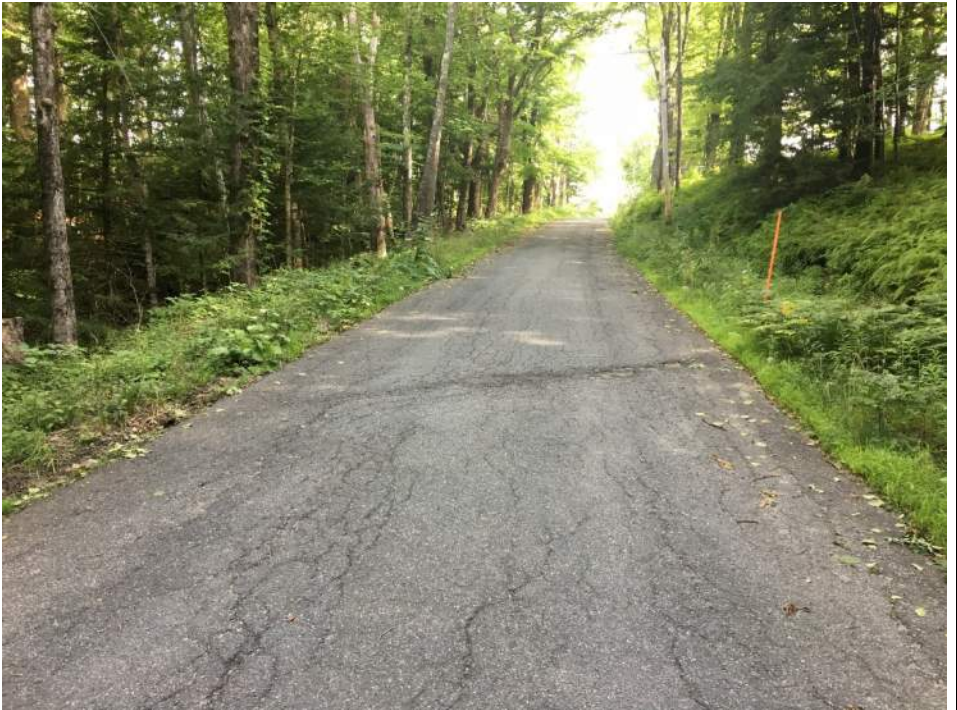
General Notes: Pavement cracks run parallel with underground culvert pipe. Slight depression and small areas of missing pavement Rotted ends of pipe with sediment build up at entrance and pipe blockages could have an affect on pipe drainage capacity

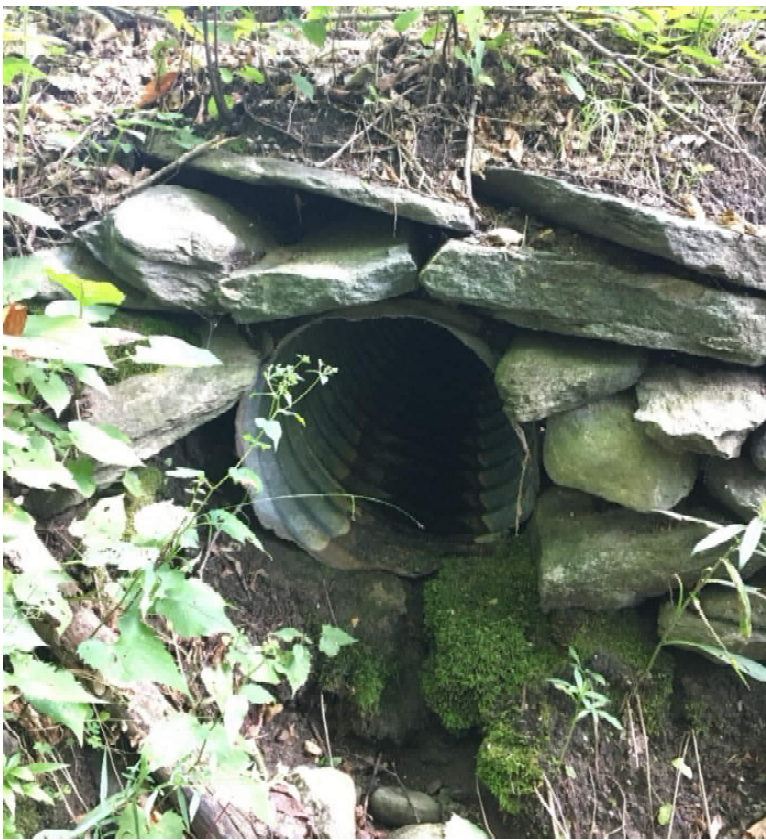
Description: Edge of pipe rotted Multiple blockages towards center of pipe were not able to be identified or assess the inner pipe condition Outflow highly eroded bank side towards roadside stream

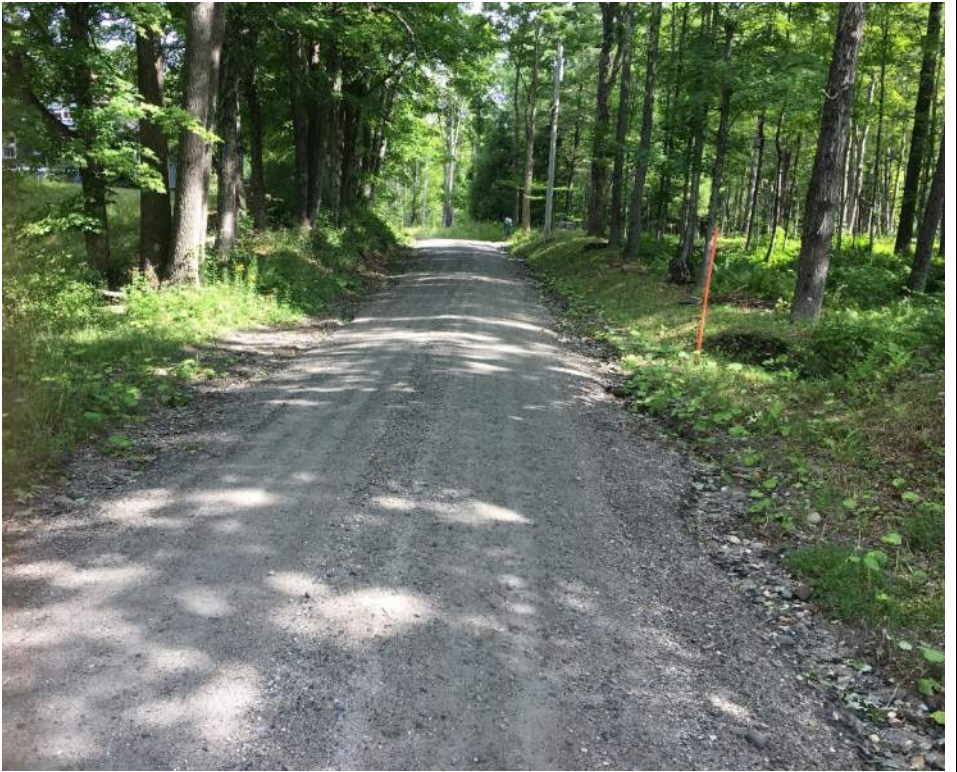
General Notes: Deep erosion patterns on both sides of the road Elongation of pipe throughout due to weight of stonehead walls and road

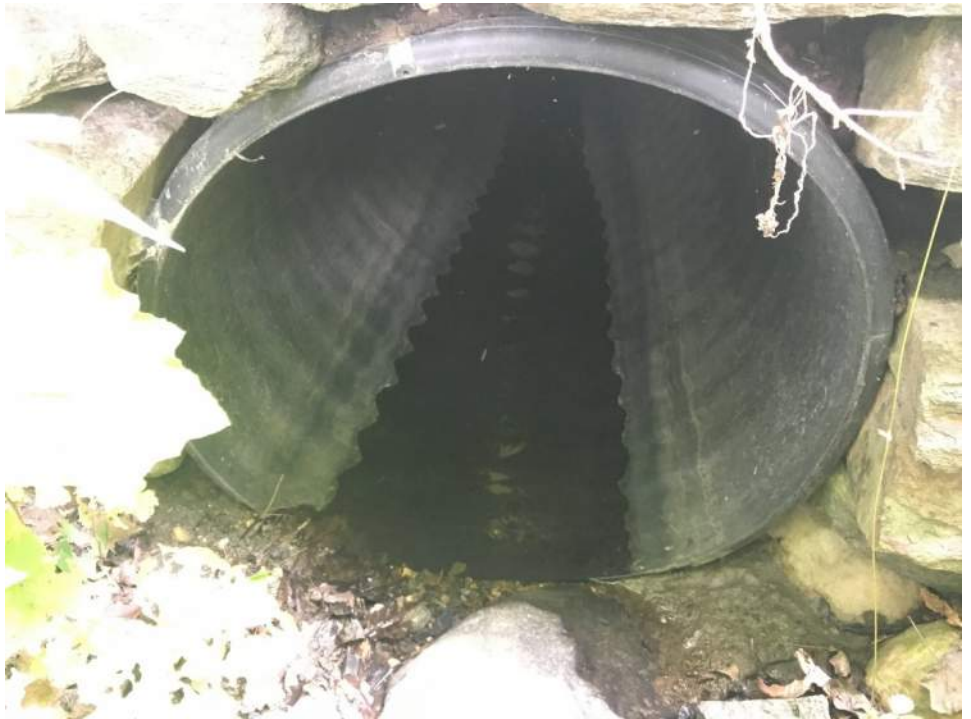
No concerning erosion patterns

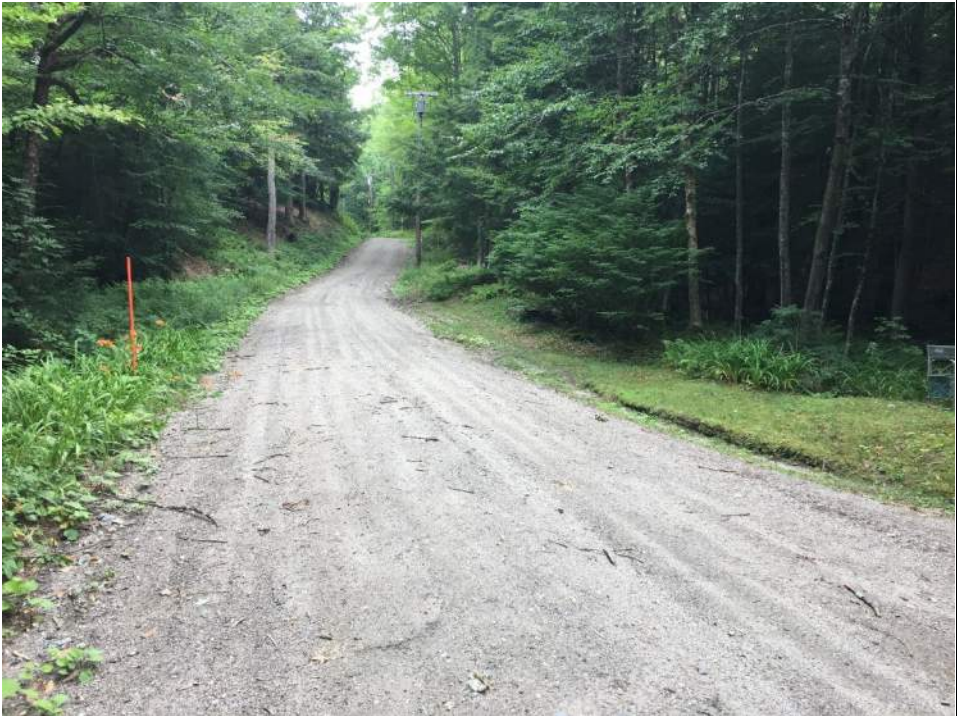
General Notes: Deep undercutting erosion out of outlet pipe caused by 20" water drop Pipe in adequate condition Road on inlet side has roadside water erosion path over culvert

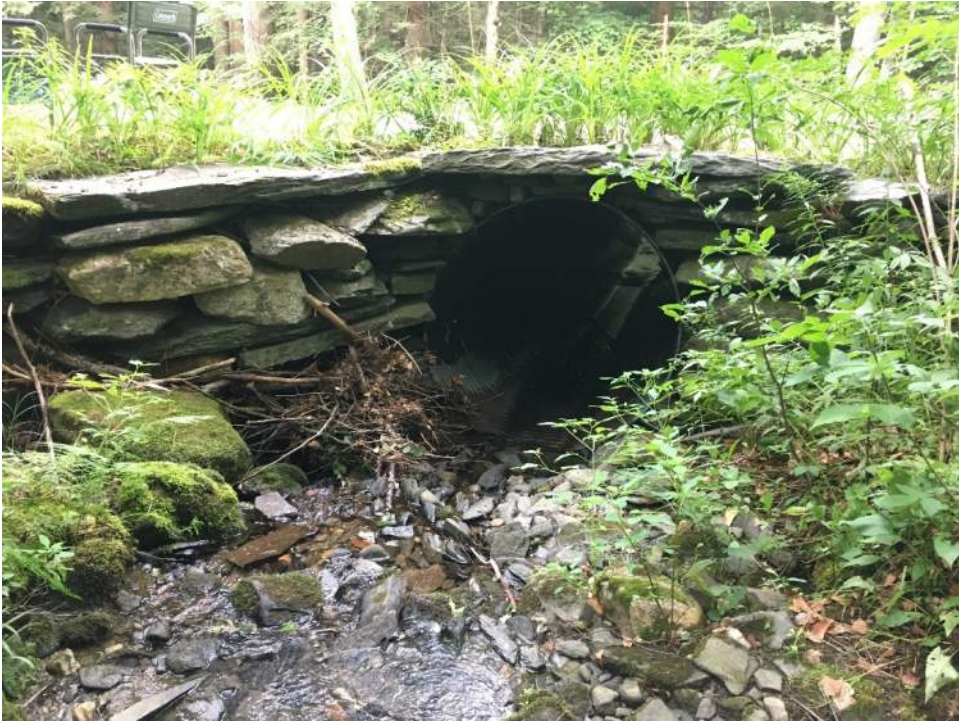
Description:			
<p>Stick and debris build up on left side of culvert</p> <p>No shape deformation or signs of rotted metal</p> <p>Small undercutting erosion on side and underneath pipe</p>

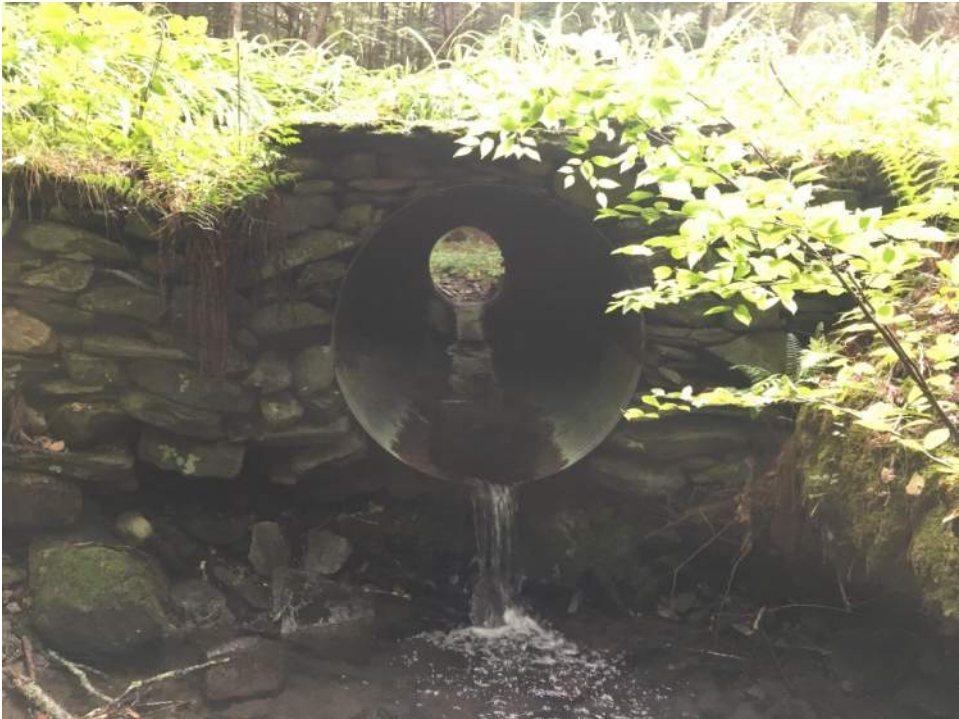
Description:			
<p>20" water drop</p> <p>Deep undercutting erosion</p> <p>No shape deformation or signs of rotted metal</p>

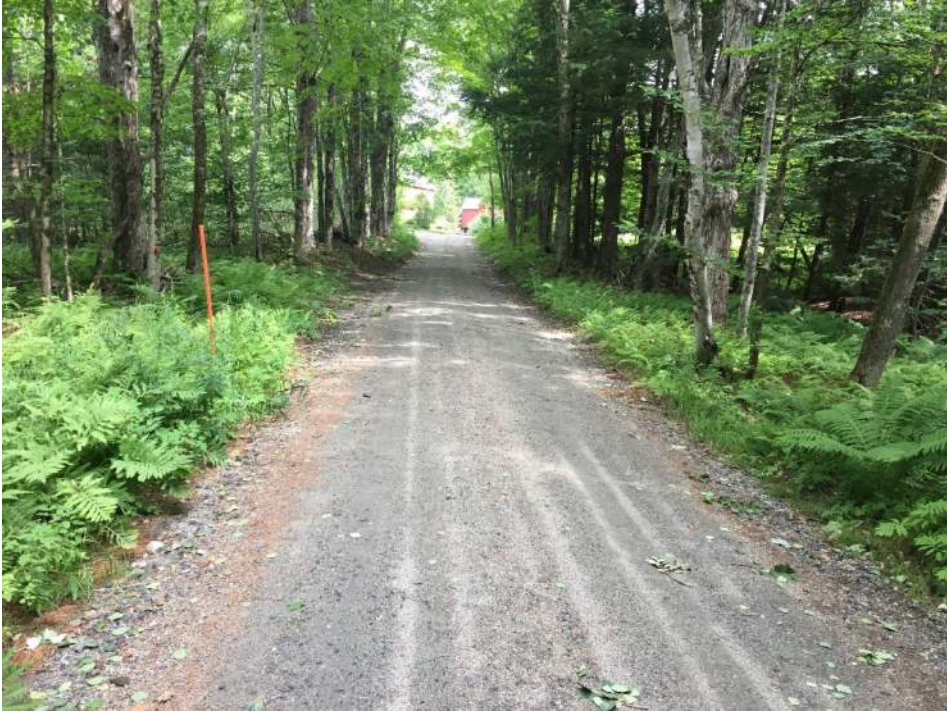
General Notes: The outlet of the pipe is starting to break down with signs of rot forming The entrance to the pipe is clogged with debris creating a blockage for water flow Undercutting of the pipe is present due to water drop and pool of water

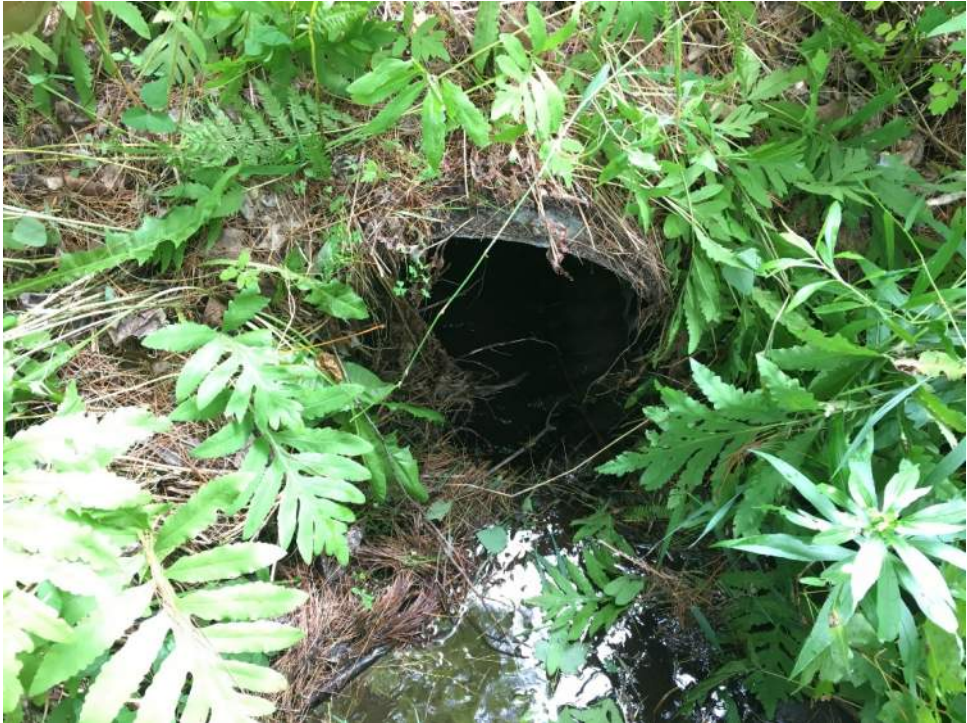
Description: Debris (sticks and pine needle build up and create a water blockage

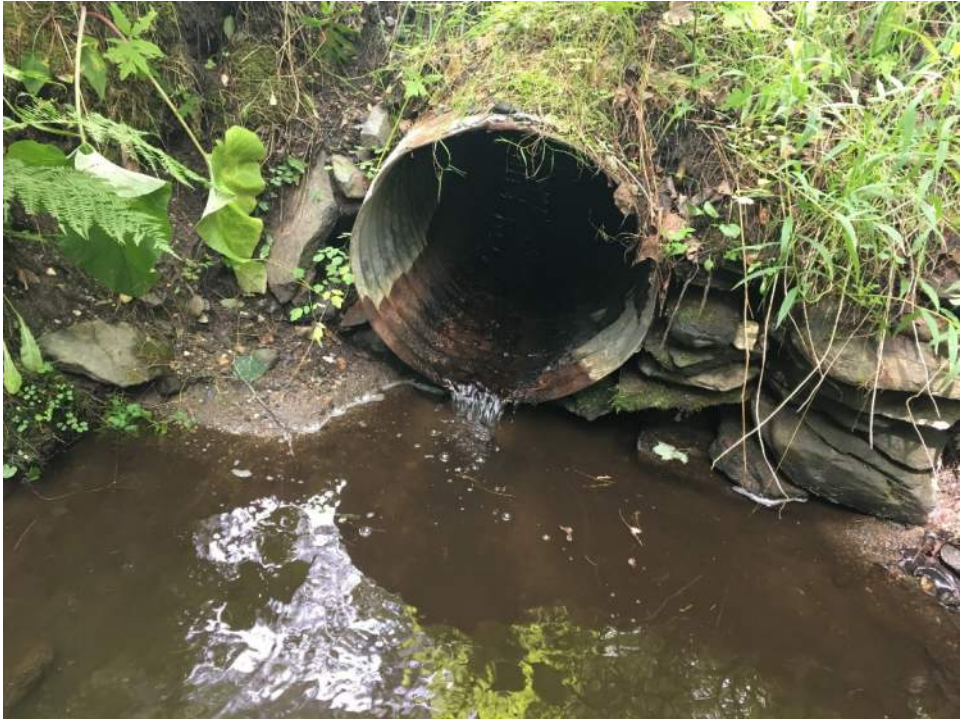
Description: Early signs of rot forming along the bottom 2" water drop fills a bowl that is eroding underneath pipe

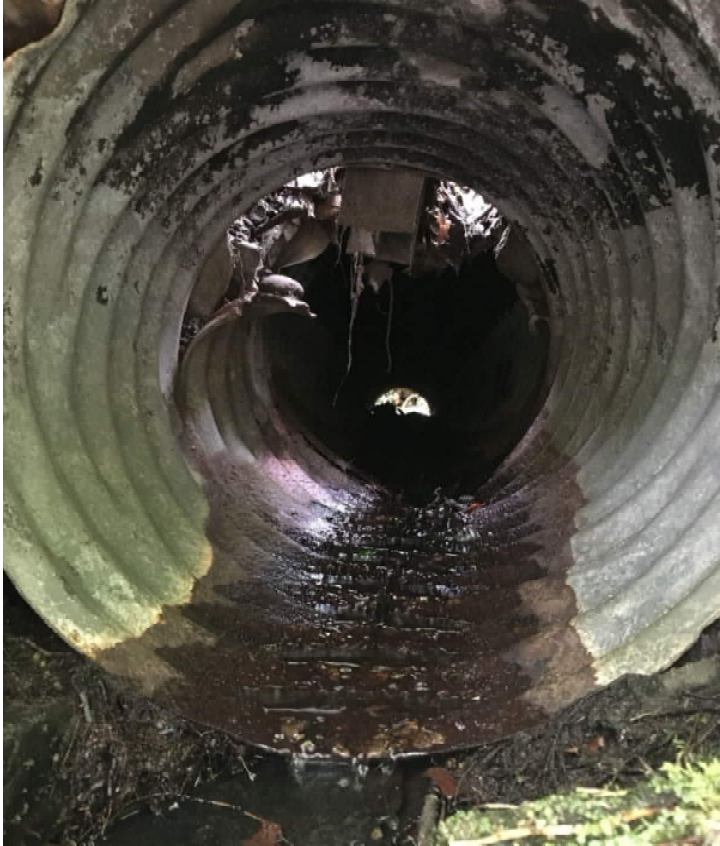
Description: Debris is visibly stuck in center of pipe Guard rail post had been placed directly through the culvert splitting it open. The entirety of the pipe is open to the road filling with road and other road debris

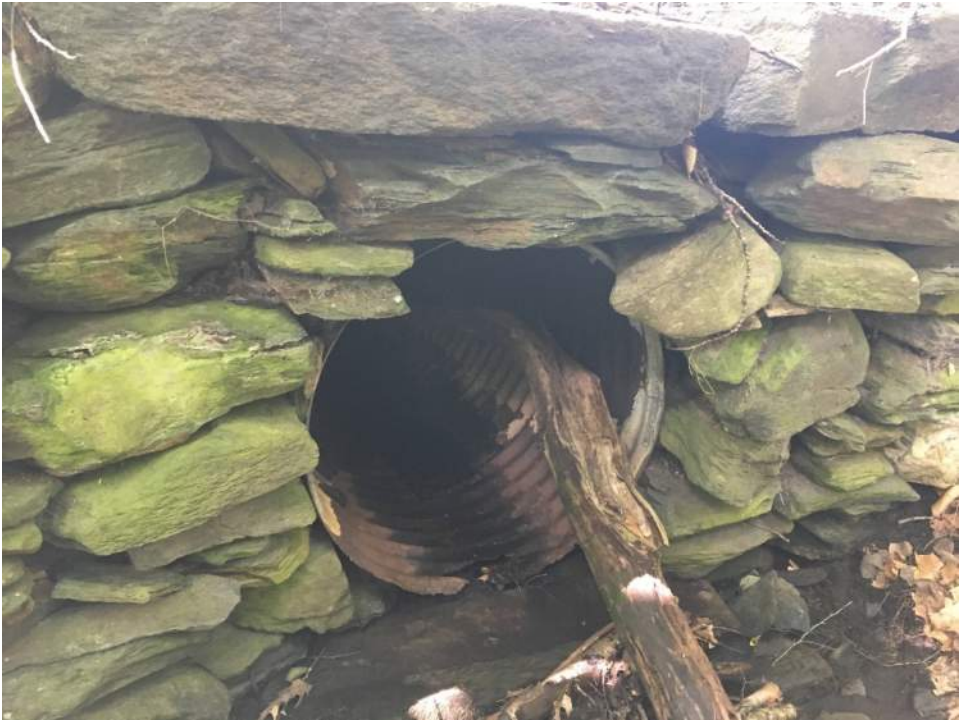
Description:			
<p>Water again is free flowing but from underneath the culvert. The stream appears from under a rock 15' downstream of the culvert pipe</p> <p>Bottom of pipe has rotted edge</p>

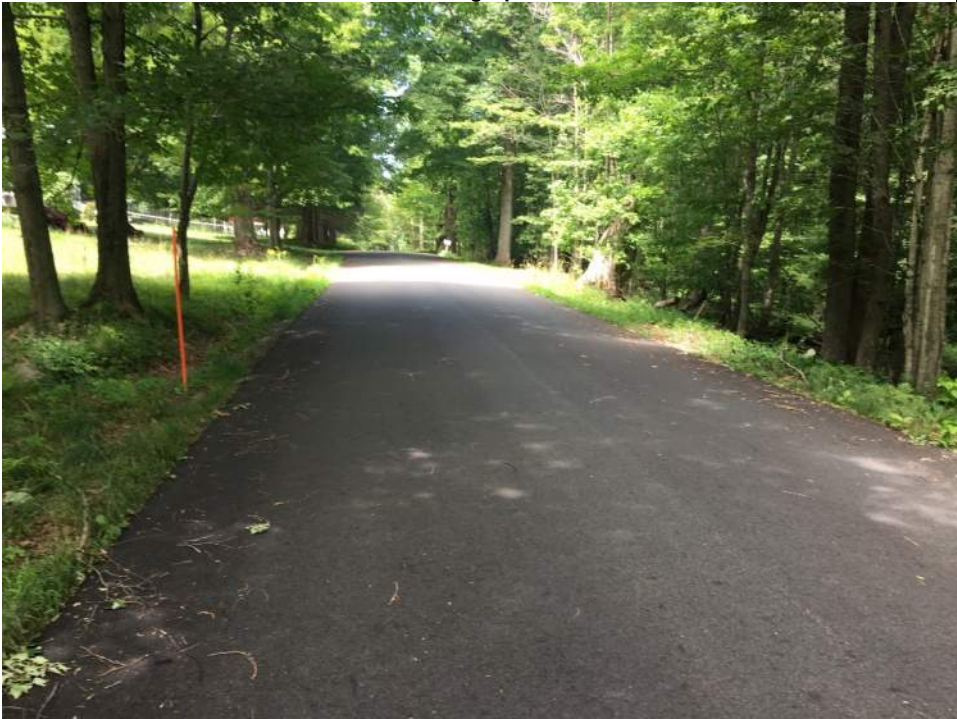
General Notes: Leaves collecting at entrance and base of culvert preventing the culvert from being able to clear out the leaves stuck inside the pipe

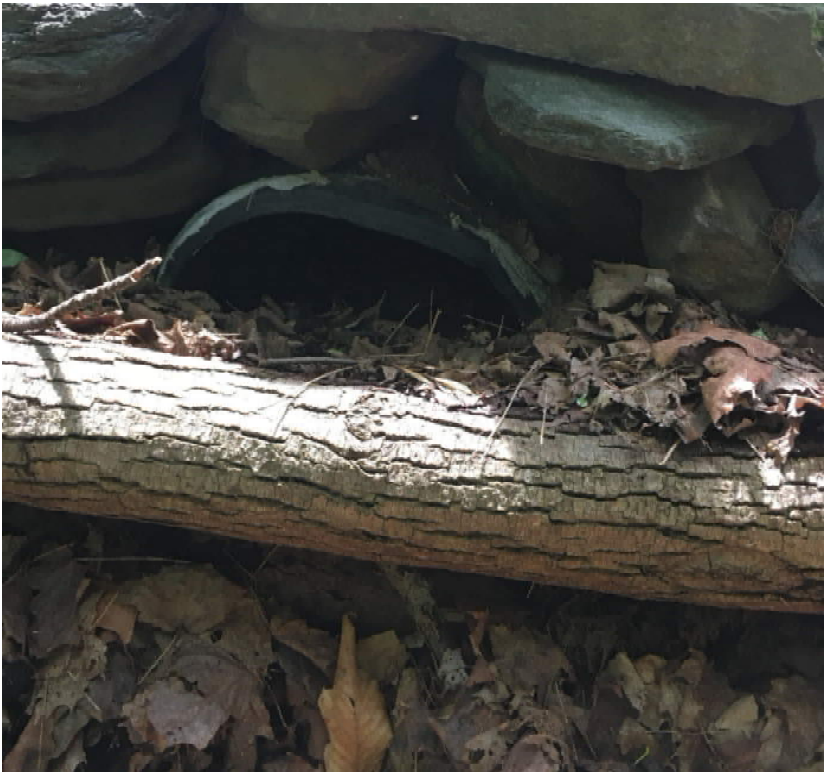
Description: Falling tree allowing a build up of leaves from leaving pipe. Downhill of culvert valley filled with leaves

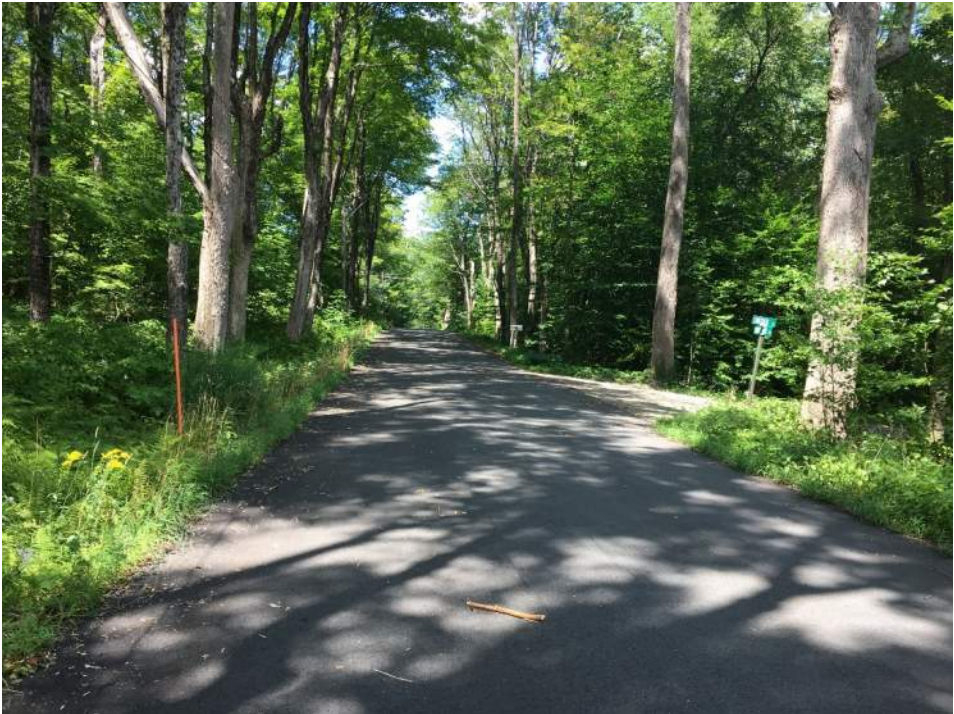
General Notes: Rotting is occurring on pipe bottom at both entrance and exits 20" water drop out of exit has caused erosion under the pipe

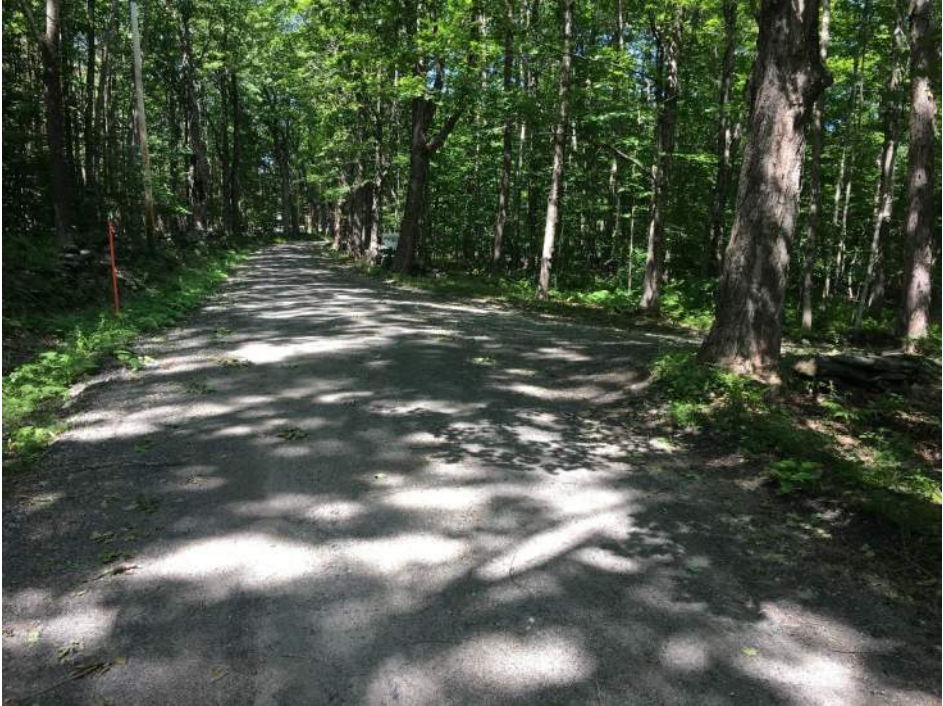
General Notes: 5.5" to 6.5" of sediment observed at ends of culvert Indications that pipe in current condition has reached its capacity in storms

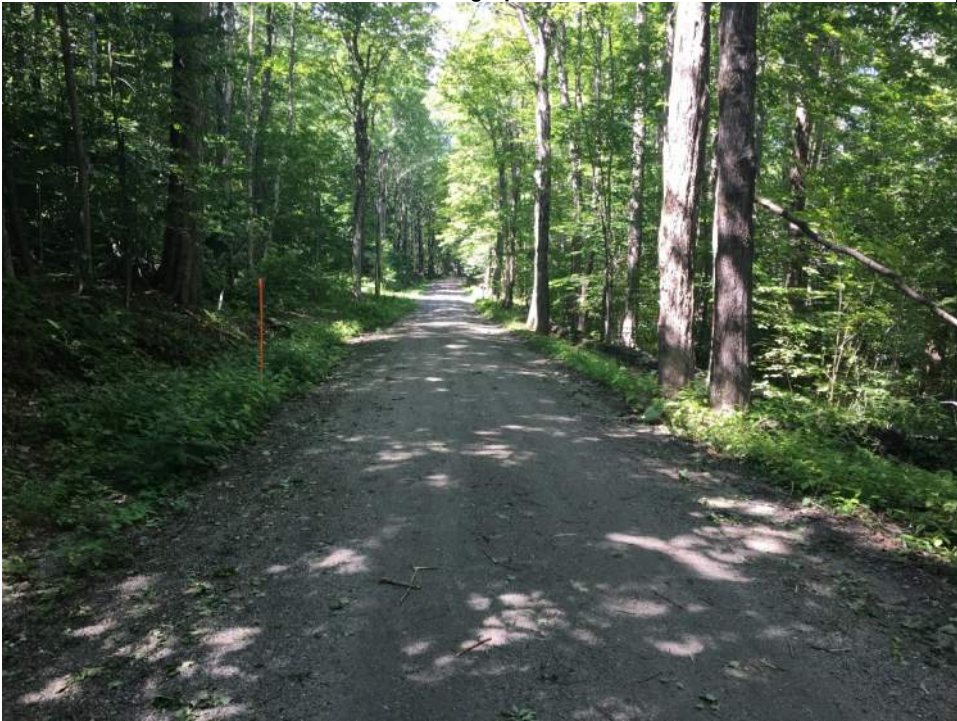
General Notes: Pipe filled with a thick layer of sediment reducing the capacity of drainage pipe Signs of rot or structural failure on pipe Large deformation on entrance of pipe appears to be an impact hit due to no material on top of pipe where deformation is observed

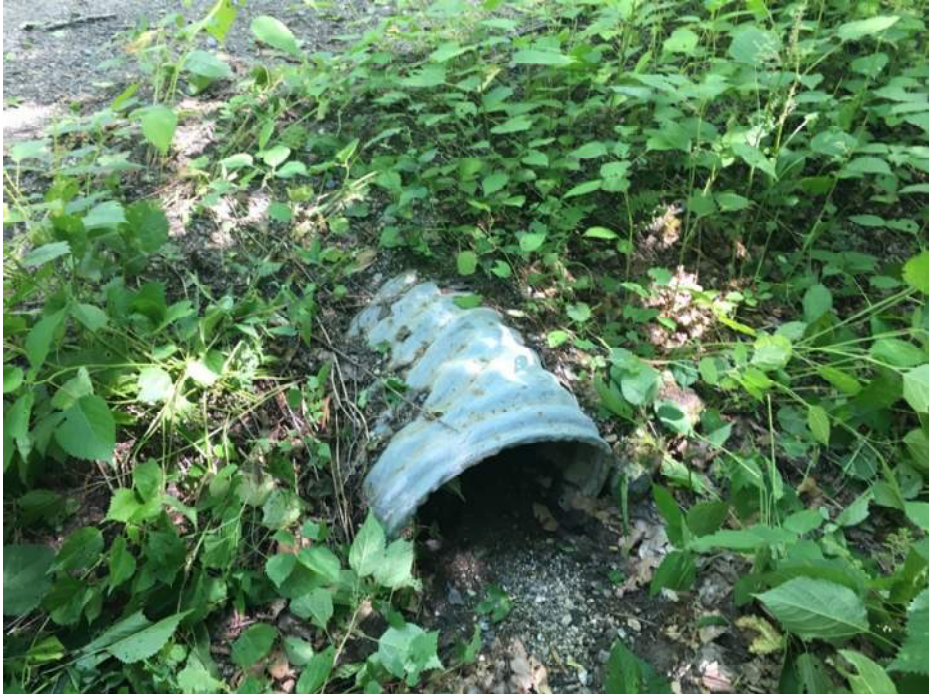
Description:			
Large deformation on top left			
Pipe material in adequate condition. No signs of rot or structural failure 4" of sediment build up at entrance

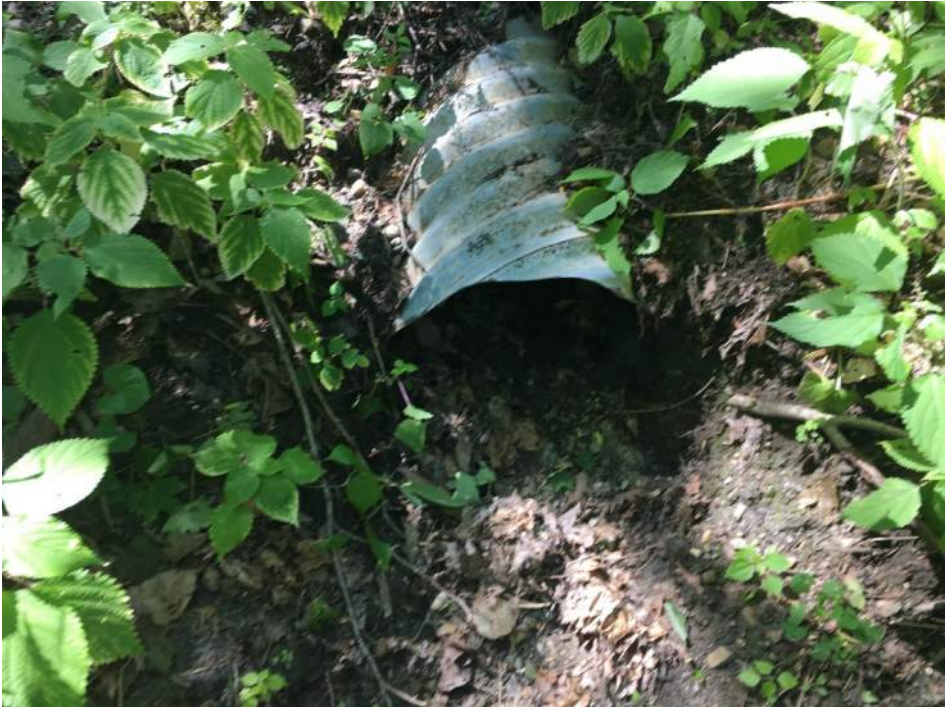
Description:			
5.5" of sediment build up at end of pipe			
Pipe material in adequate condition. No signs of rot or structural failure

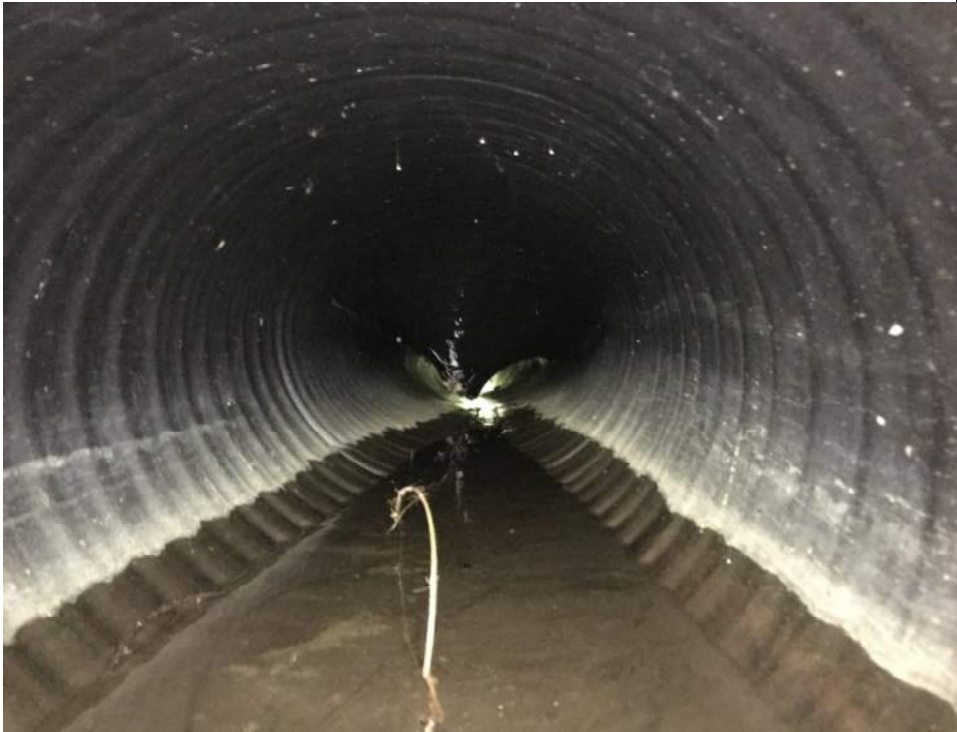
General Notes: Pipe has collapsed in center of the pipe. No signs of collapse on the road way
