Memorandum

Date: September 17, 2020

Project #: 42625.00

Re: Plainfield Culvert Assessments

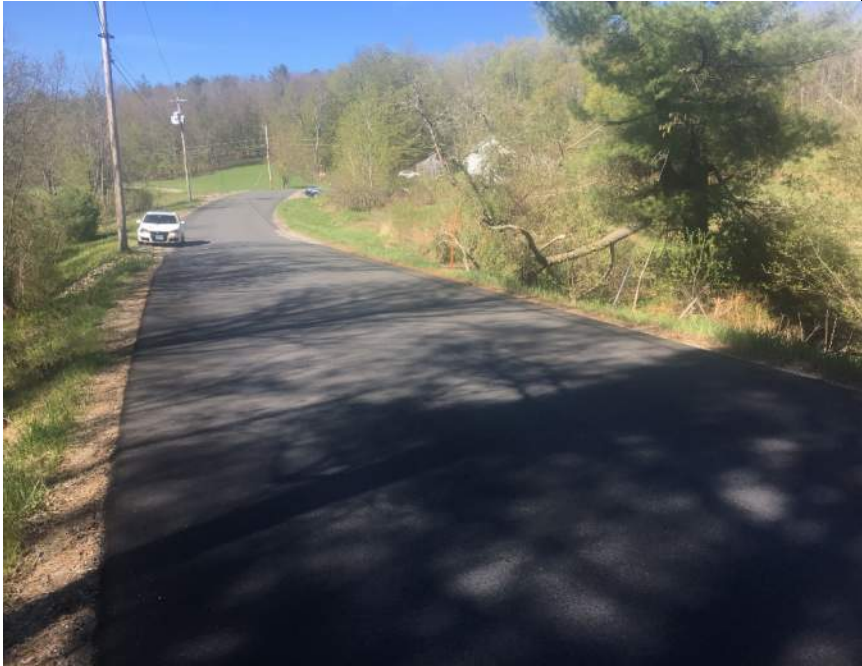
General Notes: No apparent signs of metal rotting Depression in the top of pipe directly under the roadway Large amount of debris build up blocking entrance to culvert

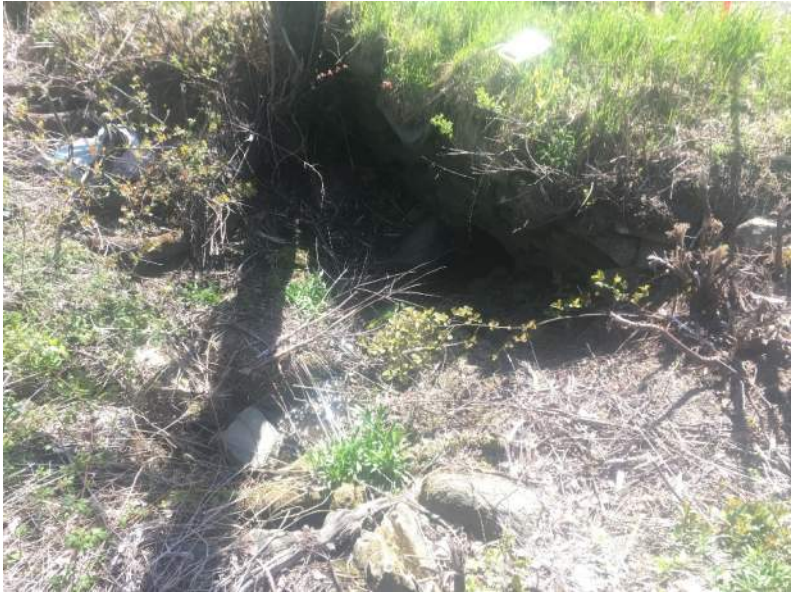
Description: Significant rot first foot of pipe Stone head wall causing culvert to collapse under weight

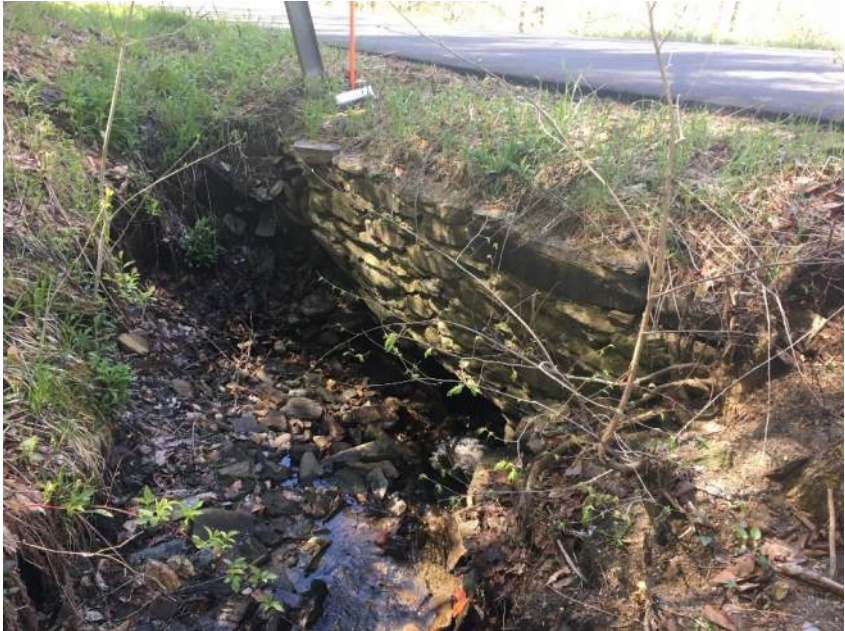
Description:			
<p>Left side of pipe lip bent in front of entrance reducing the water flow and allowing debris to build up</p> <p>Stone headwall presents a slight lean away from road</p> <p>Entrance does not have sediment build up or erosion</p>

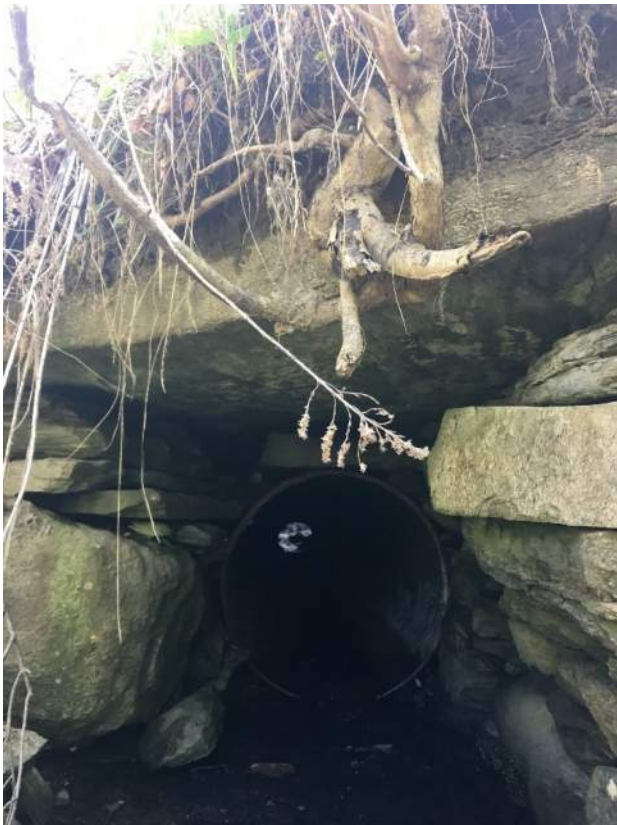
Description:			
<p>No sediment build up</p> <p>Small signs of undercutting</p> <p>No rot or deformation</p>

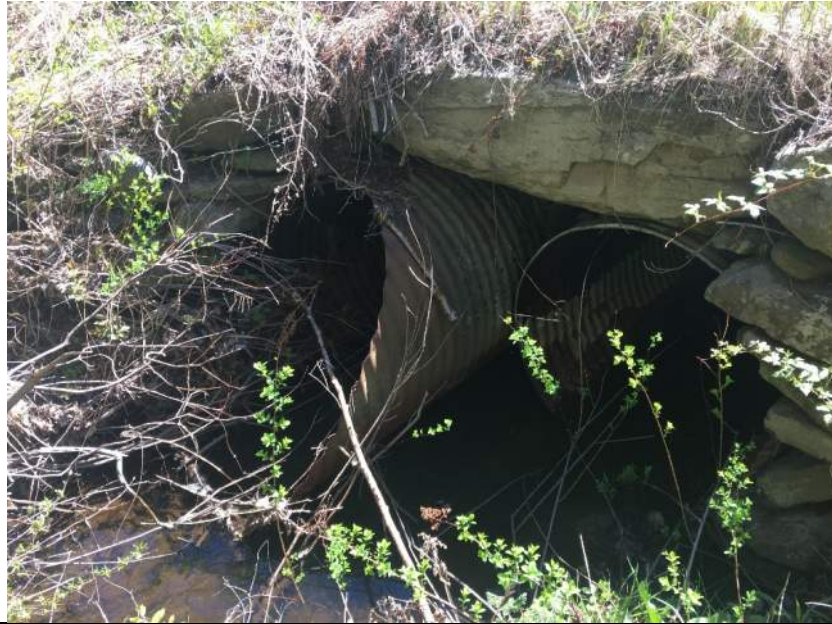
Upstream Condition

Left pipe completely rotted bottom 4' into pipe with 5' erosion under cutting

Right pipe has rot holes with 1' of under cutting

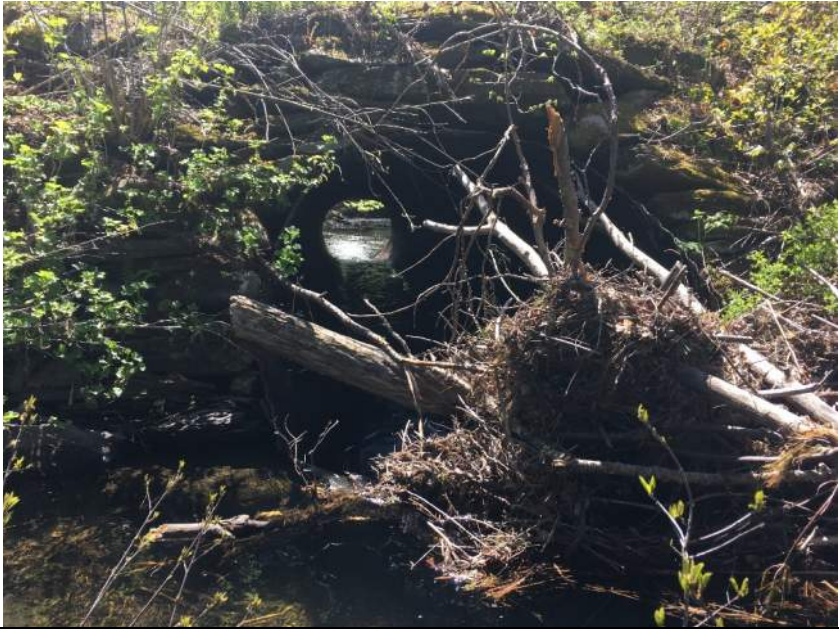
Description:			
<p>Front bottom lift bent upward causing a blockage and allow build up of debris</p> <p>No signs of metal rotting</p>

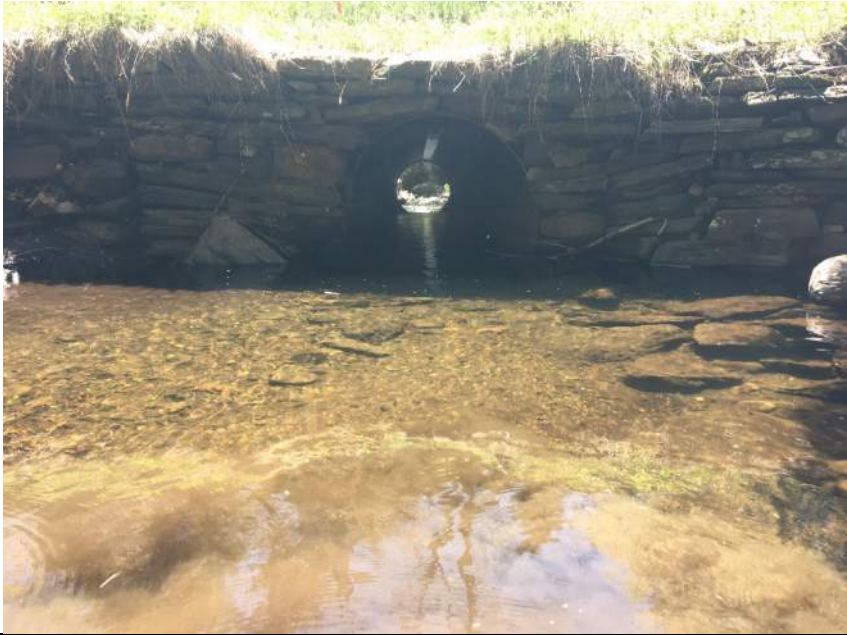
Description: Metal pipe appears to be in adequate shape. There is signs of erosion in the soil behind the stone head wall. This may indicate signs of the head wall seperating from the soil.

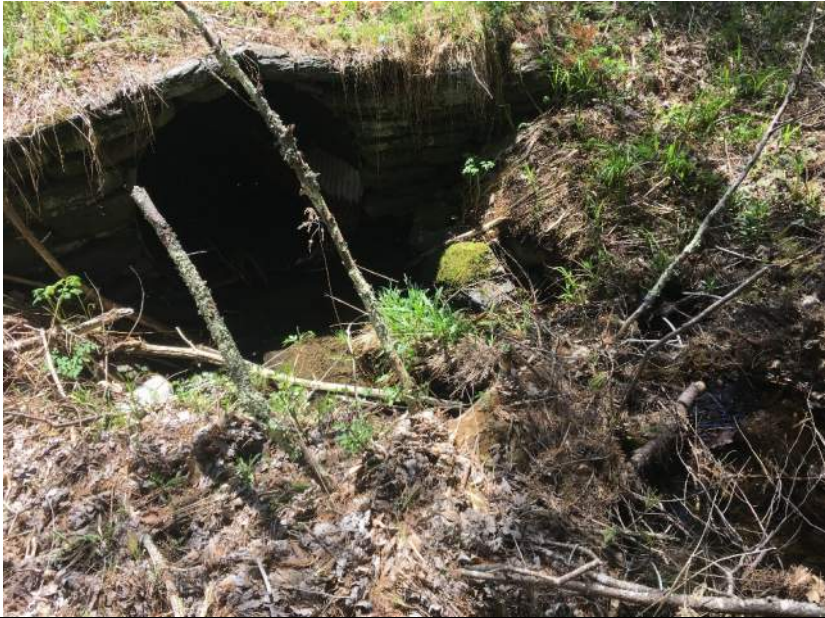
Description: Blockage built up before entrance containing large sticks and leaves

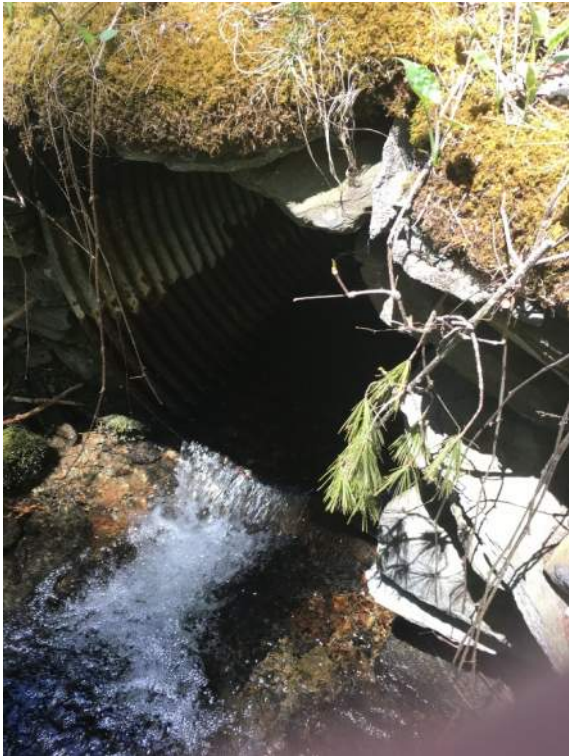
Description: Stonewall leaning away from road 3" deep undercutting Pipe starting to show signs of rot

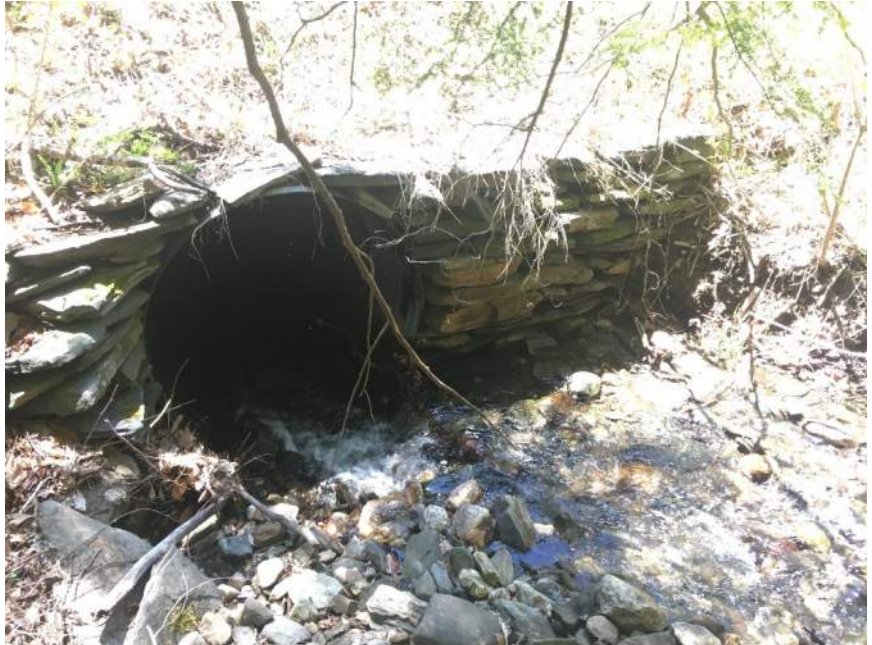
Upstream Condition

Pipe in adequate condition

Little to no erosion around entrance to culvert

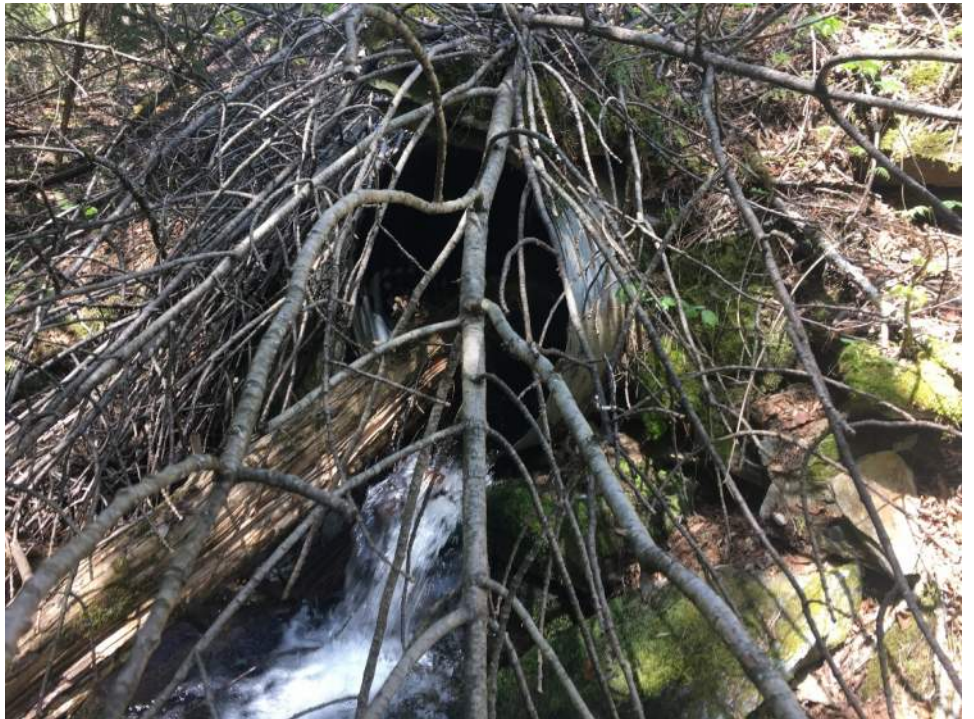
Downstream Condition

1.5' water drop and large overhang

Pile of sticks and tree trunks piled up blocking the exit from discharging debris

General Notes: Debris needs to be cleaner out of exit to restore full function of culvert Pipe is in adequate condition, no visible signs of damage

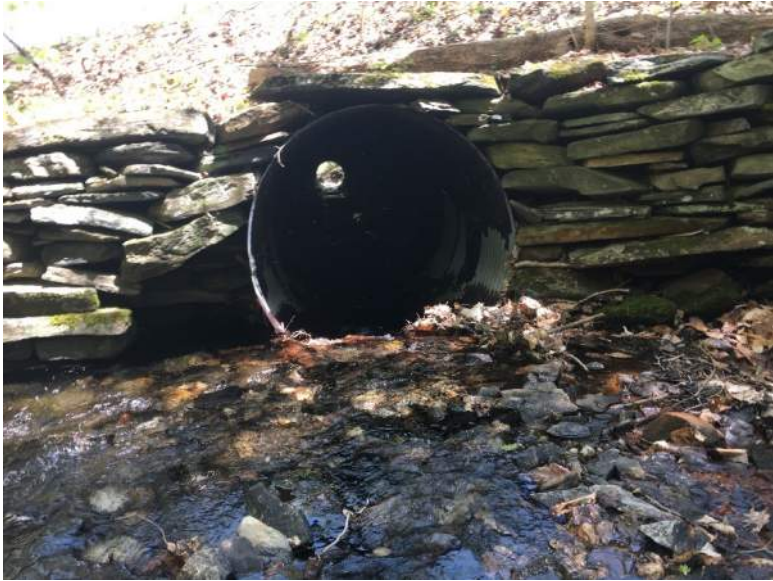
Description: Build up of sticks and leaves causing a blockage 5" in height Undercutting to the left of entrance pours into pipe through a quarter sized rot hole

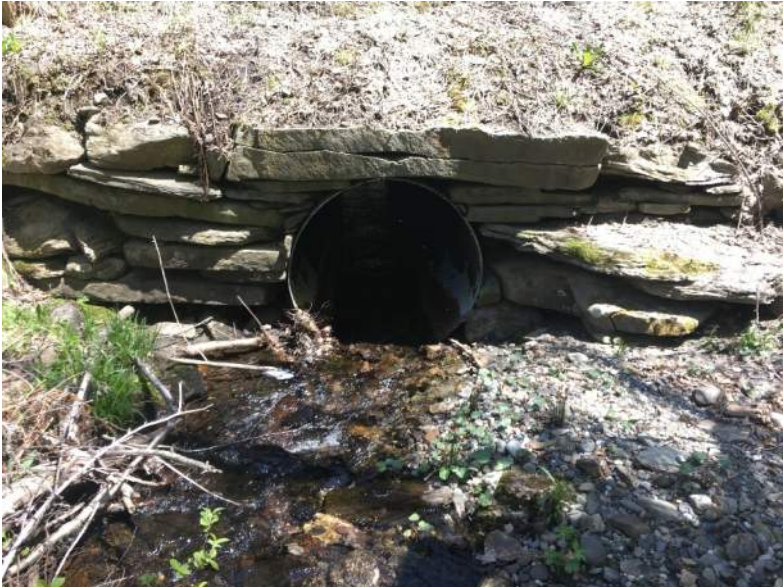
Description:			
Slight depression in center of pipe Stone headwall is in good condition Starting to observe signs of rotting metal

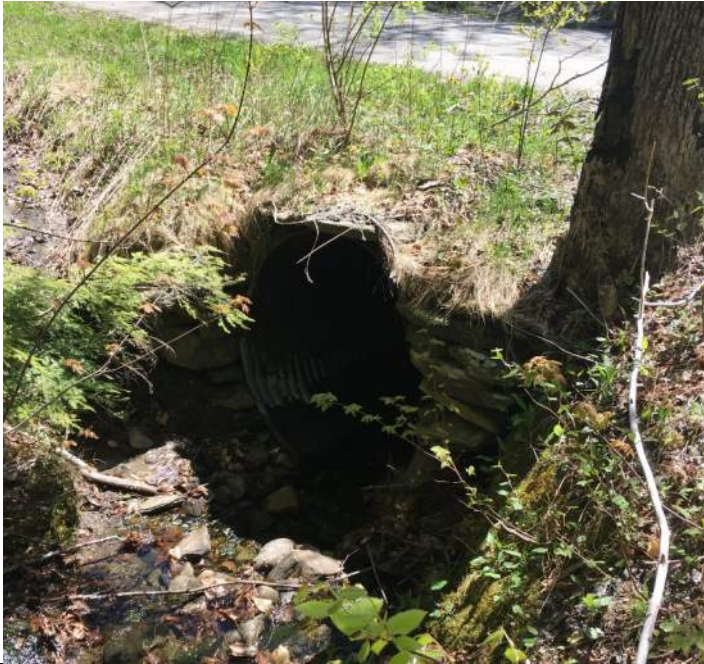
Description:			
Pipe in good condition No signs of erosion No signs of deformation

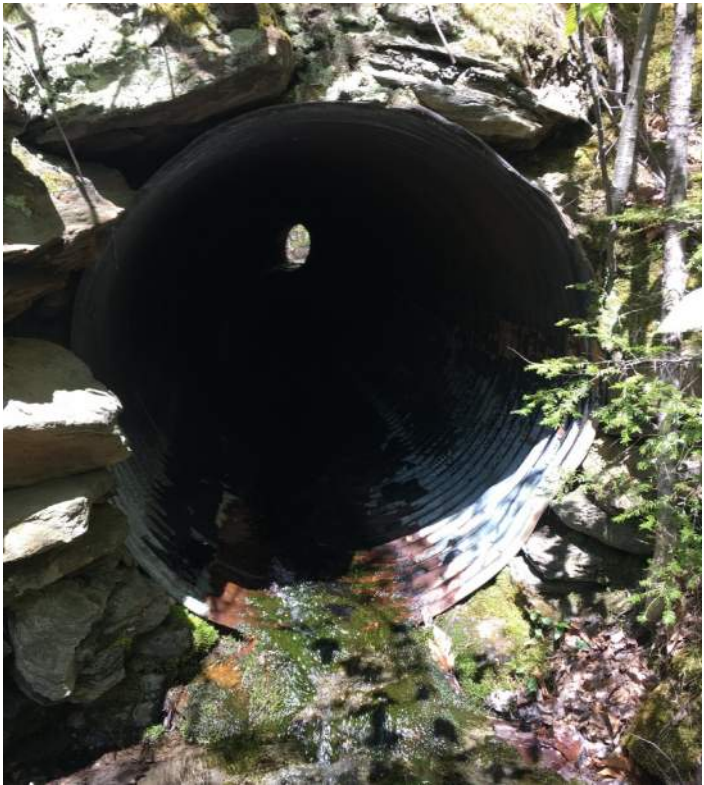
Description:			
Pipe still has majority of rubber coating No signs of pipe deteriorating

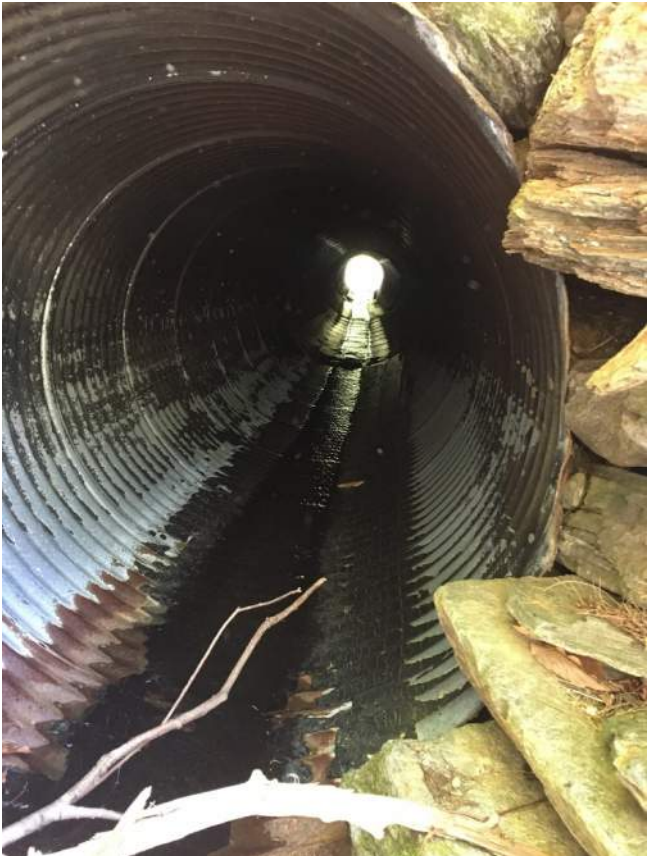
General Notes: Entrance of pipe is bent upward allowing water to flow underneath pipe There is no significant erosion concerns Rust line covers majority of the bottom of pipe indicatting high water flows

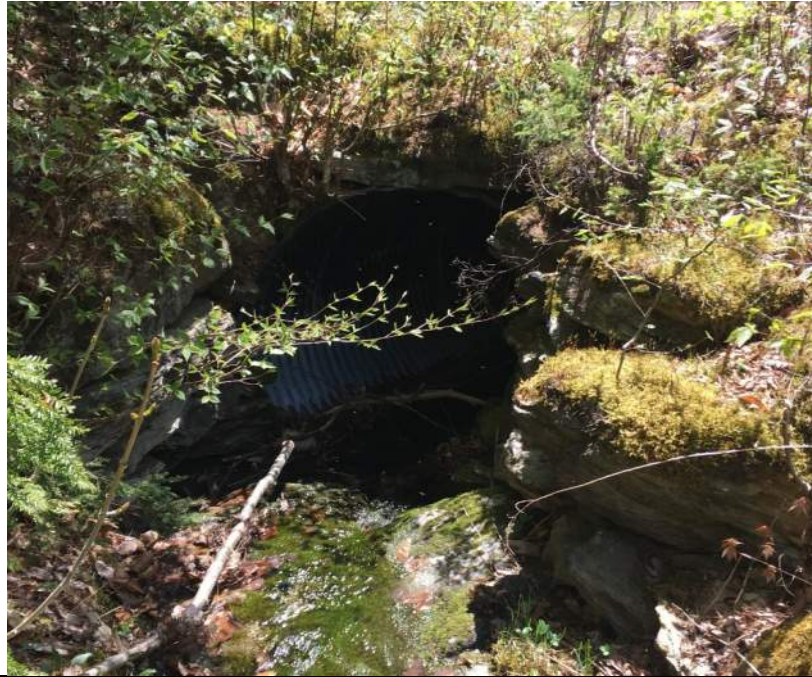
Front lip of metal pipe is bent upward but is not observed to cause any flow reduction through the pipe but does allow water to flow under pipe

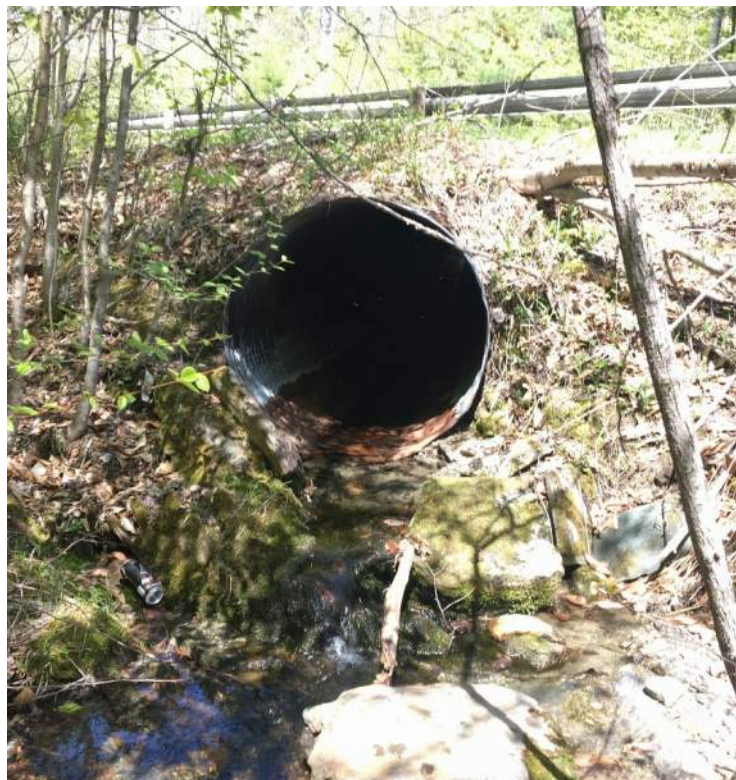
No signs of erosion

High rust line

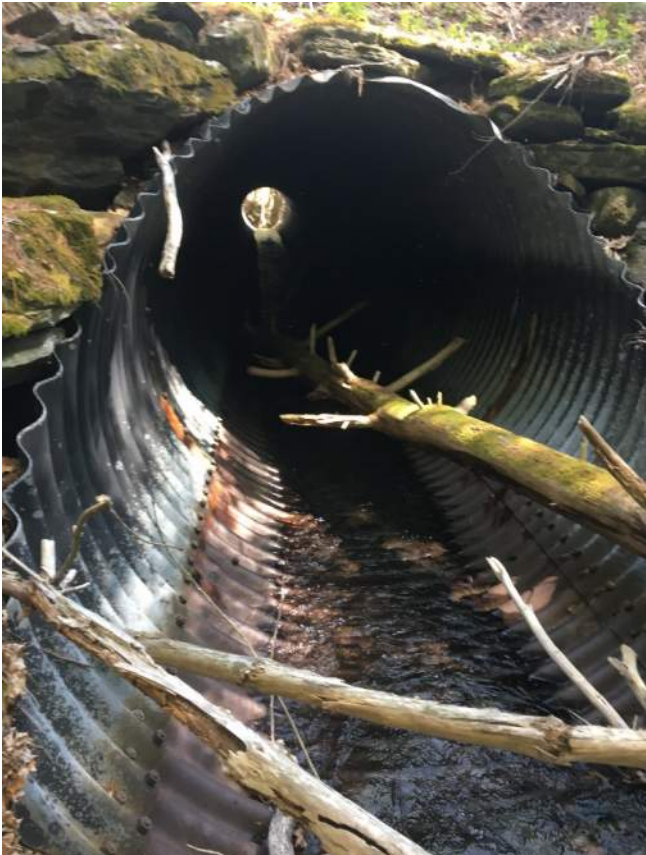
General Notes: Debris build up at entrance could reduce water flow Pipe is in adequate conditon. Some noted signs of rust and erosion.

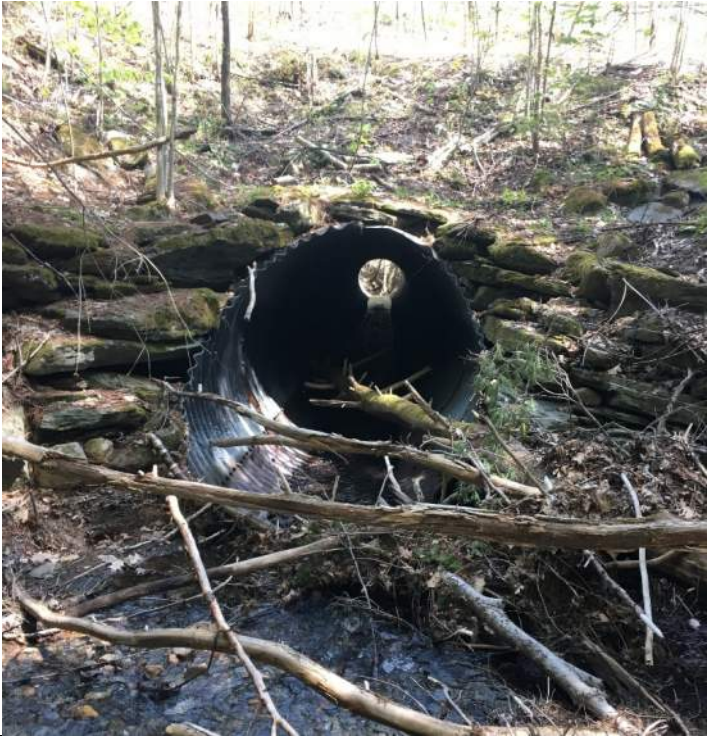
Description:			
<p>Undercutting erosion directly under pipe and to the right of pipe</p> <p>No visible signs of rot or depressions in pipe. Pipe in adequate condition.</p> <p>Debris build up in front of entrance including fallen trees and rocks</p>

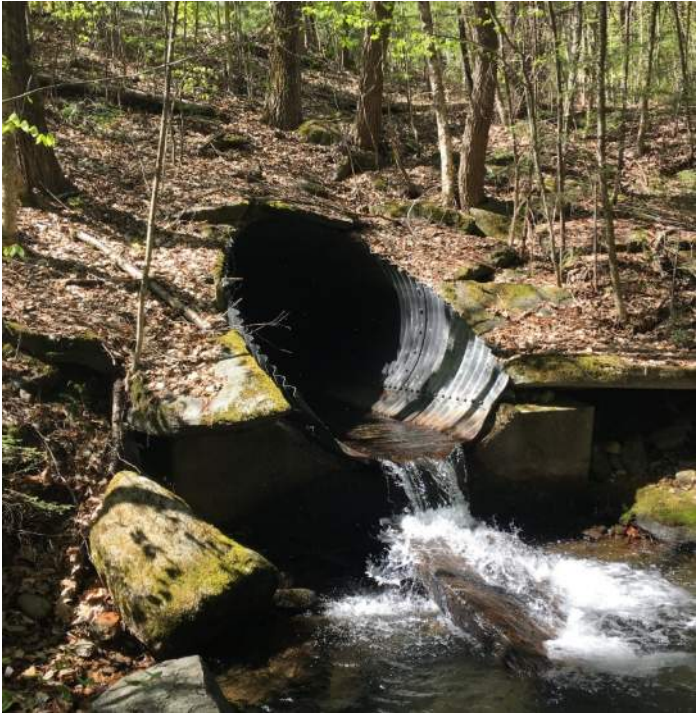
Description:			
<p>No visible signs of rotting. Light surface rust starting to form.</p> <p>2' water drop on to large rock</p> <p>Pipe supported by concrete base which is in good condition</p>

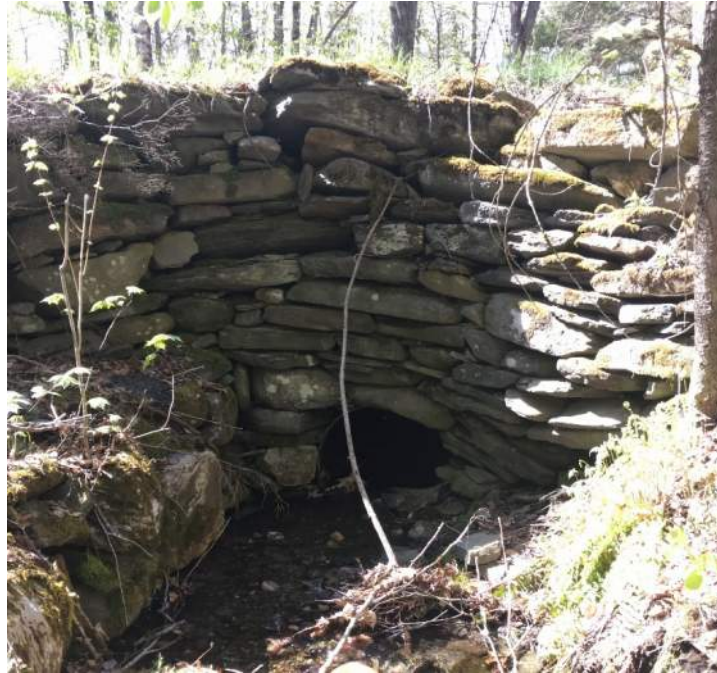
Large rock causing a blockage at entrance could act to reduce water flow

No signs of pipe damage including deformation or rot

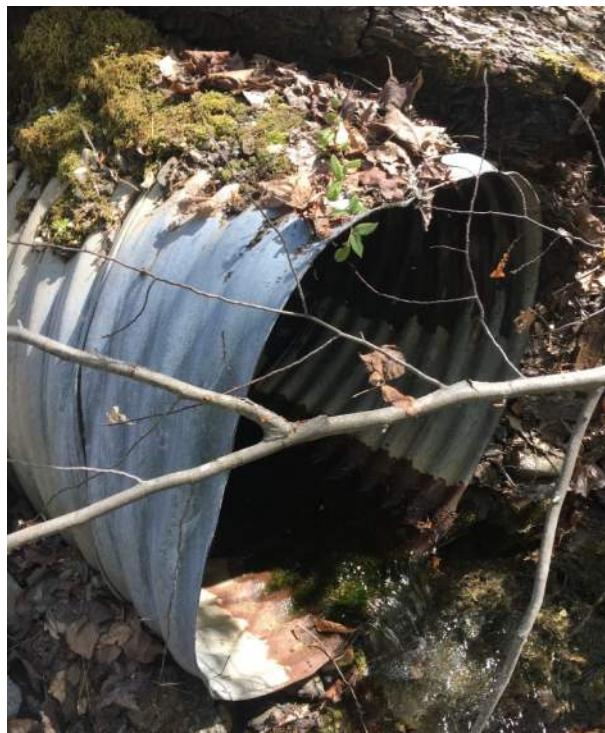
2" water drop with erosion directly underneath pipe

Depression in the top of the pipe towards end of pipe but not under the roadway

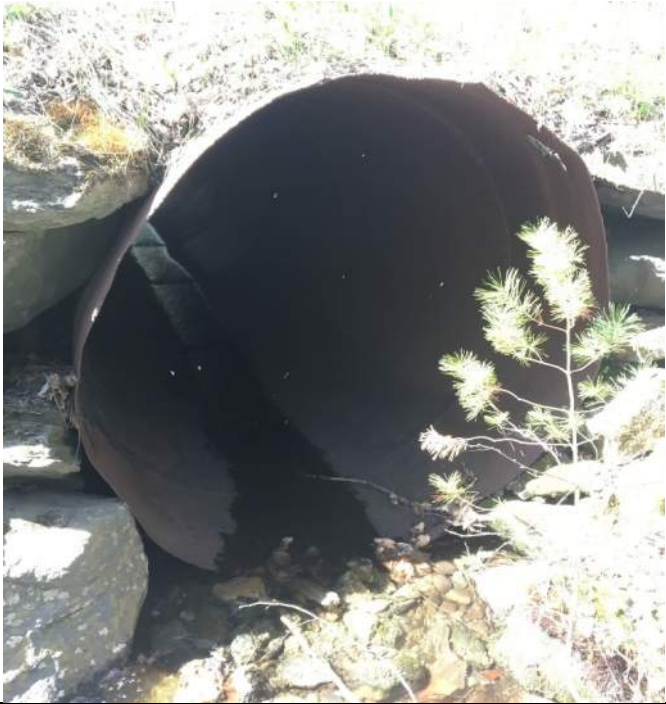
Description:			
<p>Entirety of pipe is rusted but no signs of rotting</p> <p>Water flows on both sides of pipe</p> <p>Entrance shows signs of metal deformation on upper left portion</p>

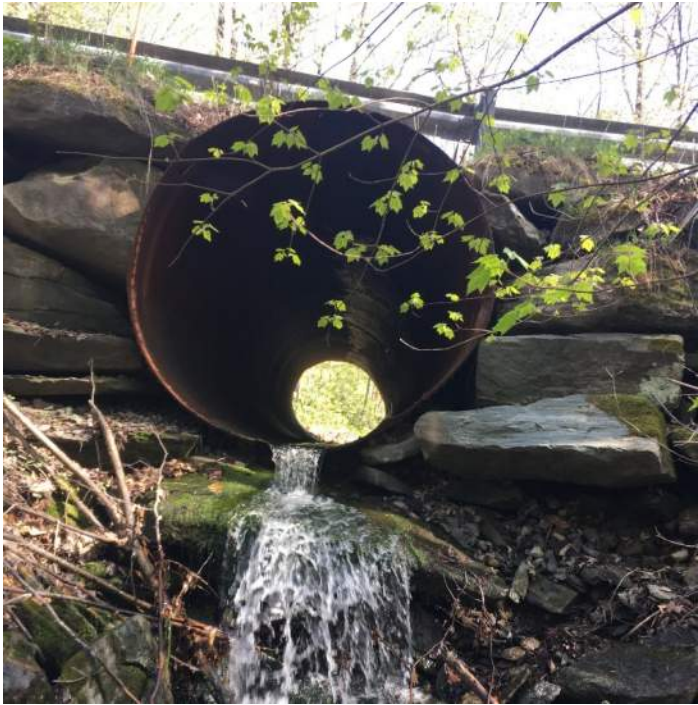
Description:			
<p>Water path through pipe has worn into metal</p> <p>High water drop onto large rock</p> <p>Gaps observed underneath pipe possibility from water erosion</p>

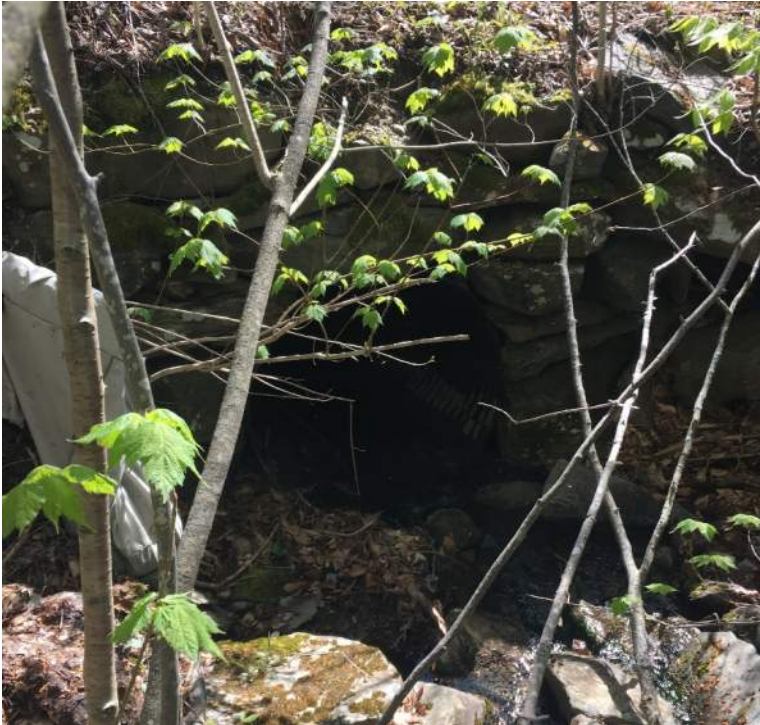
Description: Rotted bottom of pipe Water eroded and flowing to the right of the pipe

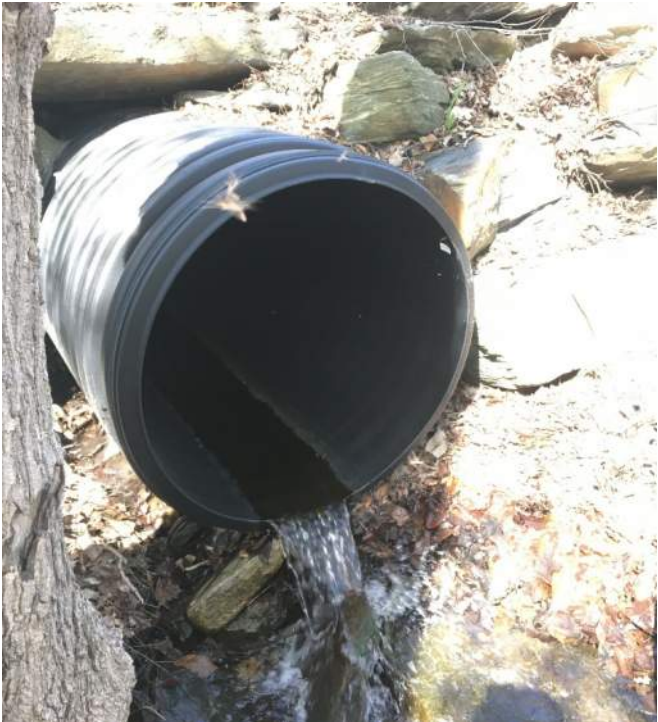
Description: Last 8' of culvert switches to corrugated PVC piping 6" water drop Transition from steel pipe to smaller HDPE pipe causes water blockage Unable to see end of steel pipe to verify condition of pipe and transition

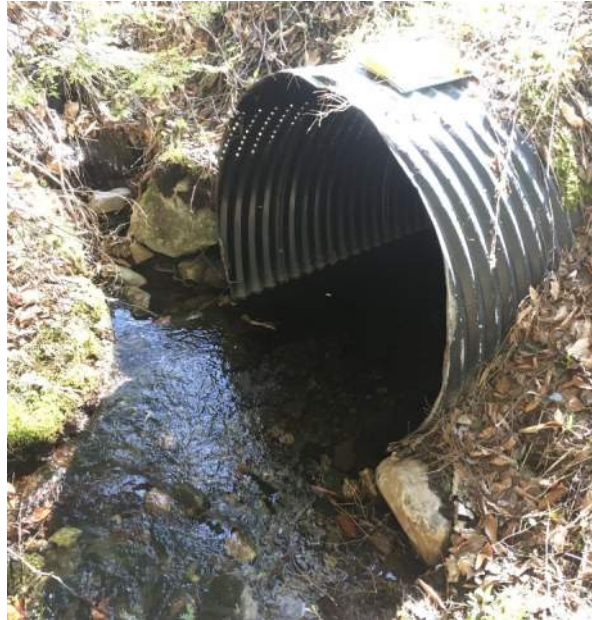
10' to 12' of metal pipe has drilled holes on sides of pipe until transition to older solid corrugated steel pipe

Bottom of pipe filled with sediment and rocks

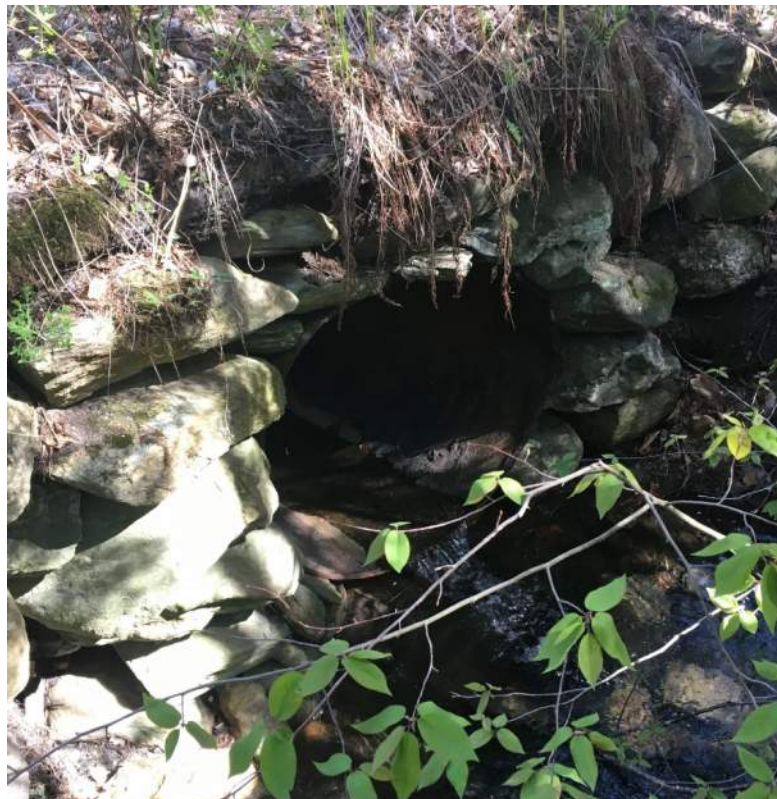
Last 10' of piping is transitioned to a smooth bore pipe

Appears to be buckling on sides of pipe along with rot and puncture holes

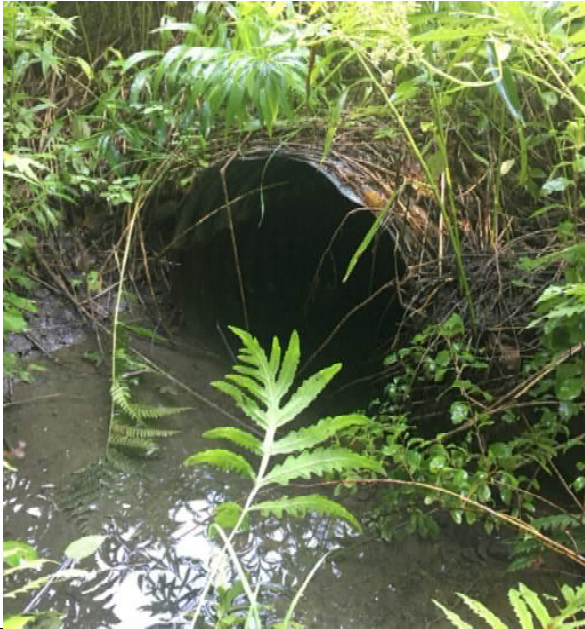
Description:			
Fine sediment build up No signs of deterioration of metal at opening Erosion undercutting to the right side of metal pipe

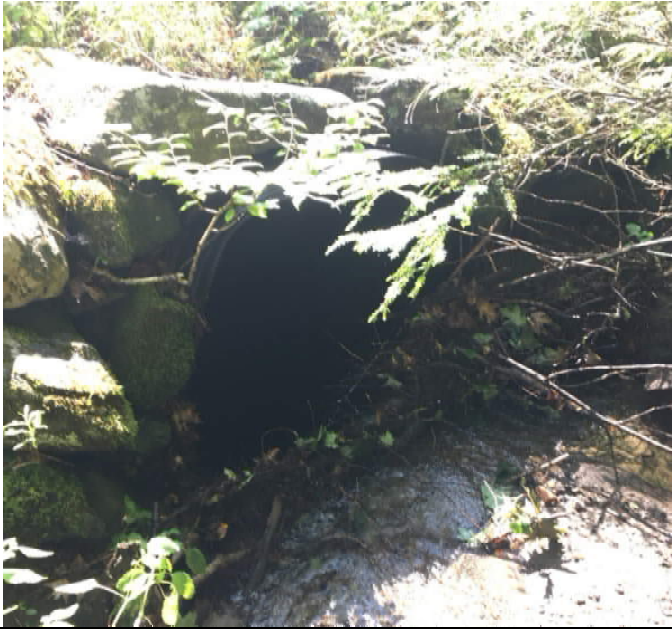
Description: 16" of sediment build up held up by sticks and debris Erosion to the right of the culvert causes the water flow to go past the culvert before draining

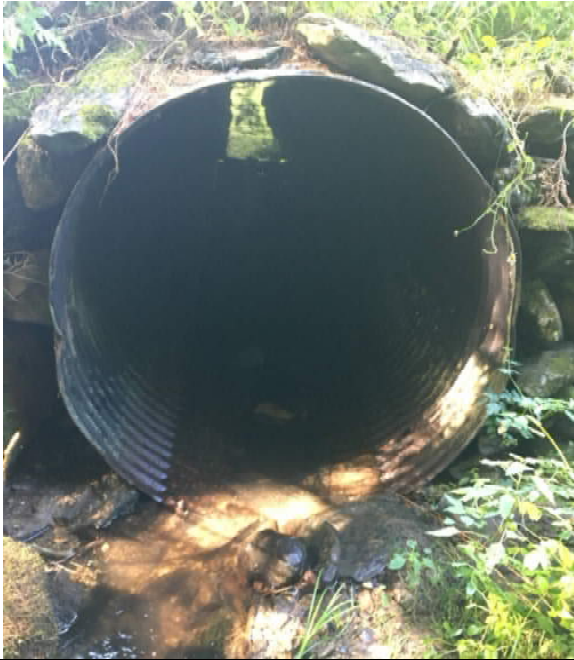
Description:			
Small stick blockage about 10-15' into the pipe causing slight disruption of water flow			
No sediment build up Undercutting on either side of pipe Two dime size rot holes on left bottom side of pipe along with rust line on bottom of pipe. No other indication of pipe deterioration visibly seen

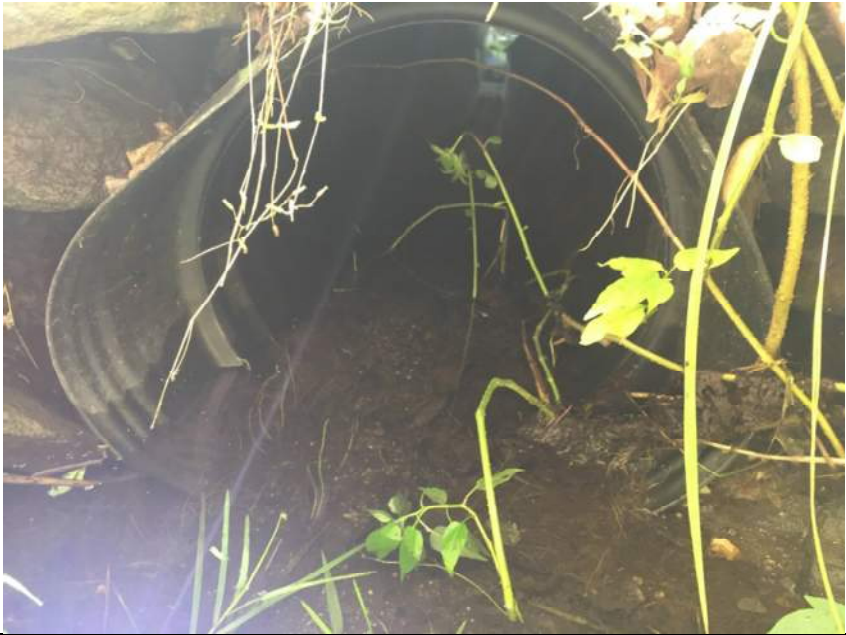
Description: Front lip is bent downward from stonewall on top pipe interior of pipe appears to be in good shape Thin layer of sediment build up on bottom of the pipe. 3 noted plants growing in the sediment

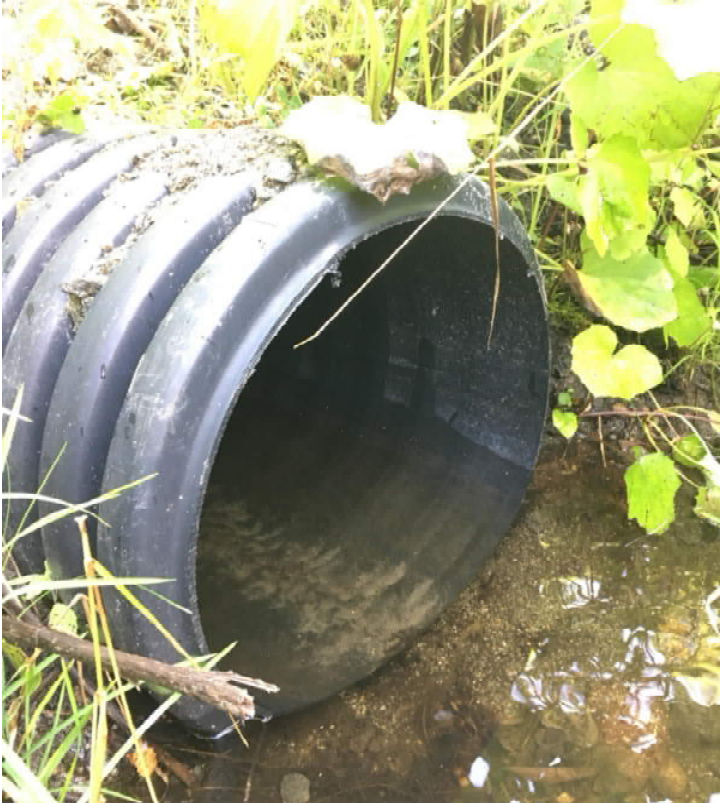
vhb Engineers Scientists Planners Designers		<h2 style="text-align: center;">Culvert Adjacent Assessment</h2>	
Client Name: Town of Plainfield		Downstream Condition	
Culvert ID No: 21			
Photos:

Description: Pipe in good condition Low water flow No sediment build up in pipe

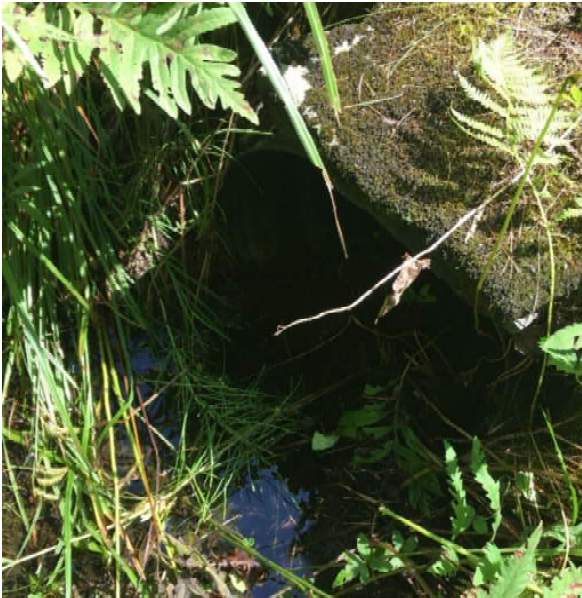
vhb Engineers Scientists Planners Designers		<h2 style="text-align: center;">Culvert Assessment</h2>	
Client Name: Town of Plainfield		Upstream Condition	
Culvert ID No: 22			
Photo:

Description:			
<p>Debris build up a foot into the pipe comprised of dead stemmed plants</p> <p>Low water flow</p> <p>Pipe visibly appears to be in good condition</p>

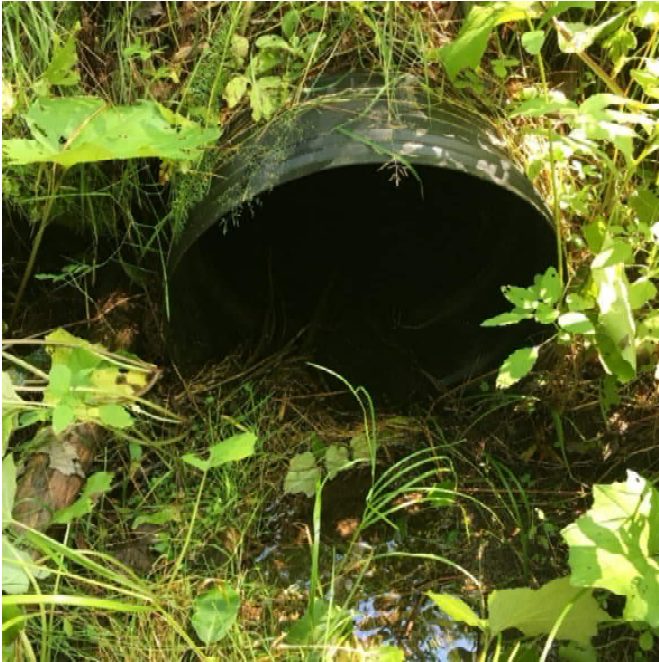
vhb Engineers Scientists Planners Designers		<h2 style="text-align: center;">Culvert Assessment</h2>	
Client Name: Town of Plainfield		Upstream Condition	
Culvert ID No: 23			
Photo:

Description:			
<p>Small build up of pine needles and debris not causing a significant affect to water flow</p> <p>No signs of erosion or undercutting</p> <p>Pipe visibly appears to be in good condition</p>

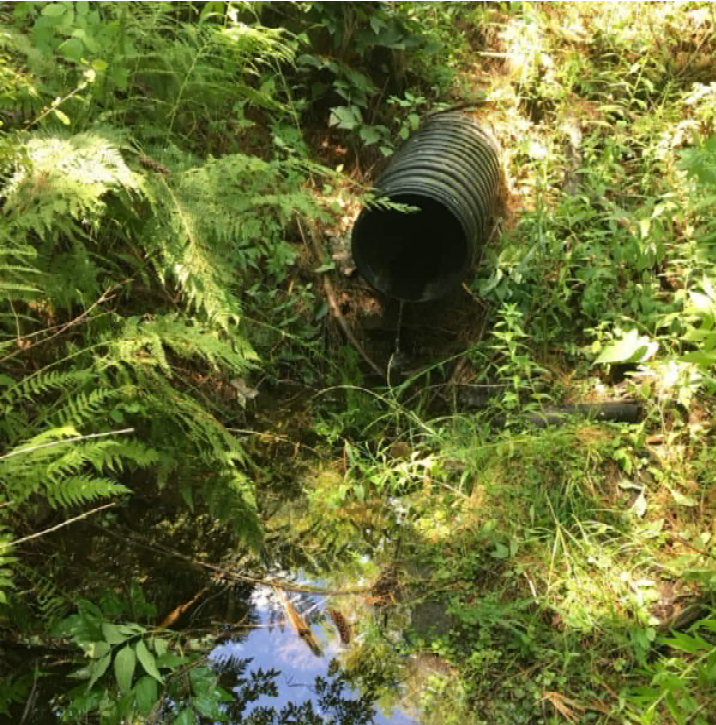
vhb Engineers Scientists Planners Designers		<h2 style="text-align: center;">Culvert Adjacent Assessment</h2>	
Client Name: Town of Plainfield		Downstream Condition	
Culvert ID No: 23			
Photos:

General Notes: Pipe in good condition Outlet drops water from 10" up and is causing erosion on the underside of pipe

Description:			
<p>10" water drop</p> <p>10" deep water undercutting</p> <p>Pipe visibly appears to be in good conditions</p> <p>Pipe fills a bowl that does not appear to have an outlet</p>

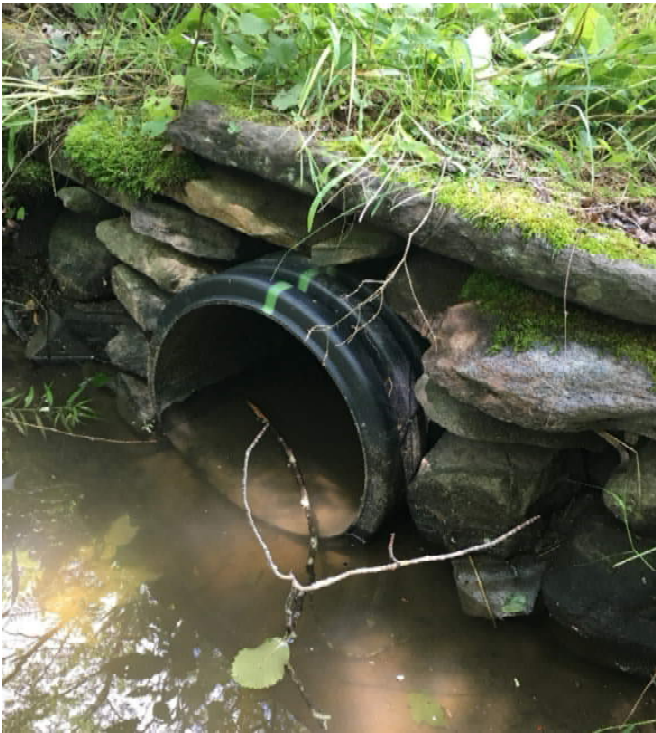
Client Name: Town of Plainfield	Downstream Condition	Culvert ID No: 24
--	-----------------------------	--------------------------

Description: 4" of stagnant water sits in the end of the pipe The bowl that the pipe fills is not filled to the outlet

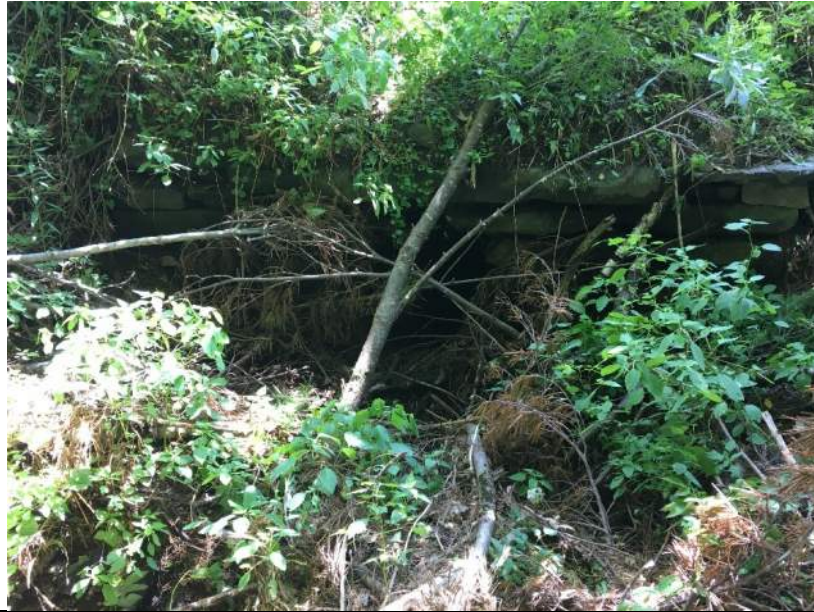
Upstream Condition

General Notes: Debris at entrance of pipe is creating a blockage Pipe visibly appears to be in adequate condition

Entrance is blocked up by a thick layer of debris (tree trunks, branches, leaves, etc.)

Condition of pipe was not able to be determined through the debris

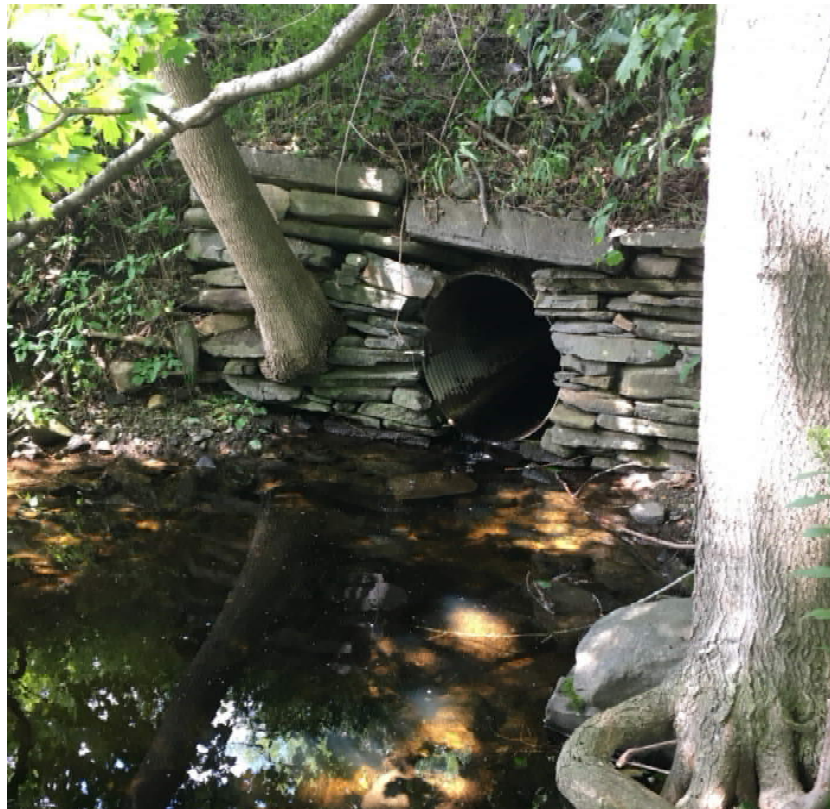
Downstream Condition

Bottom of pipe is rusted but no signs of rot

Water flows out of pipe over a rock and then into the water below

Small signs of undercutting to the left of the pipe as water flows over the rock

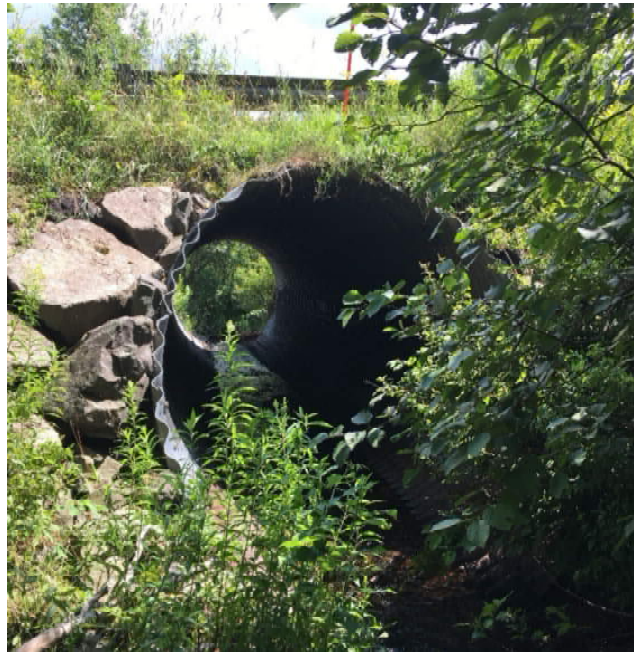
Upstream Condition

No significant signs of erosion

Pipe visibly appears to be in good condition
