Memorandum

Date: September 17, 2020

Project #: 42625.00

Re: Plainfield Culvert Assessments

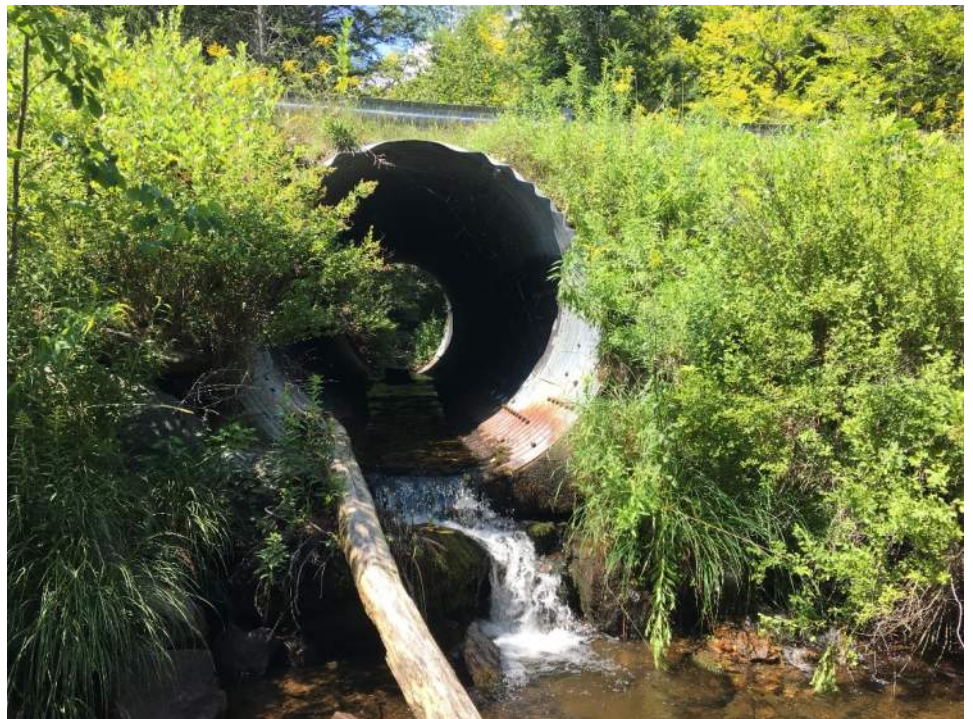
Downstream Condition

General Notes: Significant water drops have cause significant erosion under the pipe and its base Metal pipe upon inspection appears to be in adequate condition (no rot or deformation)

After the initial 12" drop the water flows over a rock and drops another 16"

One tree trunk has flown through the culvert and got jammed in the soil on the other side could potentially cause future blockages

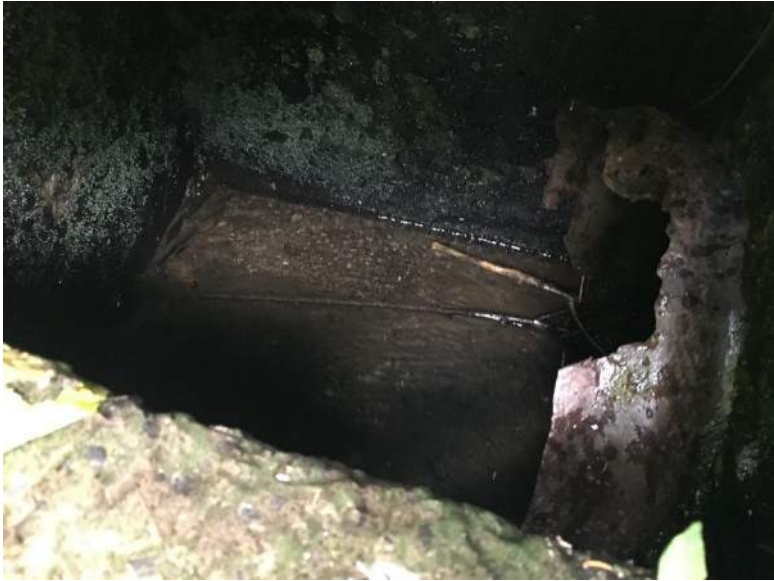
vhb Engineers Scientists Planners Designers		<h2 style="text-align: center;">Culvert Assessment</h2>	
Client Name: Town of Plainfield		Upstream Condition	
Culvert ID No: 27			
Photo:

Description:			
<p>Metal entrance is rotted and is missing sections</p> <p>Entrance pipe is in a concrete box with a open flow side entrance</p> <p>Concrete box is clean of debris</p>

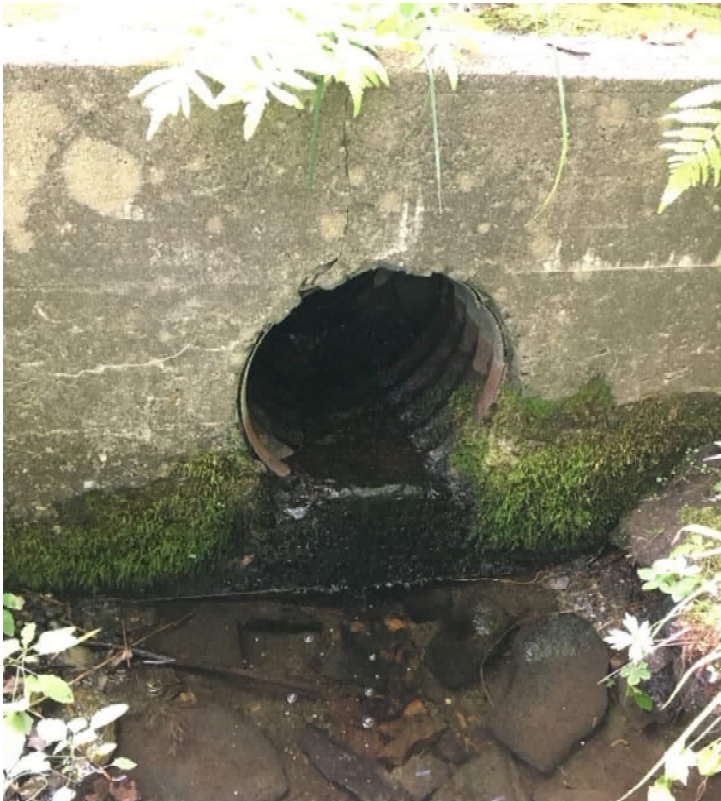
vhb Engineers Scientists Planners Designers		<h2 style="text-align: center;">Culvert Adjacent Assessment</h2>	
Client Name: Town of Plainfield		Downstream Condition	
Culvert ID No: 27			
Photos:

Description:			
<p>Exit pipe has significant rot</p> <p>Pipe is enclosed in concrete</p> <p>Water drops 10" down the face of the concrete</p>

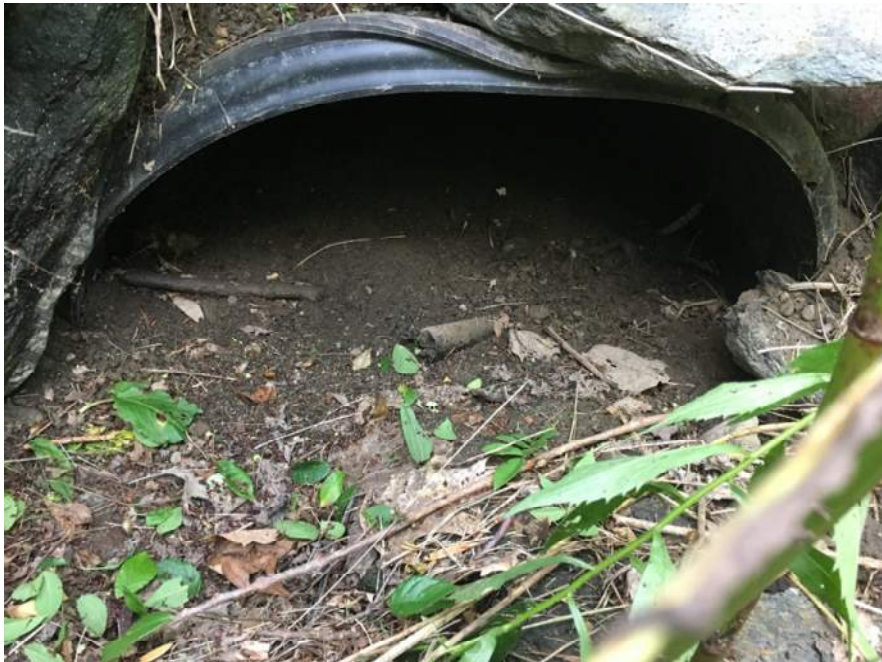
Engineers Scientists Planners Designers		<h2 style="text-align: right;">Culvert Adjacent Assessment</h2>	
Client Name: Town of Plainfield		Downstream Condition	
Culvert ID No: 28			
Photos:

Description:			
<p>Steel: At higher elevation than PVC. Not accessible due to heavy vegetation.</p> <p>PVC: Only 11.5" of pipe height due to heavy sedimentation build up.</p> <p>Major pipe deformation possibly from stone head wall.</p>

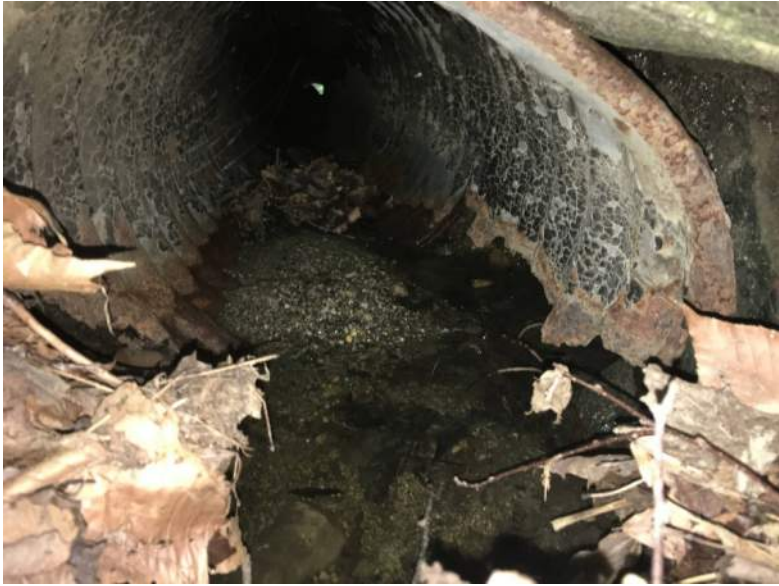
vhb Engineers Scientists Planners Designers		<h2 style="text-align: center;">Culvert Assessment</h2>	
Client Name: Town of Plainfield		Upstream Condition	
Culvert ID No: 29			
Photo:

General Notes: Pavement cracks run parallel with underground culvert pipe. Slight depression and small areas of missing pavement Rotted ends of pipe with sediment build up at entrance and pipe blockages could have an affect on pipe drainage capacity

Description: 8" of sediment build up at entrance Bottom of pipe rotted away leaving behind eroded sediment bowl trapping water before flowing down pipe

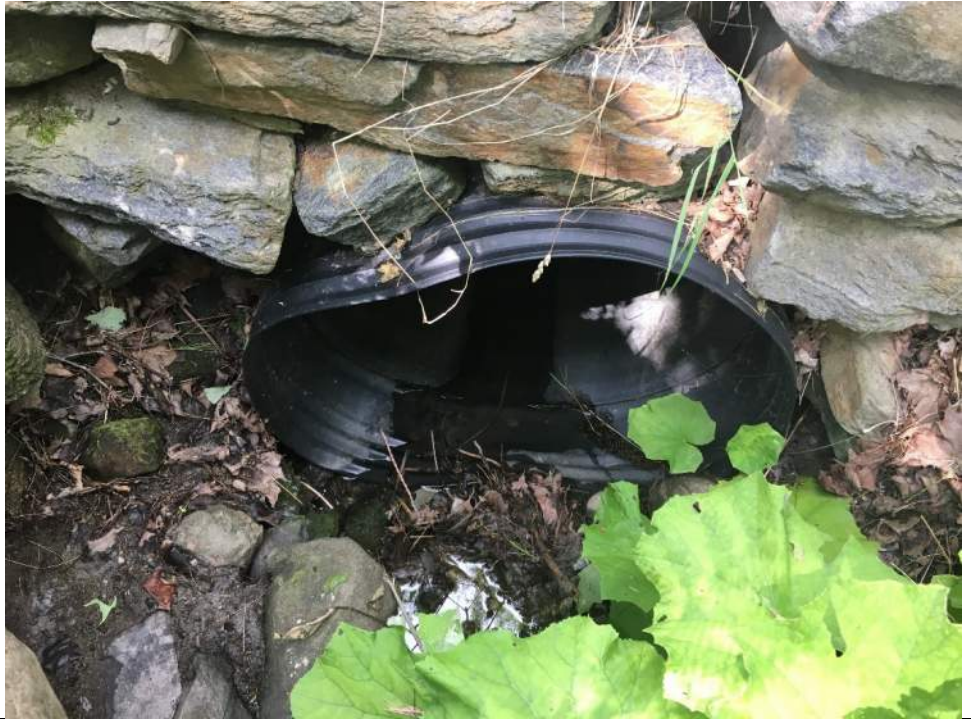
Upstream Condition

Slight erosion undercutting to the left side of the pipe

Front bottom flip bulged upward filled underneath by sediment causing a blockage

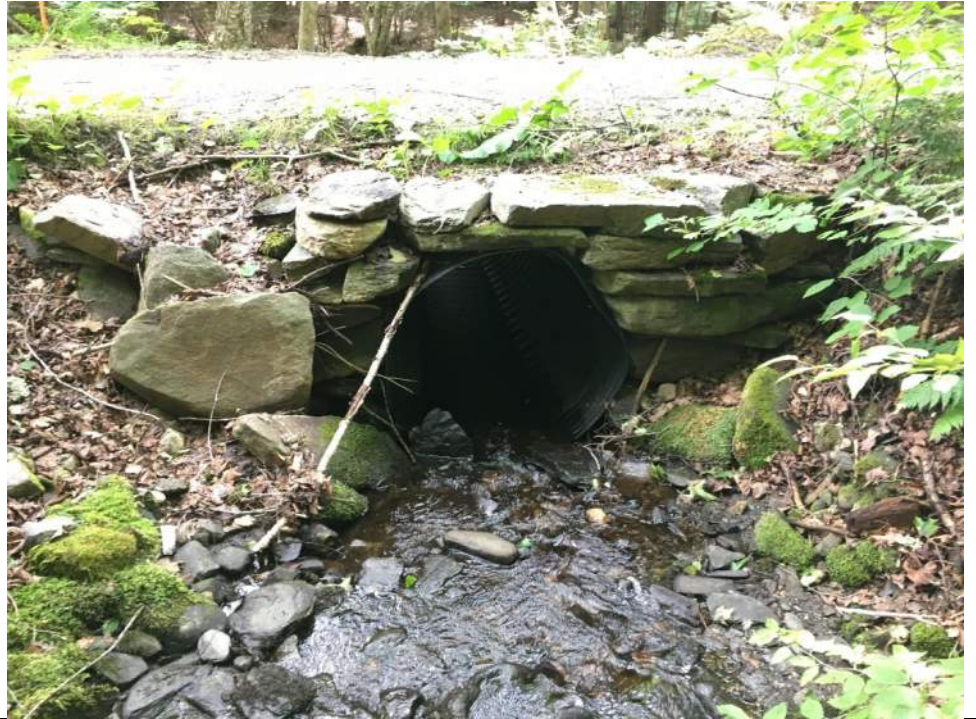
Undercutting occurs on both sides of the pipe

Pipe visibly appears to be in good condition with exception to top lift bent inwards

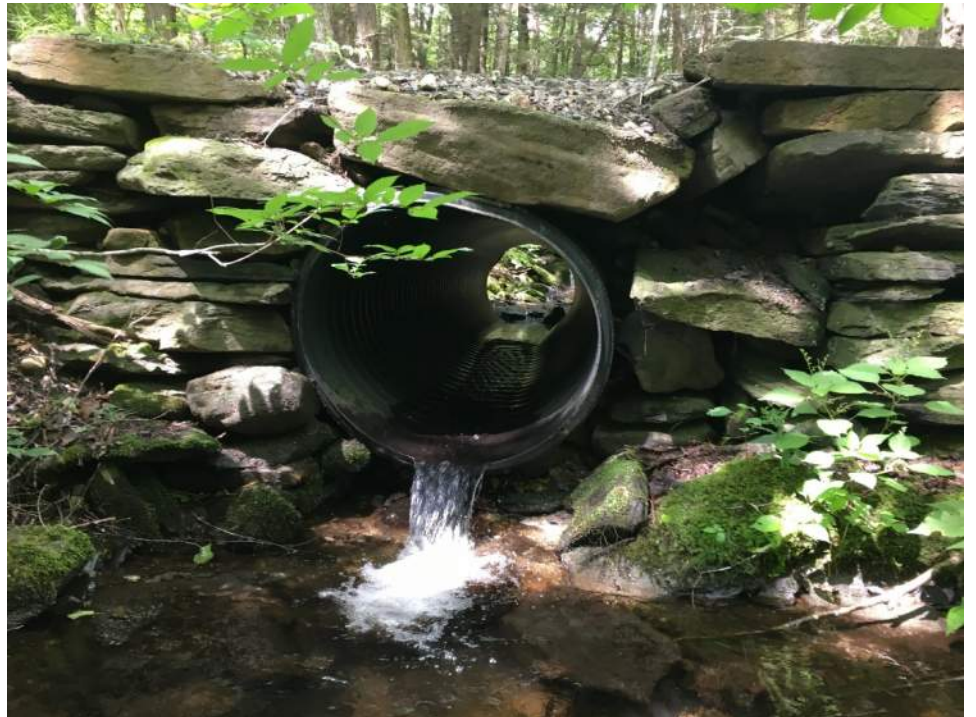
8" water drop in combination with water pool directly under pipe is cause a 12" deep under cutting

Top right section of the outlet is being depressed inwards by a large stone headwall rock directly on the side of the roadway

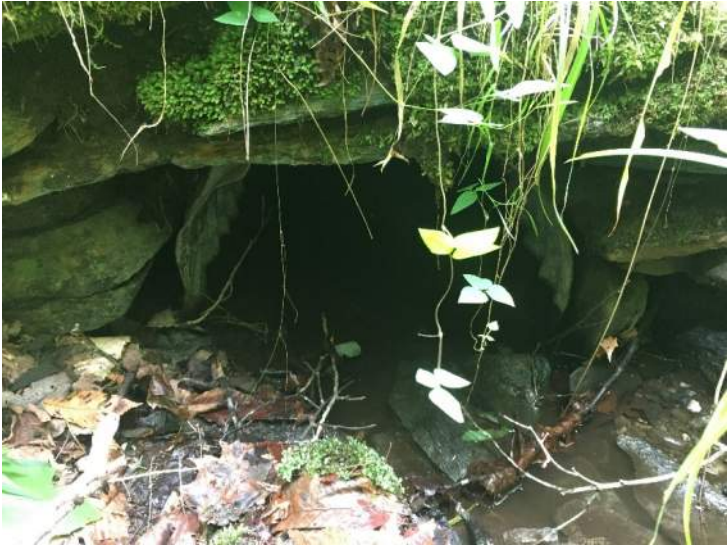
vhb Engineers Scientists Planners Designers		<h2 style="text-align: center;">Culvert Assessment</h2>	
Client Name: Town of Plainfield		Upstream Condition	
Culvert ID No: 34			
Photo:

Description: Bottom of pipe filled with sediment

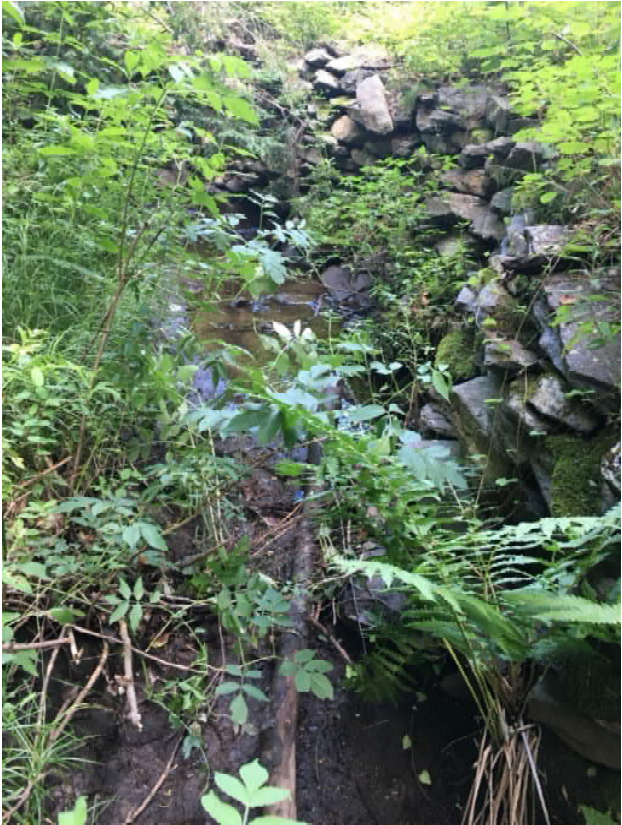
General Notes: Culvert has signs of being used during rainfall but the water observed flowing was seeping under road entering before culvert and exiting after culvert.

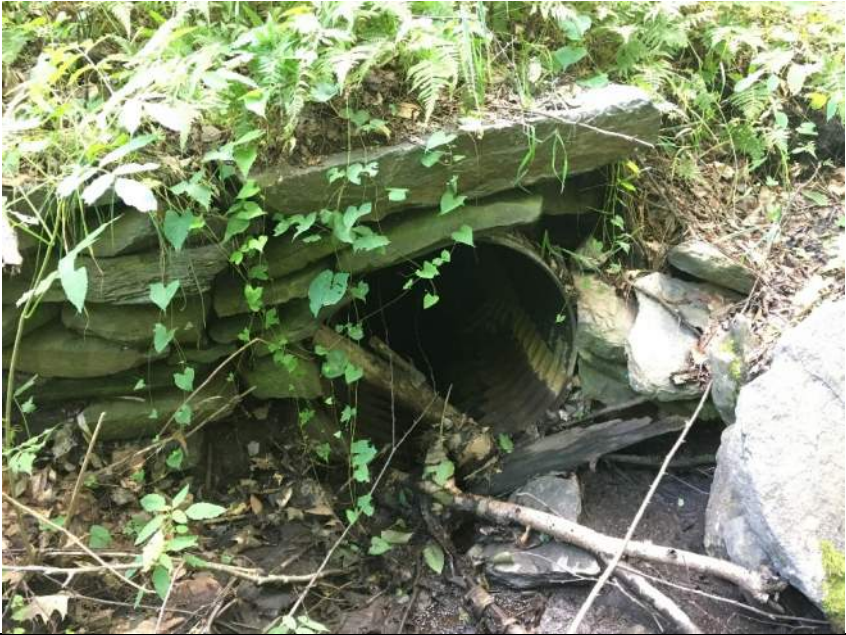
vhb Engineers Scientists Planners Designers		<h2 style="text-align: center;">Culvert Assessment</h2>	
Client Name: Town of Plainfield		Upstream Condition	
Culvert ID No: 35			
Photo:

Description:			
<p>Sticks and debris are held up at the entrance</p> <p>There is evidence of a few rot spots on the metal</p> <p>Water appears to be free flowing under the road before it reaches the culvert. The soil in front of the culvert is wet but the flowing stream stops 15' before the culvert and flows underground</p>

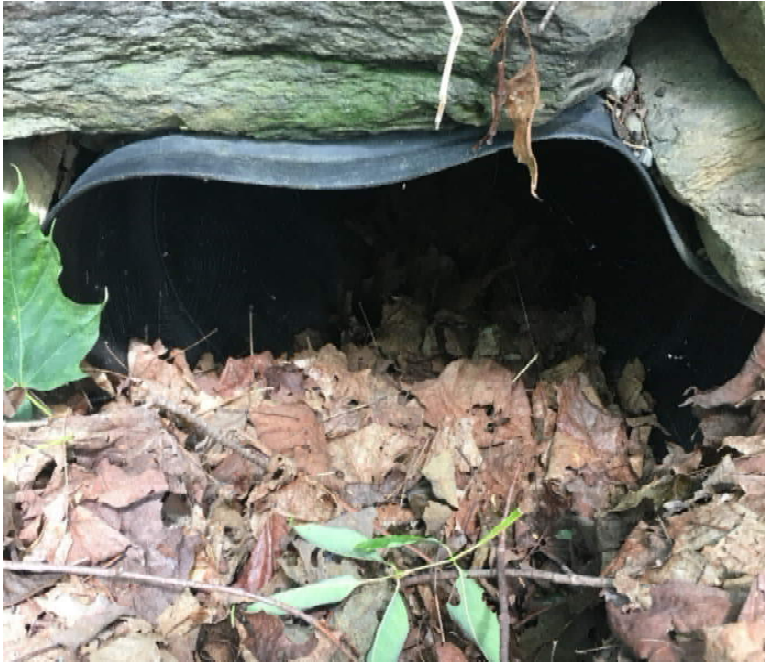
vhb Engineers Scientists Planners Designers		<h2 style="text-align: center;">Culvert Assessment</h2>		
Client Name: Town of Plainfield		Upstream Condition		Culvert ID No: 36
Photo:

Description: Extent of pipe filled with leaves Top front lip bending under weight of stone head wall

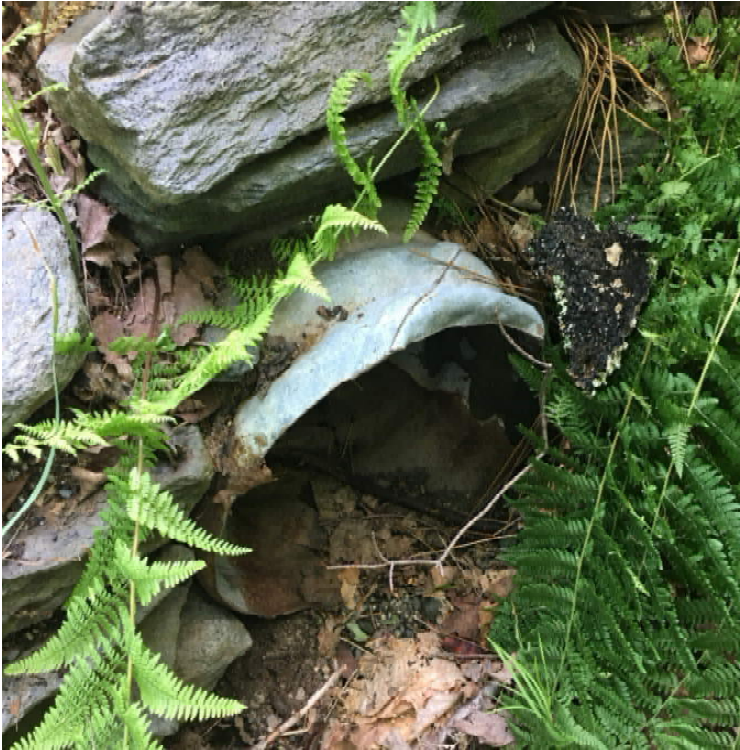
vhb Engineers Scientists Planners Designers		<h2 style="text-align: center;">Culvert Assessment</h2>	
Client Name: Town of Plainfield		Upstream Condition	
Culvert ID No: 37			
Photo:

Description: Bottom of pipe is rotting Deep undercutting on right side of pipe

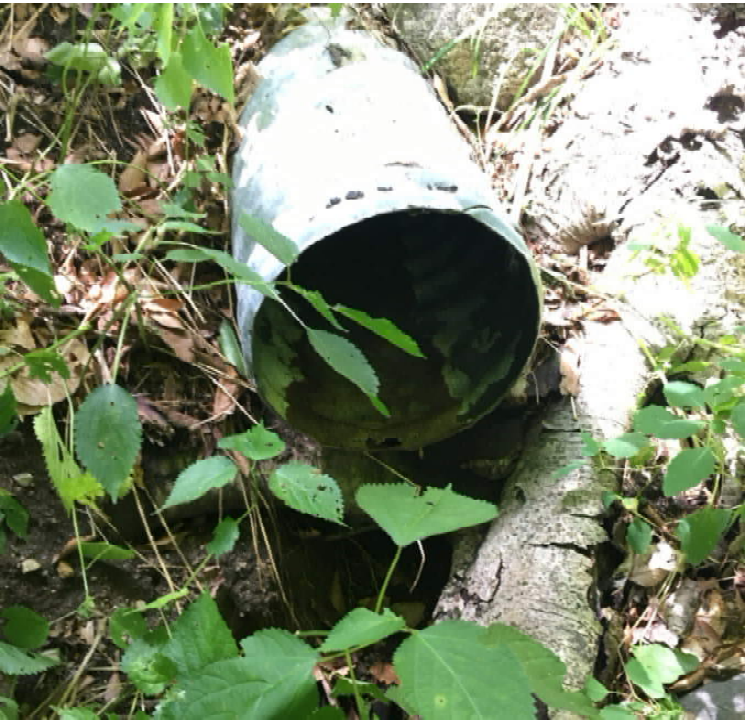
vhb Engineers Scientists Planners Designers		<h2 style="text-align: center;">Culvert Adjacent Assessment</h2>	
Client Name: Town of Plainfield		Downstream Condition	
Culvert ID No: 37			
Photos:

Description: 20" water drop over tree root growing under pipe. Soil under tree root has been eroded away. Bottom lip of exit has a rot hole forming

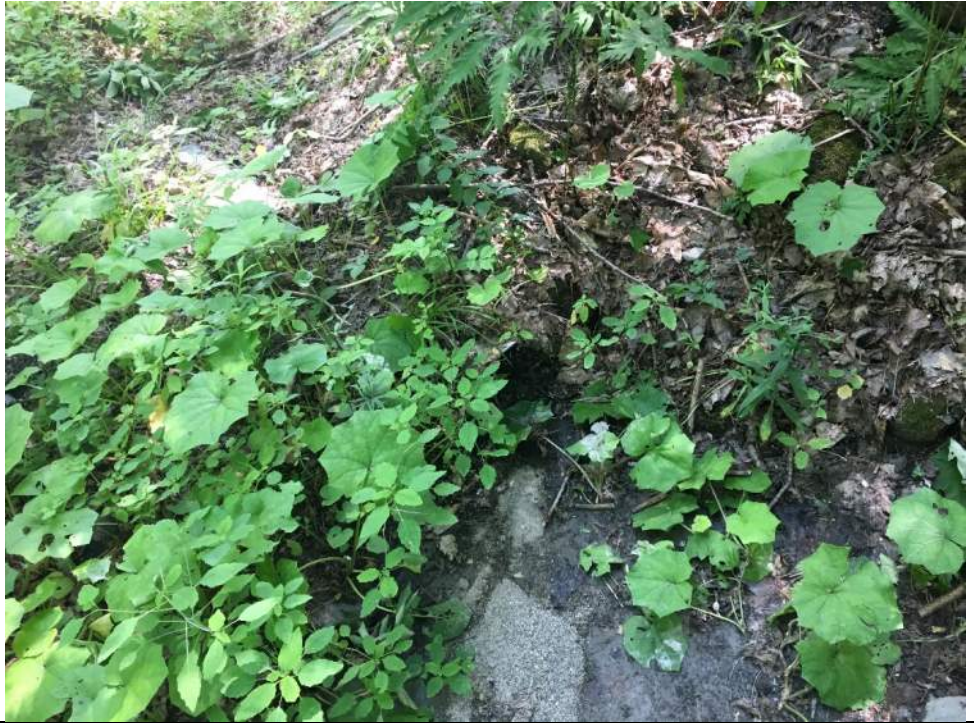
5.5" of sediment build up at bottom of pipe

Material over culvert has been washed away exposing top of culvert. Possibly indicating culvert not able to handle water flow and possible road flooding

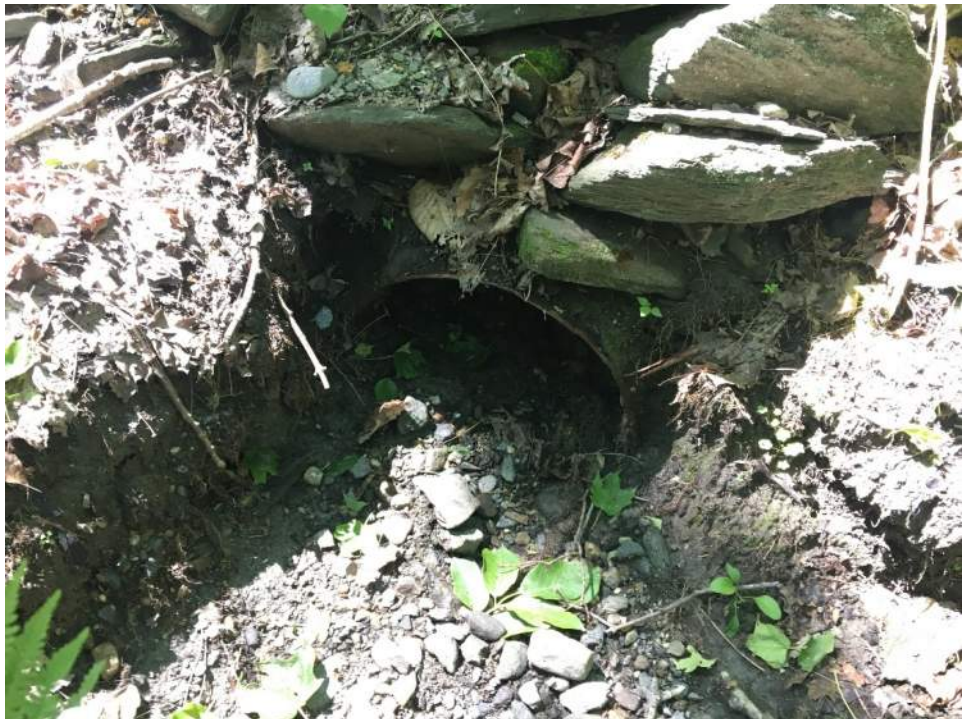
Heavy rust line on sides of pipe

6.5" of sediment build up

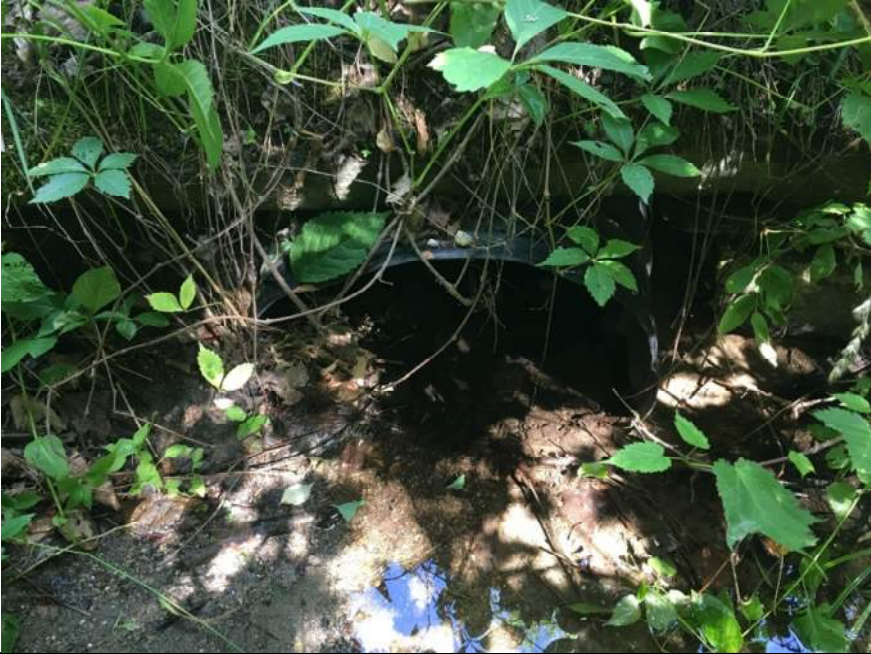
vhb Engineers Scientists Planners Designers		<h2 style="text-align: center;">Culvert Assessment</h2>	
Client Name: Town of Plainfield		Upstream Condition	
Culvert ID No: 40			
Photo:

Description:			
<p>Sticks hold back sediment from free flowing down pipe</p> <p>Slight compressive deformation through out pipe</p> <p>Pipe collapse in center of pipe</p>

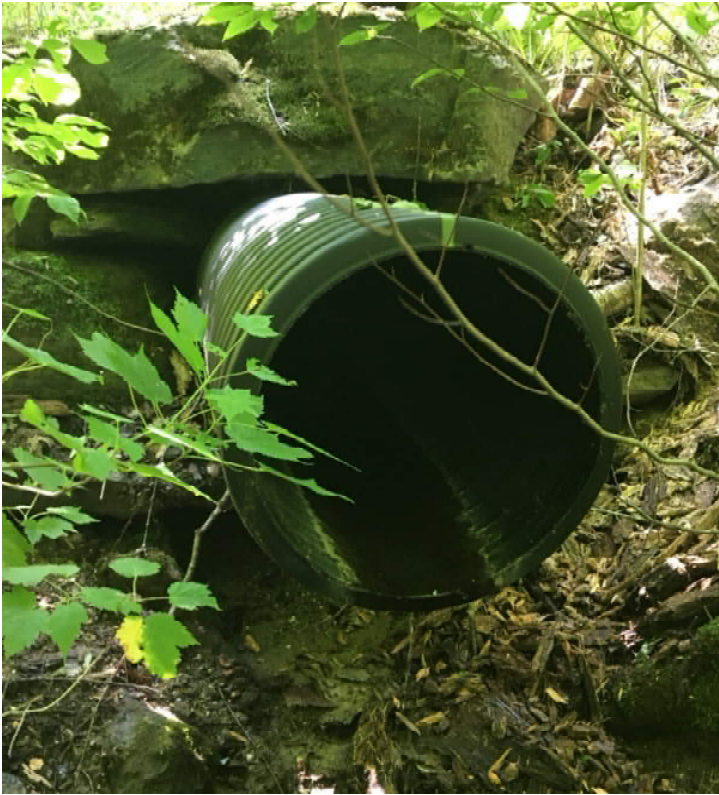
vhb Engineers Scientists Planners Designers		<h2 style="text-align: center;">Culvert Adjacent Assessment</h2>	
Client Name: Town of Plainfield		Downstream Condition	
Culvert ID No: 40			
Photos:

Description:			
<p>25" water drop with 6'+ undercutting</p>
